**Arborist Report
PRELIMINARY**

Site: City Hall Park

Re: Tree inventory

Date: November 7, 2023

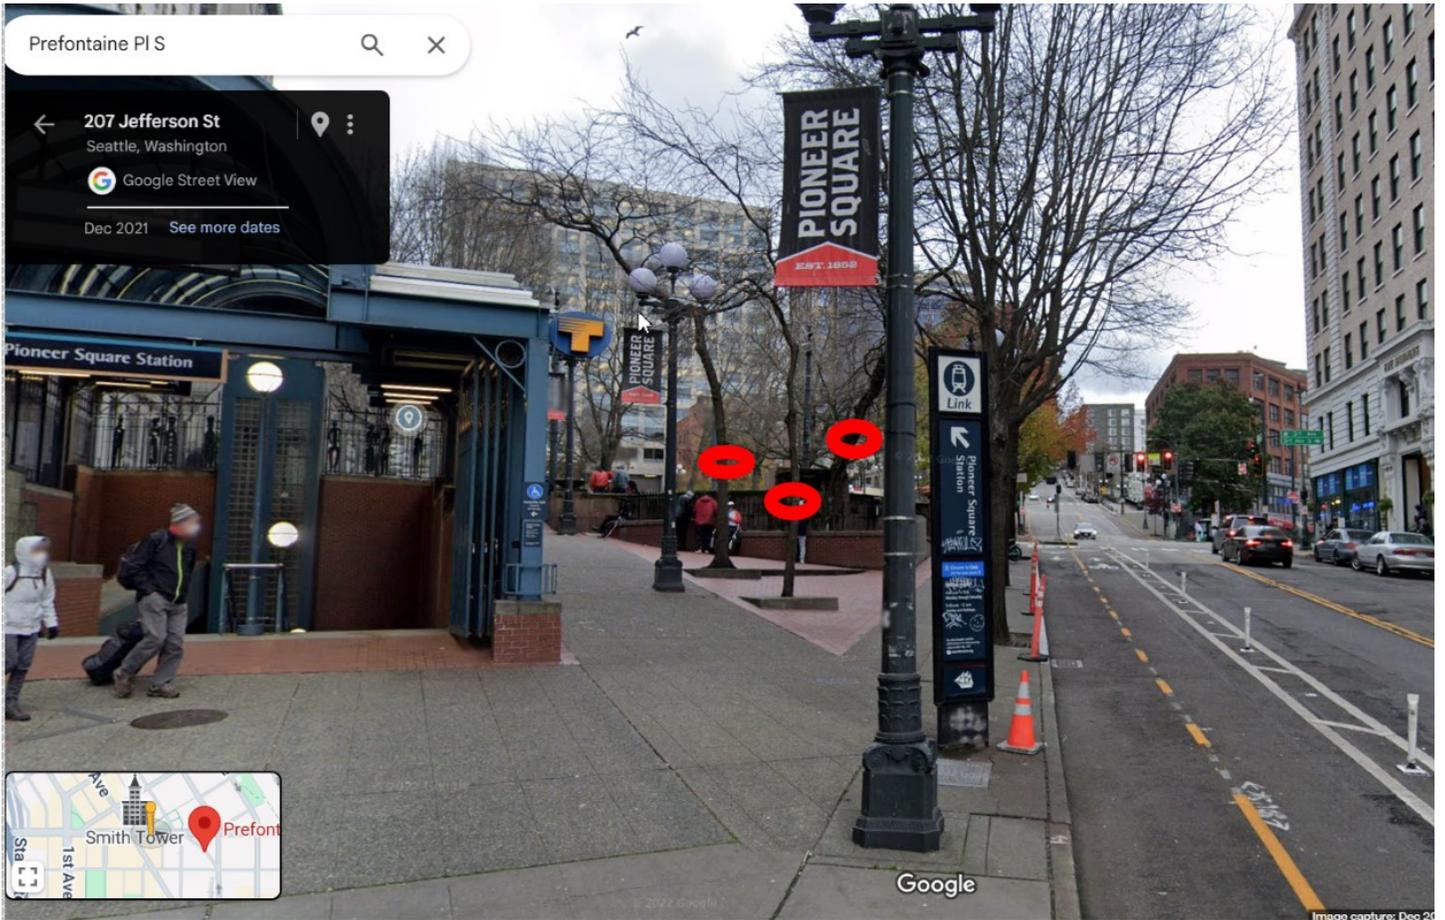
As discussed earlier, we would like to proceed with removing the tree marked with an X, which is the one most leaning. We will compensate for this tree at a 3:1 rate on a site other than Prefontaine TBD. Please confirm this understanding. Thank you!

We visited this site and with your input determined that the trees signified below with a bold red circle are in fair to poor condition and can be removed. What is the process required to expedite the removals?

Yes, confirmed. Please make sure this is reflected on the plan and the replacement tree locations are provided with the plan.

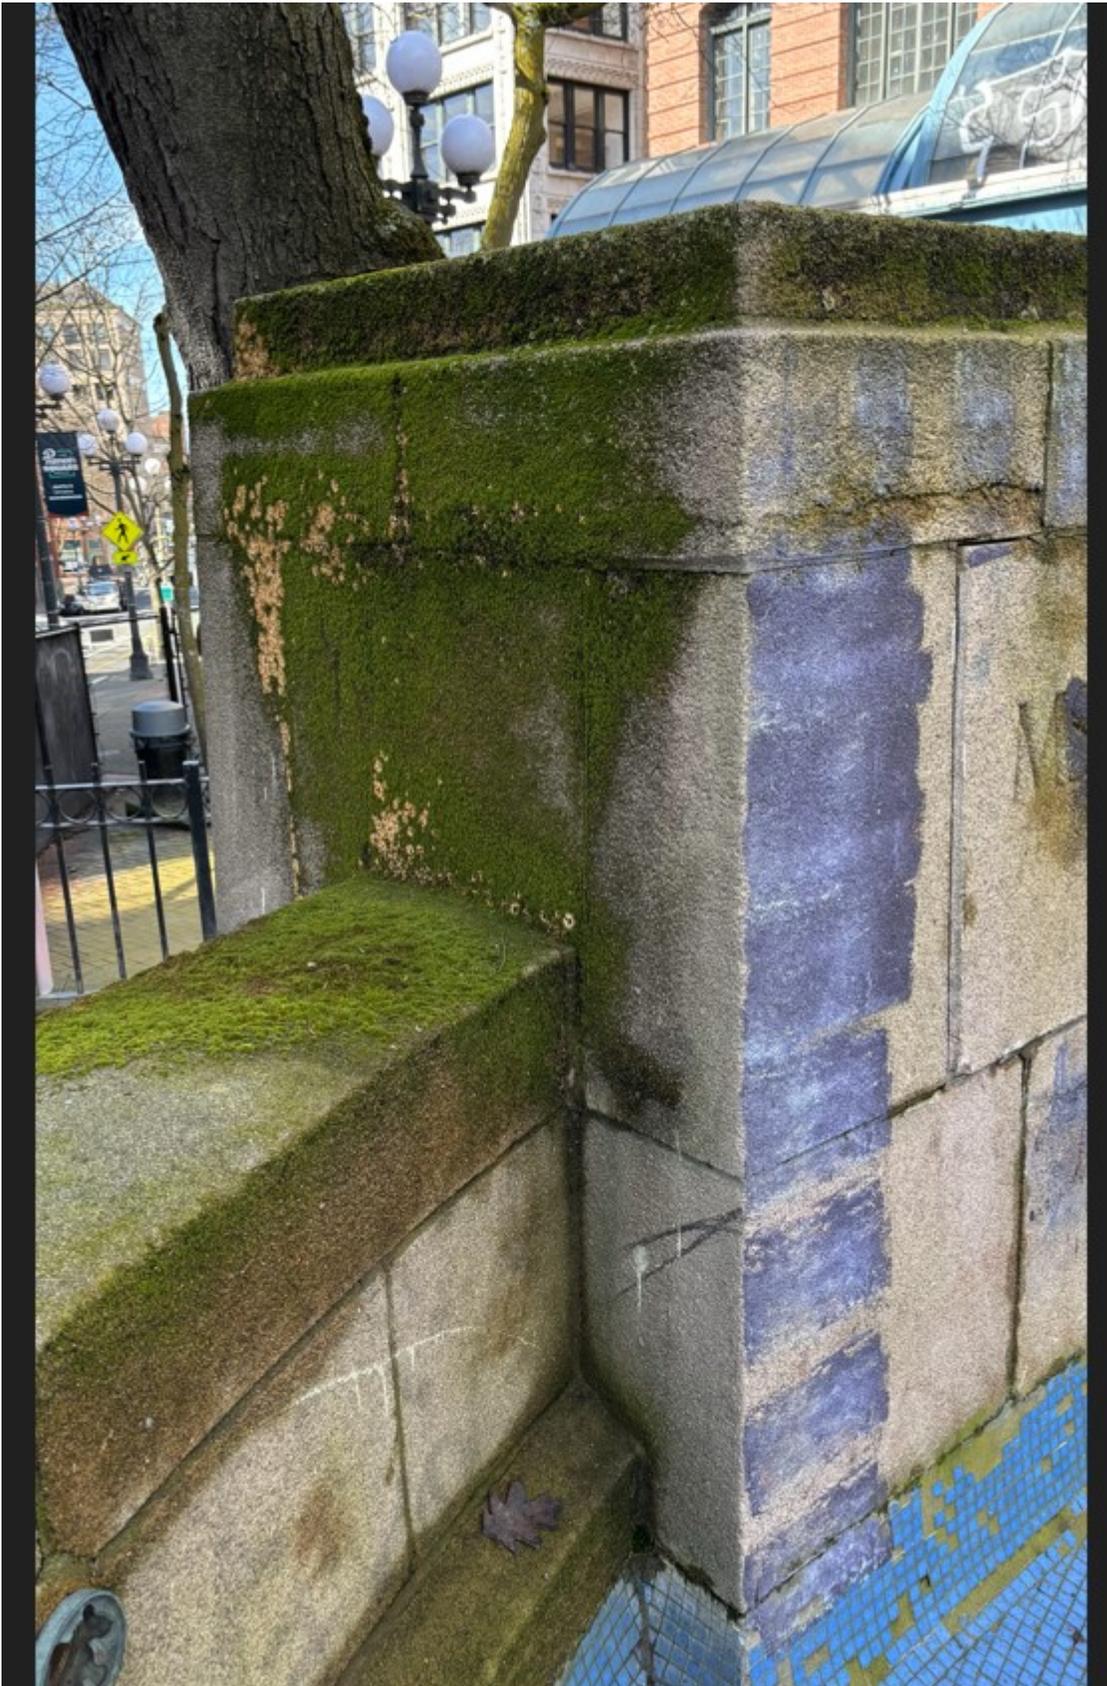
Morteza - after you left yesterday Ben and I noticed there is some damage to the main monument. Some of the blocks have shifted. After closer inspection, it appears the large tree that is leaning has been pushing on the stones in windstorms and has pushed the stones out of place by about ¼ of an inch. Ben was stressing that that tree really needs to come out in order to preserve the integrity of the structure.

In the photo below, you can see part of a scar on the bark where the trunk rubs up against the stone. The movement of the stone is hard to see in the photos, more apparent when you are on site.

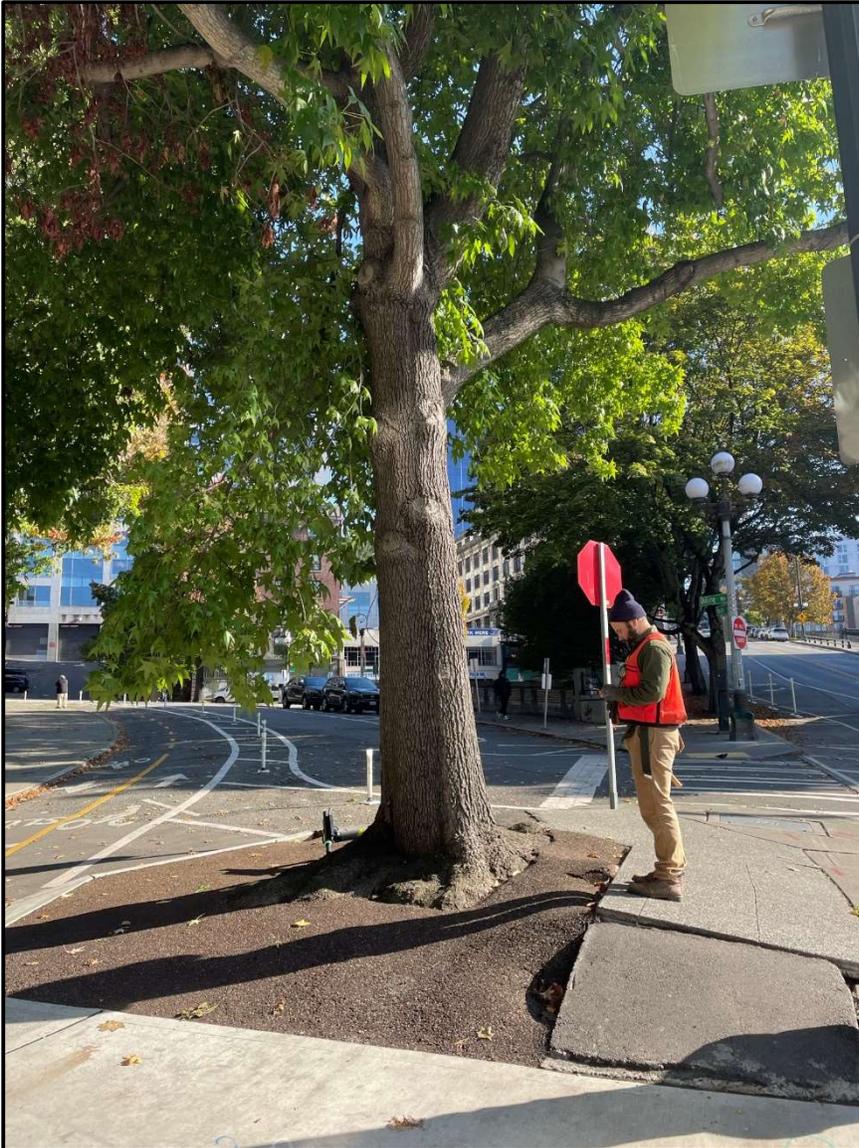
Photo 5. Street tree #TRE-1084223 has considerable sidewalk uplift.

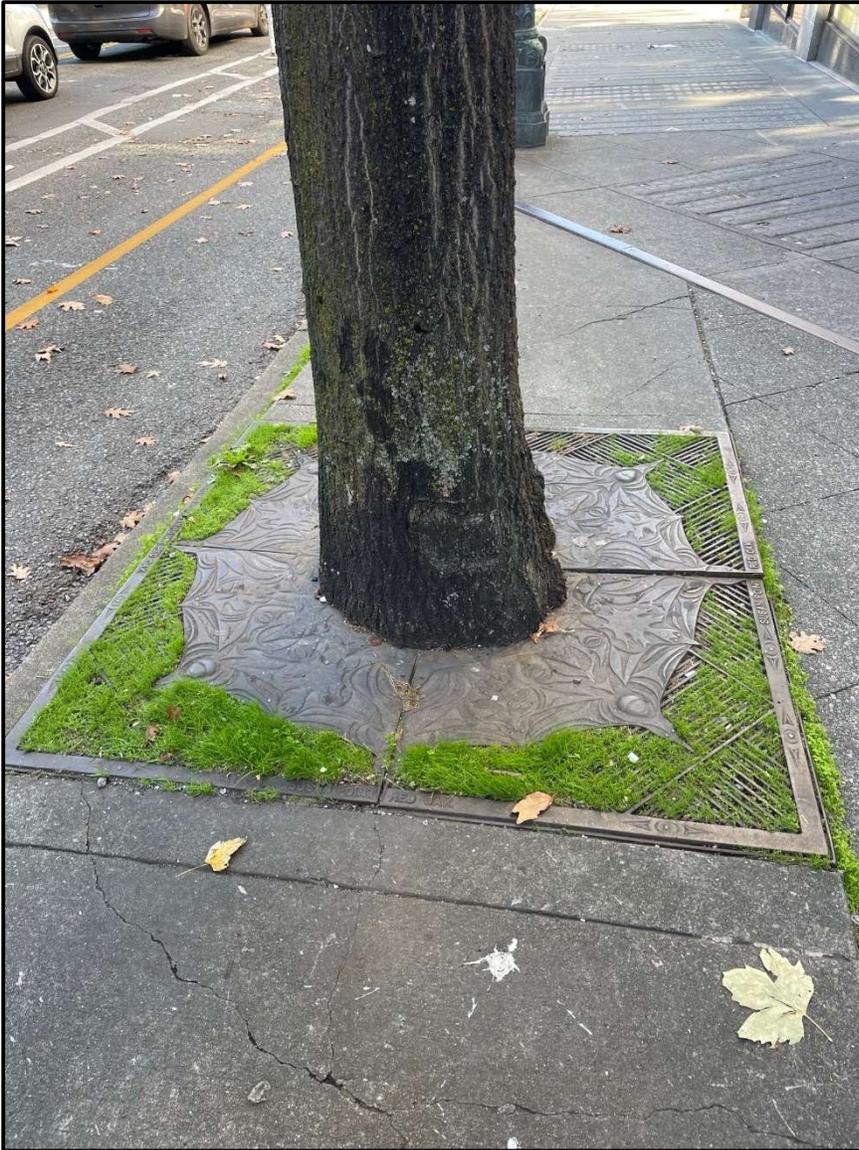
Several street trees are actively being girdled by tree grates and should be removed or managed.

Photo 11. Street tree near Prefontaine Place. Tree is being girdled by tree grate and requires management as soon as possible.

Several street trees were planted in tree wells with tree grates at the base. In 4 situations (trees TRE-1089262, TRE-68045, TRE-68069 and TRE-68073) the tree had out-grown the grate and was partially or completely engulfing the metal. These grates should be removed, replaced, or expanded as soon as possible to minimize long-term damage to the trees.
