Project name: Cannery  
Address: 213 S Main Street

213 MAIN DEMO

This report presents the results of our structural evaluation of the structure located at 213 S Main Street in Seattle, WA. This work has been performed at the request of the building owner to determine the current condition of the building as it relates to possibly repair or demolition.

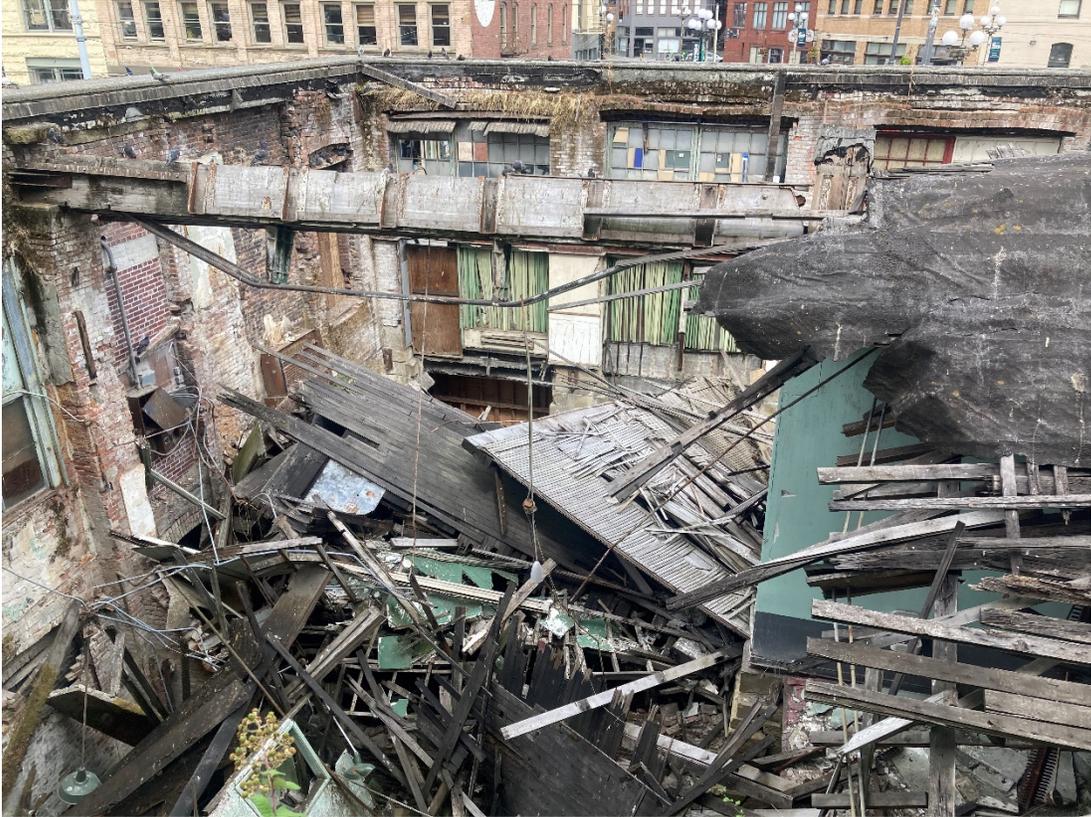
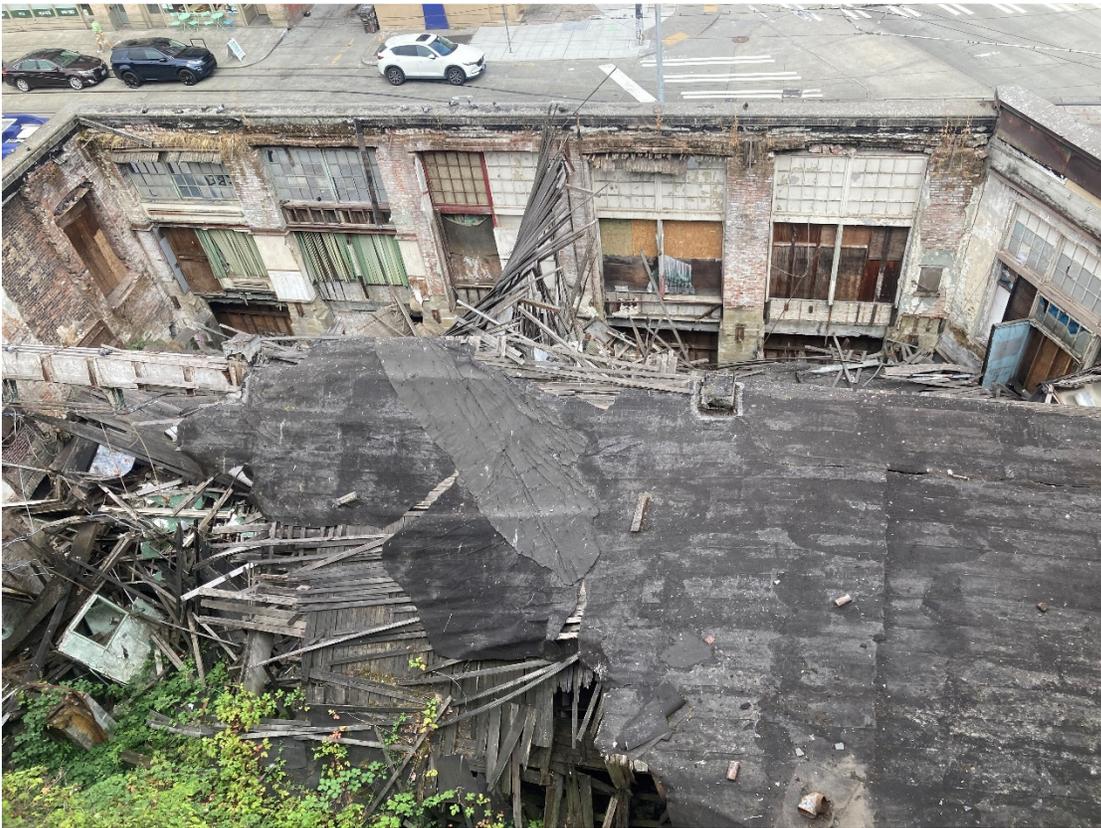
Currently, in addition to the damage from the original fire and reconstruction of the building during construction of the Second Avenue Extension, the roof has almost entirely collapsed, with only a small area remaining place at the southeast corner. Similarly, the majority of the at-grade floor framing has also collapsed. The building has remained in this condition for many years, and additional damage has resulted from the exposure to weather. Substantial plant growth from inside the building is visible from above. These conditions can be observed in the current photographs presented below, taken from the adjacent building to the south looking north.

Based on our observations, it is our opinion that the building should be classified as a “Dangerous Building” per the Existing Building Code, and we recommend that the building be demolished in the interest of safety.

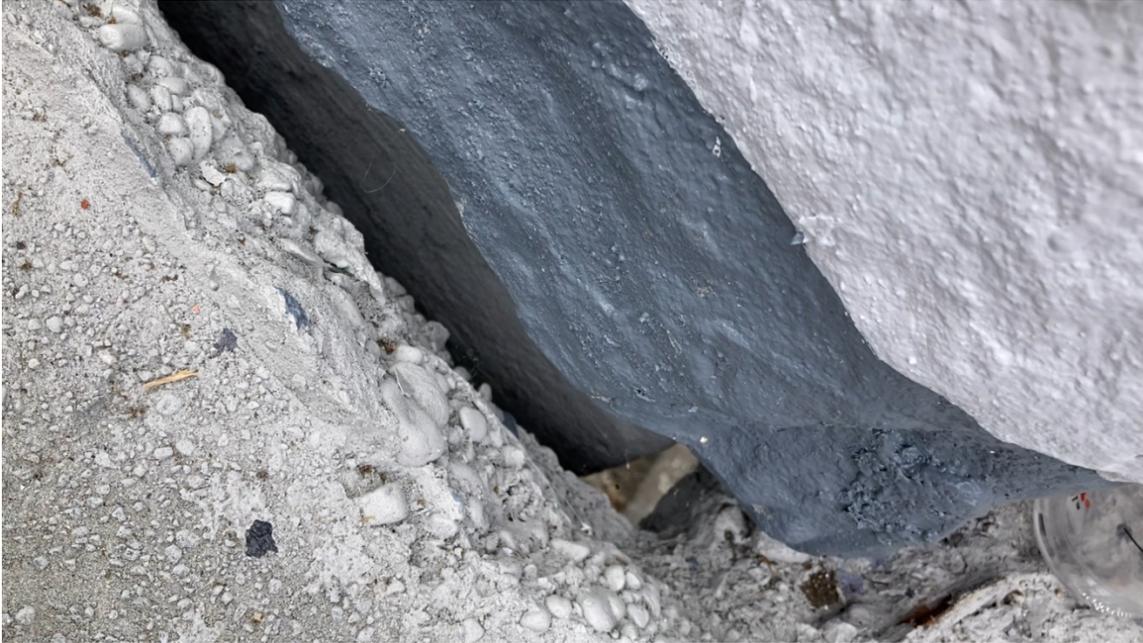
The URM walls are showing signs of significant deterioration with displaced bricks in many locations, in particular in the keystone arches over the windows on the north façade. We also observed that a gap has formed between the concrete sidewalk slab and the primary structure on the north side at the northwest corner, shown in the photo below.

The gap forming between the sidewalk slab and the primary structure suggests that the north exterior wall is beginning to move away toward the unbraced side. It is unclear if this is due to the walls failing, or due to the surcharge of earth loading from the sidewalk and street, but it is our opinion that it is likely a combination of both conditions. It is also our opinion, that the concrete cap forming the parapet is providing a sort of “ring beam” action to provide a minimal

amount of bracing, and that if not for this unintended behavior, the entire structure likely would have already collapsed.
