B.F. Day Elementary School

Landmarks Preservation Board Briefing Packet
February 28, 2025

EXISTING WINDOW CONDITION

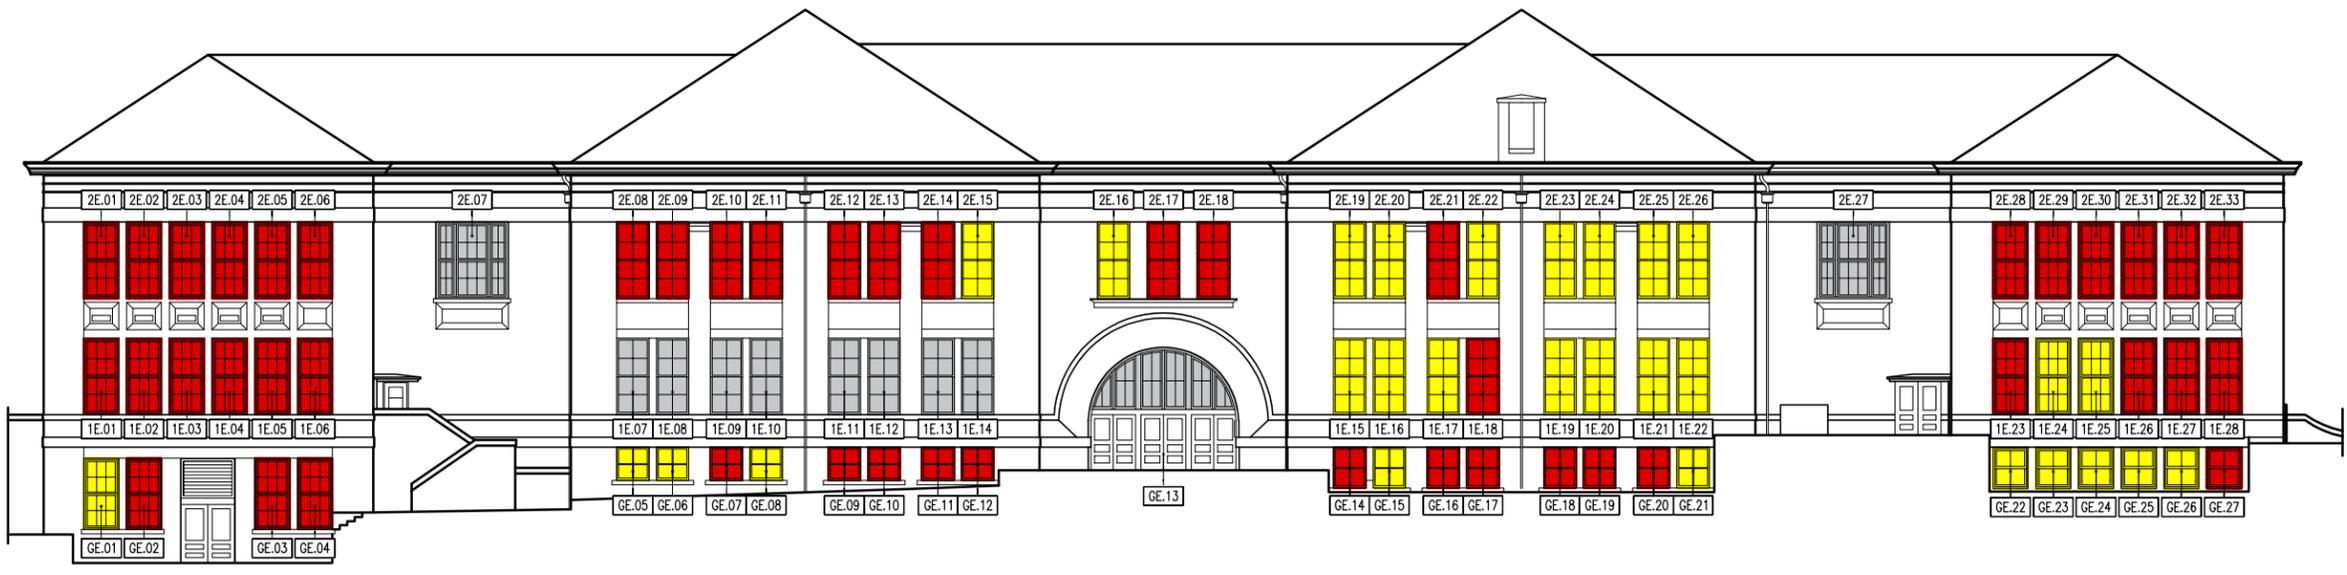
EAST ELEVATION

Window Condition Summary
 (2) openings in good condition
 (55) in moderate condition
 (128) in poor condition

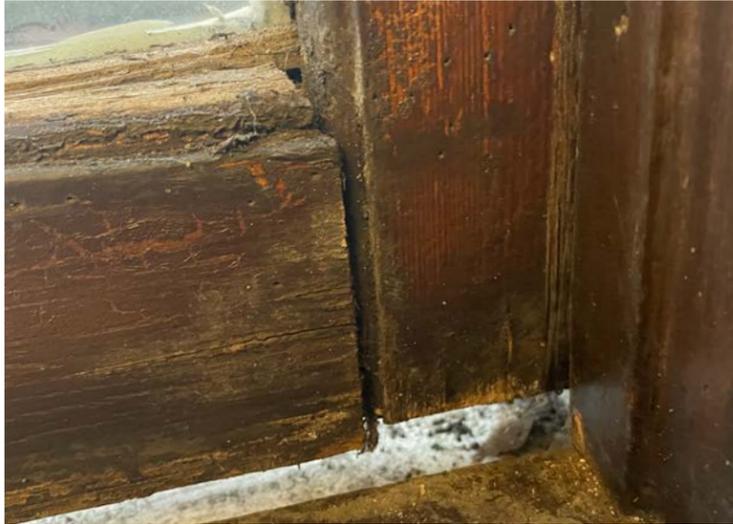
Separation between stile and bottom rail

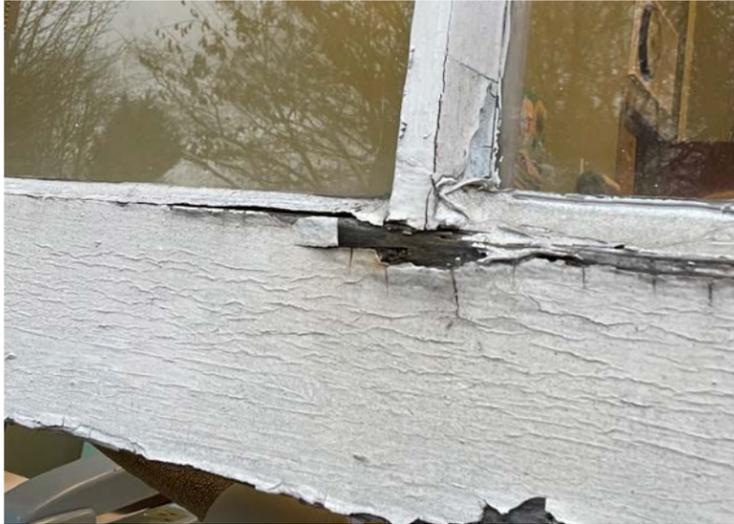
Dry rot at intersection of muntins and sash

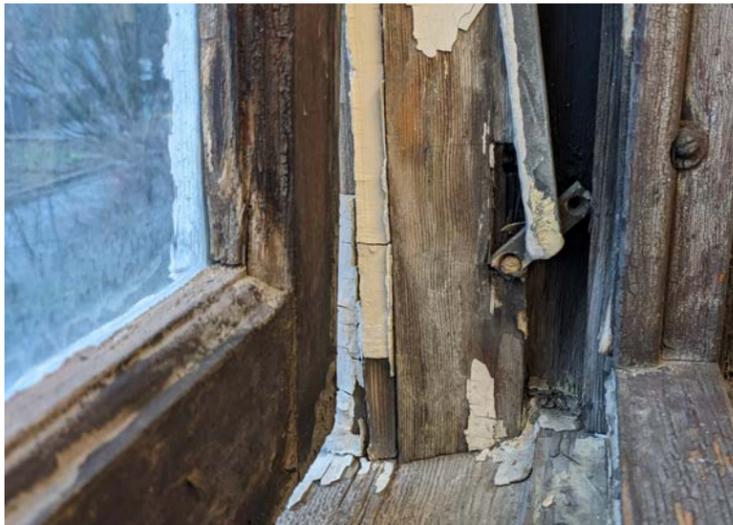
1916 tilt hardware in very bad condition

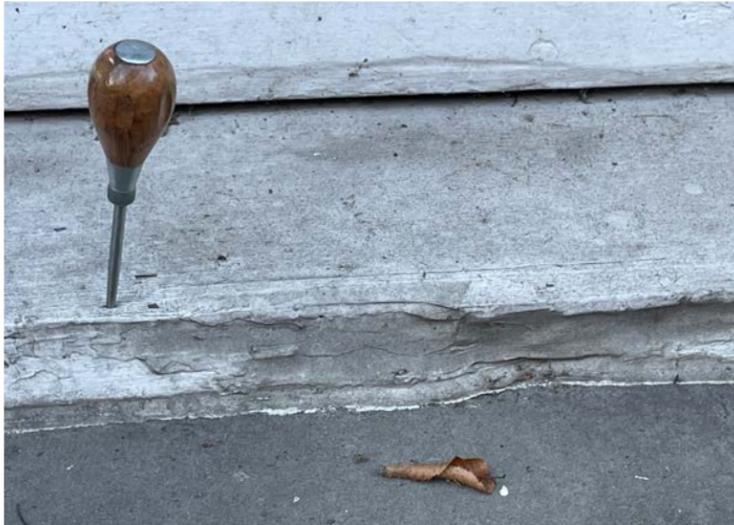
Advanced wood rot at sills

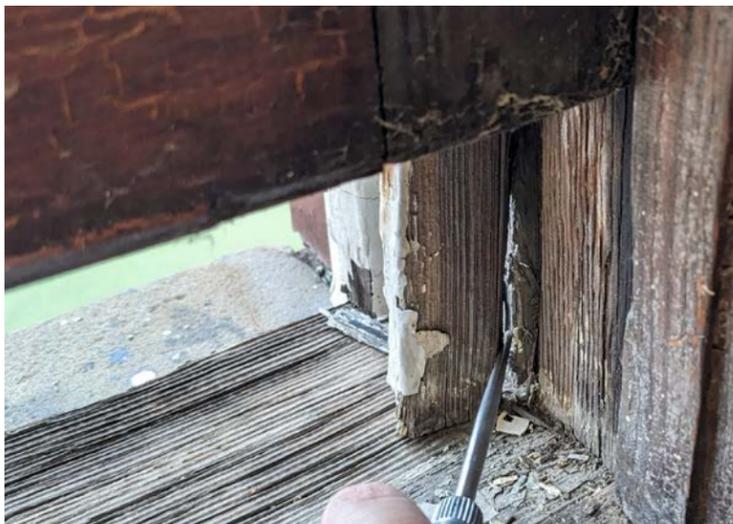
Deteriorated/partially missing parting bead

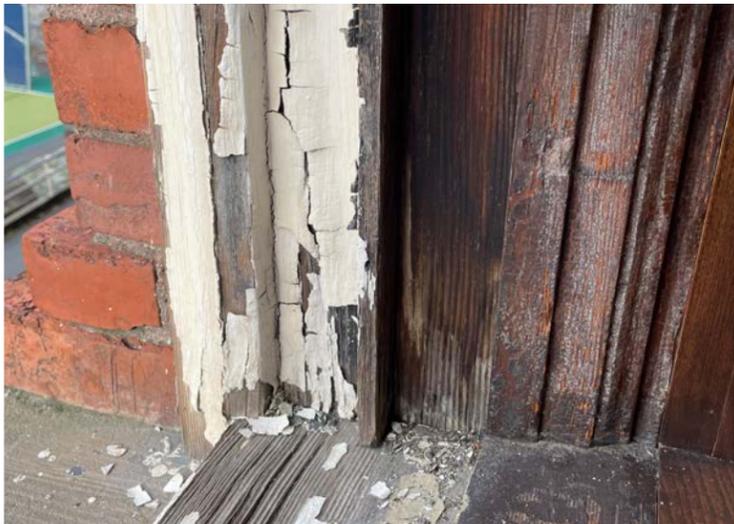
Exterior paint failure resulting in weathered bare wood at frame and sill
