# PACIFIC APARTMENTS REHABILITATION

# EXISTING CONDITIONS- CONTEMPORARY PHOTOGRAPHS

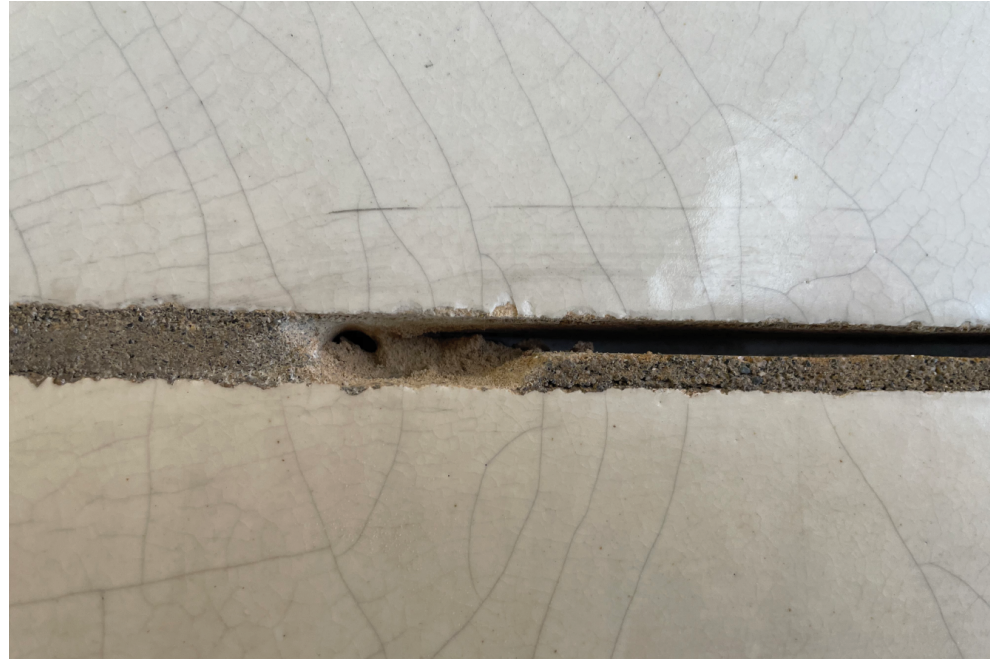
Figure 18: Typical crazed terra cotta and mortar joint at the Pacific Apartments. Note the soiled or skim coated mortar at the surface compared to the warm colored mortar deeper in the joint.  
220222 PH-Pac Sample 10 IMG\_1100.JPG. Credit: Richaven, 2022

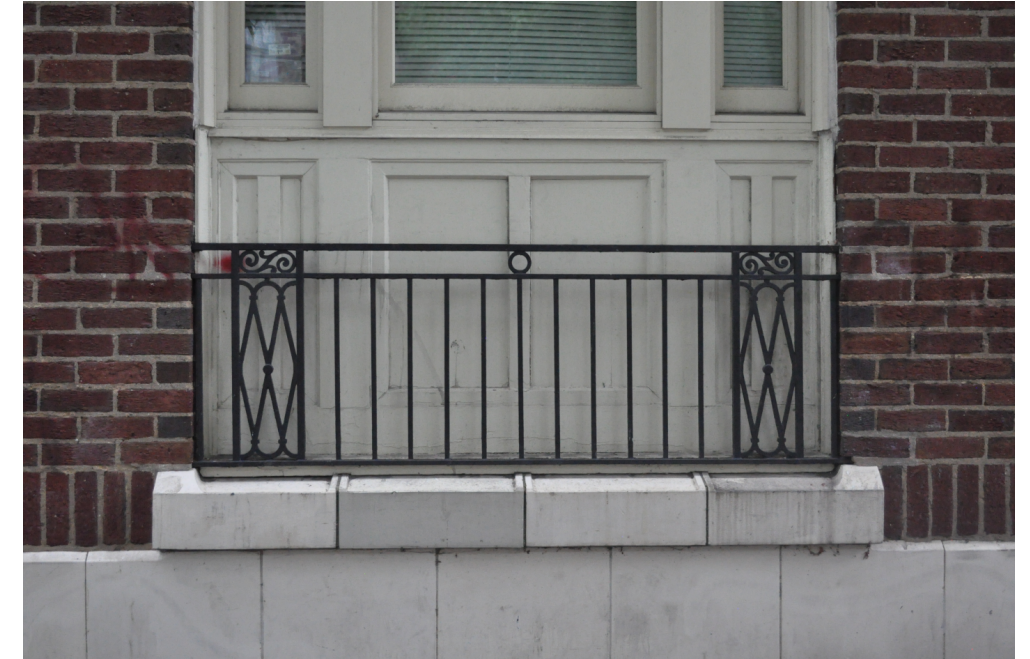
Figure 22: Typical historic wood wainscot at the base of the 2019 replacement windows illustrates minor wood repairs required, spray paint graffiti, and building soiling.  
210526 PAC EL-E DSC\_0648.JPG. Credit: Richaven, 2022

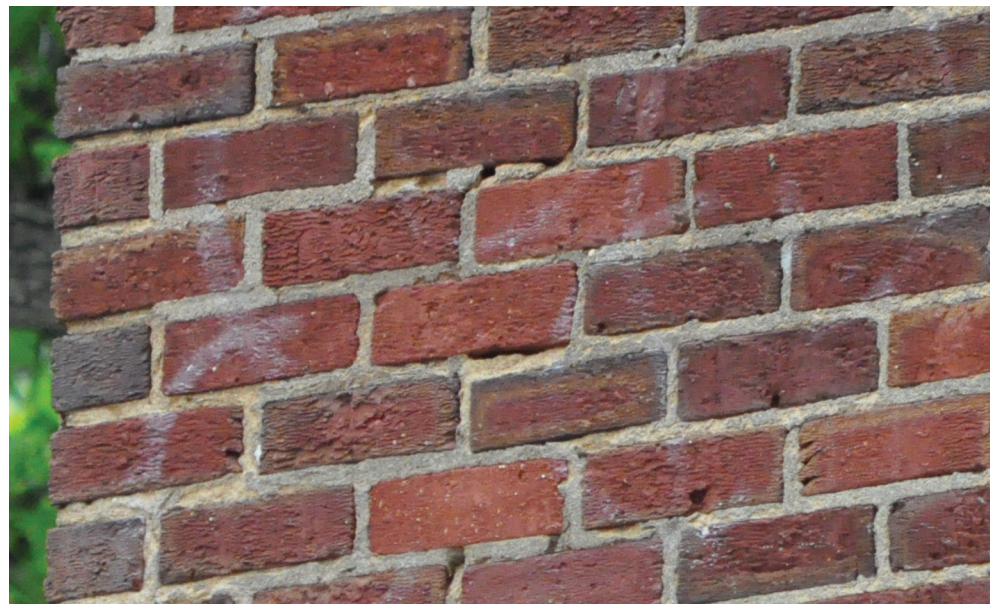
Figure 19: The brick and mortar at the northeast corner of the building illustrates the deterioration of the mortar and texture of the brick. Also present is the ghosted appearance of spray paint graffiti.  
210526 PAC EL-N-E DSC\_0479.JPG. Credit: Richaven, 2022

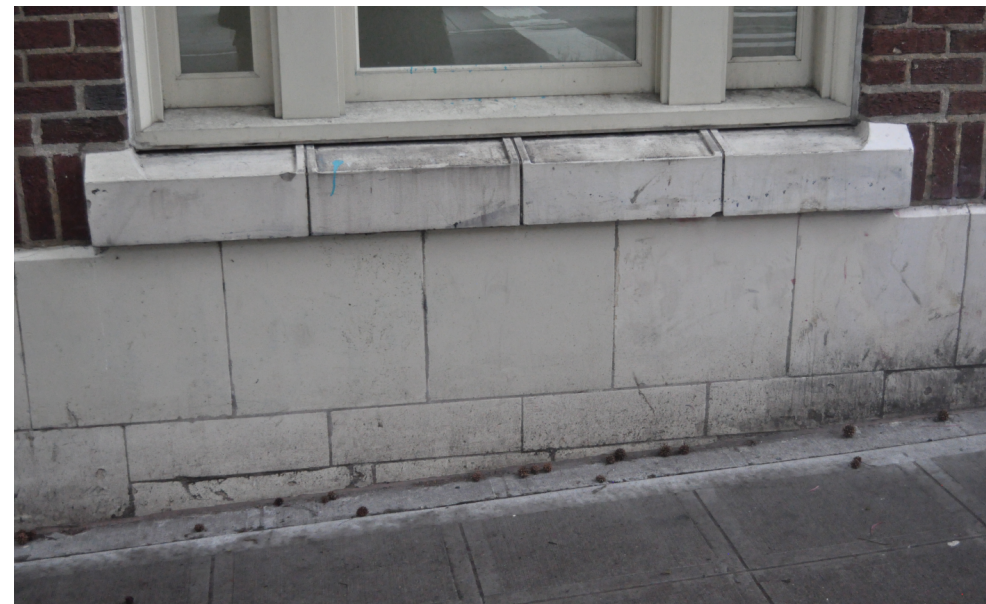
Figure 21: The terra cotta at the street level is significantly soiled with dirt, marker, paint, atmospheric soiling, backsplashed dirt, and other materials.  
210526 PAC EL-E DSC\_0651.JPG. Credit: Richaven, 2022

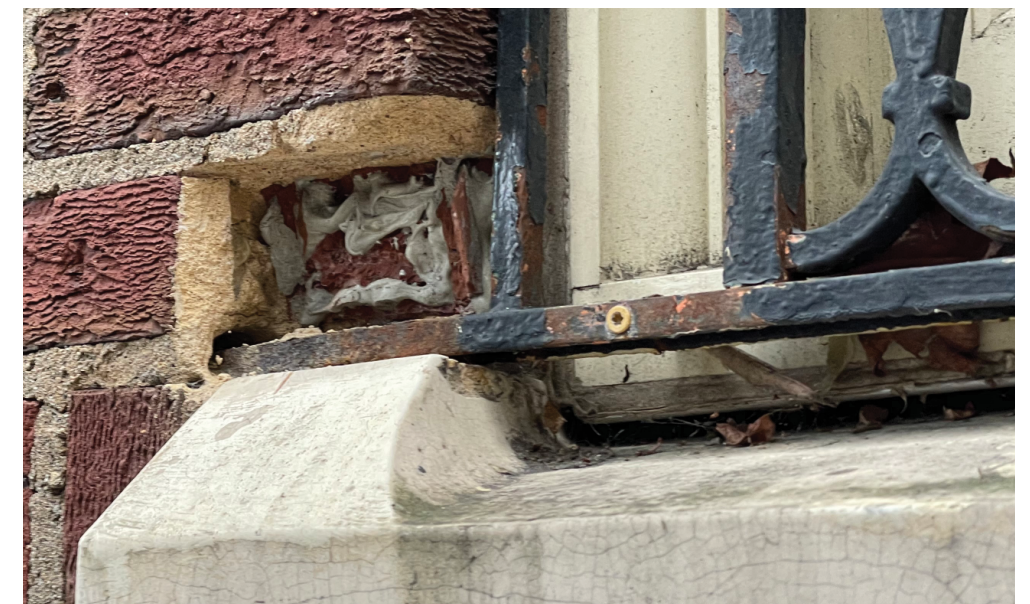
Figure 23: The brick at railings is often displaced, broken, or missing due to wear and tear on the railings, mortar deterioration, and rust jacking. Note the skim coat mortar patching over the yellow original mortar and the screw into the window.  
IMG\_1051.JPG. Credit: Richaven, 2022

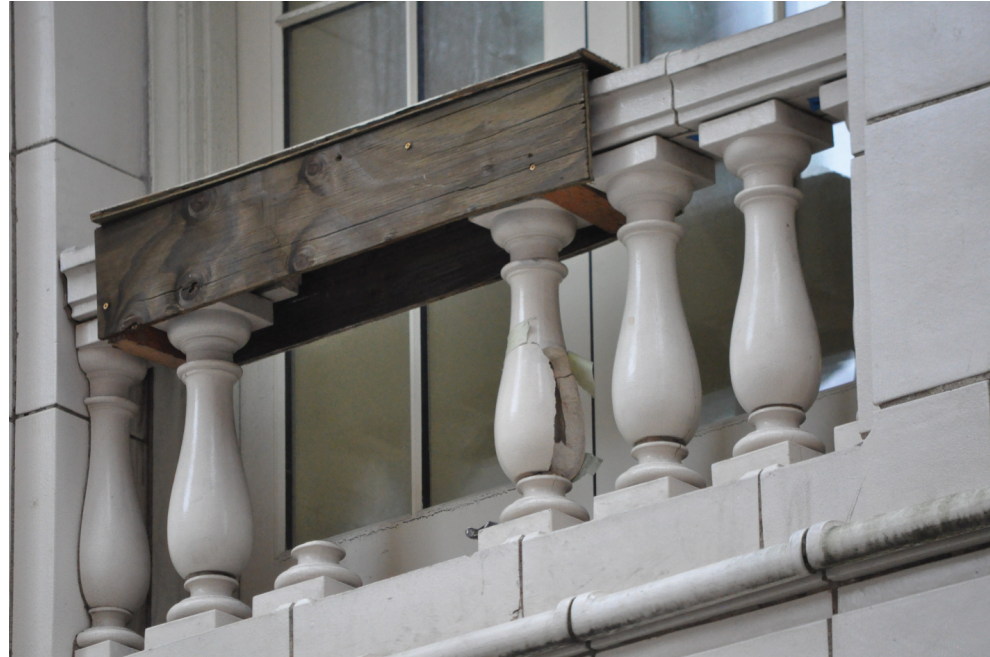
Figure 24: This severely deteriorated balustrade is located at the third floor level of the north elevation above the entry to the east (apartment) wing of the building. 210526 PAC EL-N-E DSC\_0478.JPG. Credit: Richaven, 2022

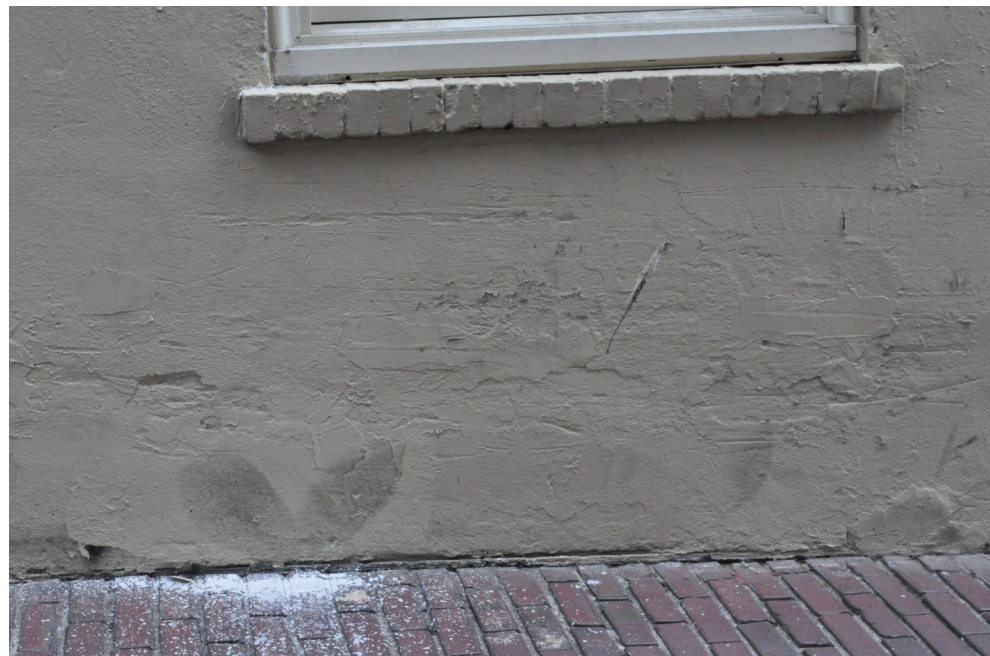
Figure 25: The west (alley) elevation of the building is coated in stucco directly applied to the hollow clay tile infill and reinforced concrete structure. This wall has been significantly damaged by vehicles and water damage and repaired multiple times. 210526 PAC EL-W DSC\_0717.JPG. Credit: Richaven, 2022

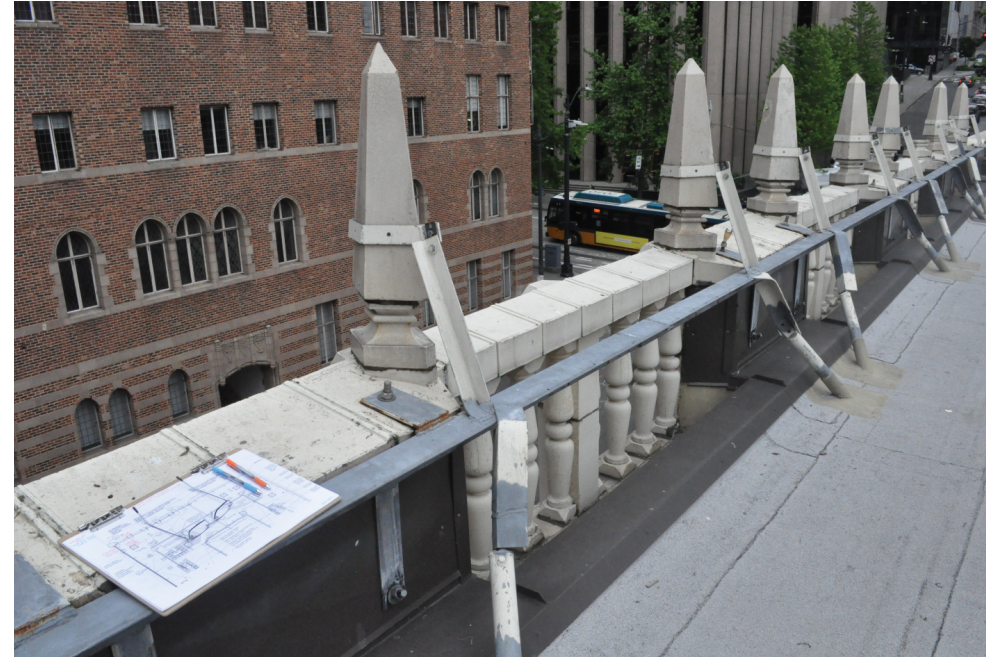
Figure 26: Finial and parapet bracing was installed in 1994. The bracing requires several repairs to comply with current code for parapet bracing requirements. 210526 PAC ROOF DSC\_0875.JPG. Credit: Richaven, 2022

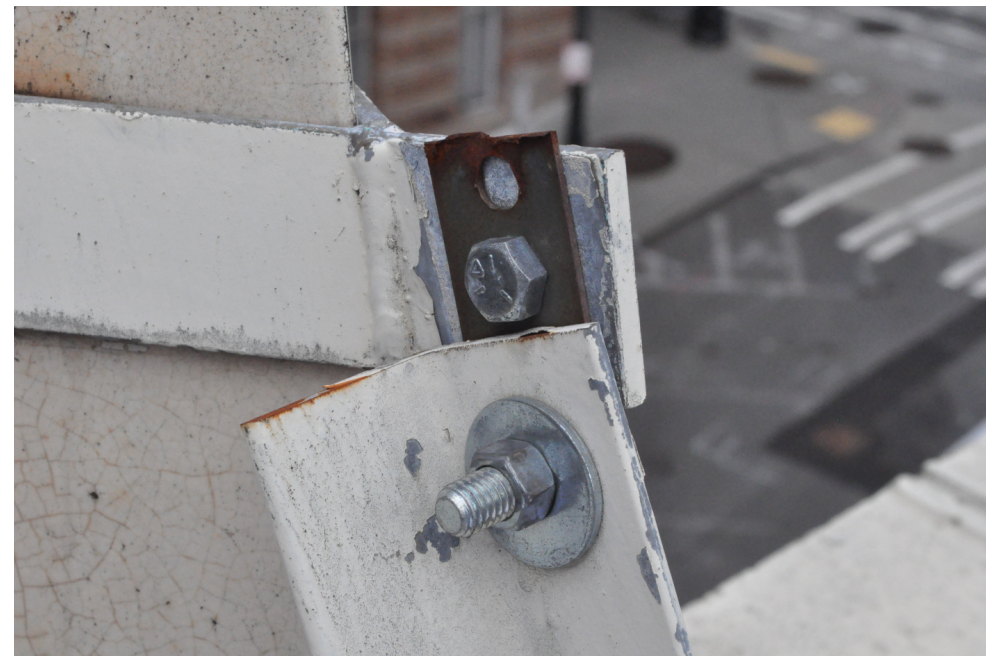
Figure 27: Make shift elements were added to the finial bracing to complete the original installation. Repairs are proposed to comply with current parapet bracing requirements. 210526 PAC ROOF DSC\_0884.JPG. Credit: Richaven, 2022

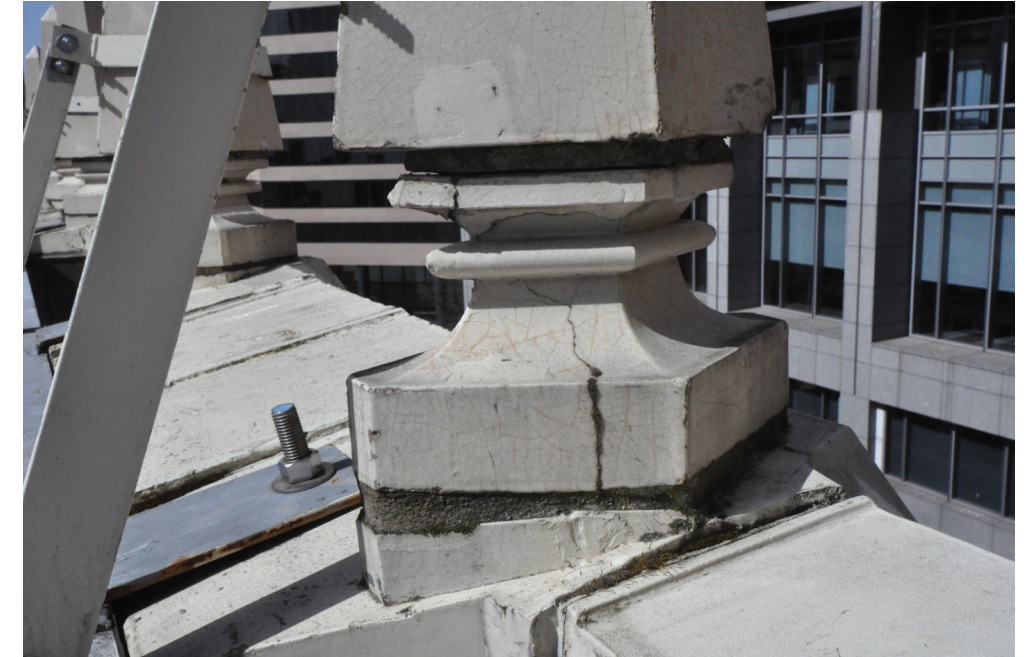
Figure 28: In several locations, original terra cotta blocks are cracking, spalled, or broken and are proposed to be replaced in-kind. See the color coded blocks on the building elevations. 210407 Pacific Hotel - DSC\_0179.JPG. Credit: Richaven, 2022

Terra cotta units have been classified as "Group A" (red) and "Group B" (green) based upon the nature of the deficiencies observed. Group A terra cotta units are cracked, spalled or otherwise damaged and will be replaced in-kind with glazed terra cotta units to match the existing deteriorated units.

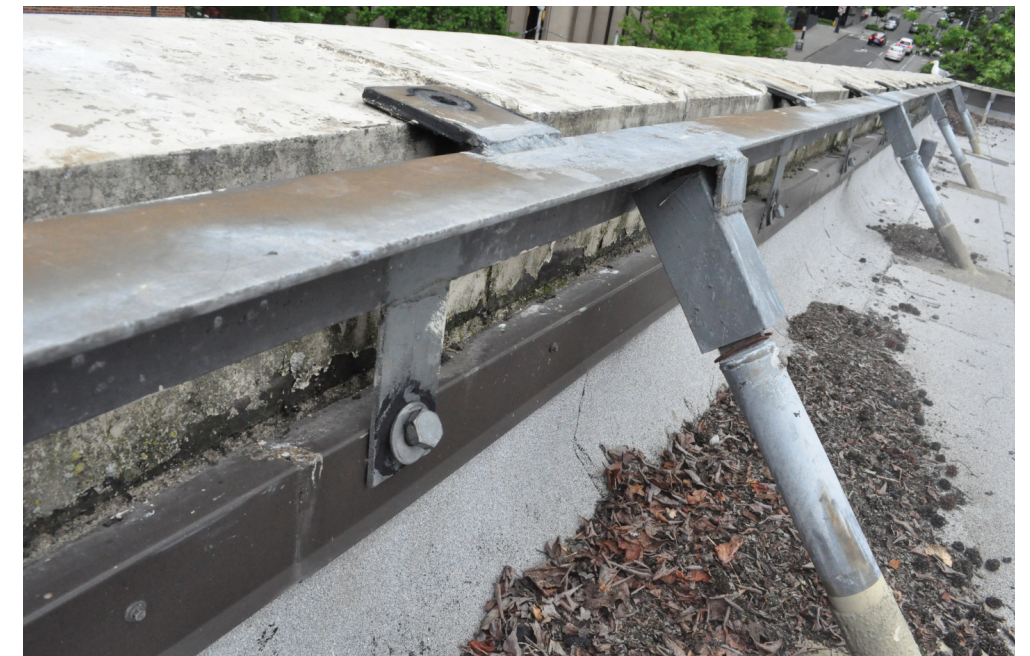
Figure 29: In some locations, parapet anchor bolts were not installed or were not sealed. Repairs are proposed to comply with current parapet bracing requirements. 210526 PAC ROOF DSC\_0900.JPG. Credit: Richaven, 2022

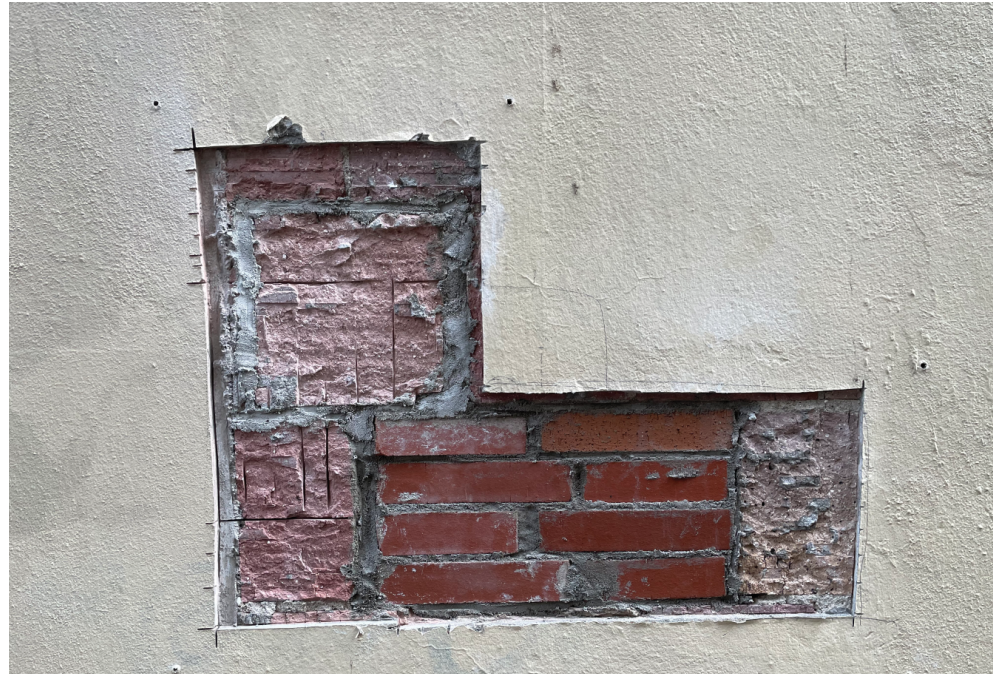
Figure 30: Samples of stucco cladding were removed from delaminated areas revealing multiple different substrates (clay tile, brick and concrete) and confirming no lath was originally installed. IMG\_1305.JPG. Credit: Richaven, 2022

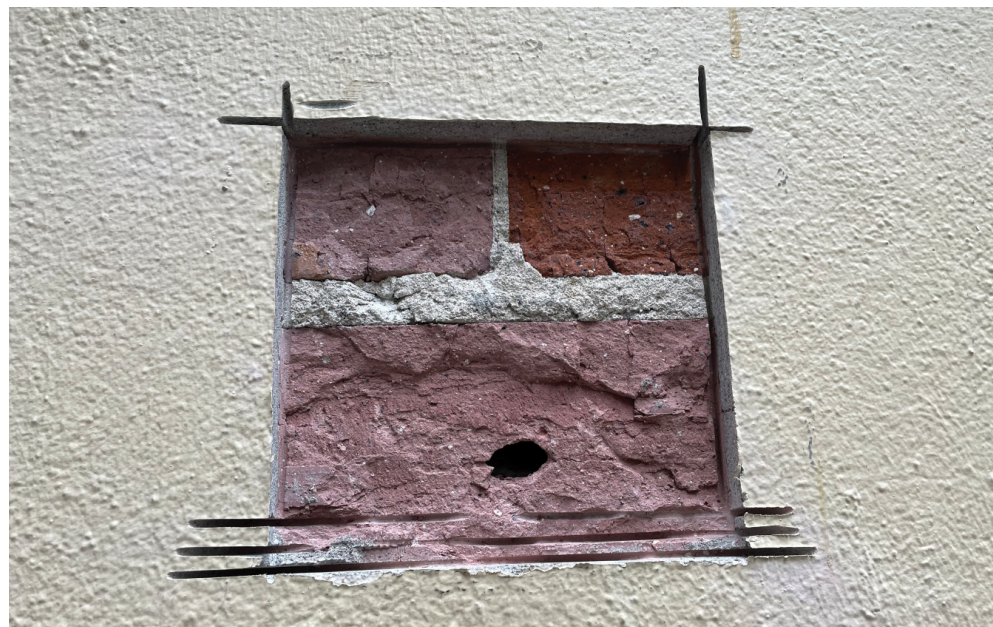
Figure 31: Stucco samples taken also revealed long term water damage to clay tile substrates where the cleavage plane was located in the thickness of the clay tile - not the stucco itself. 220222 PH-Pac Sample 12 IMG\_1130.JPG. Credit: Richaven, 2022

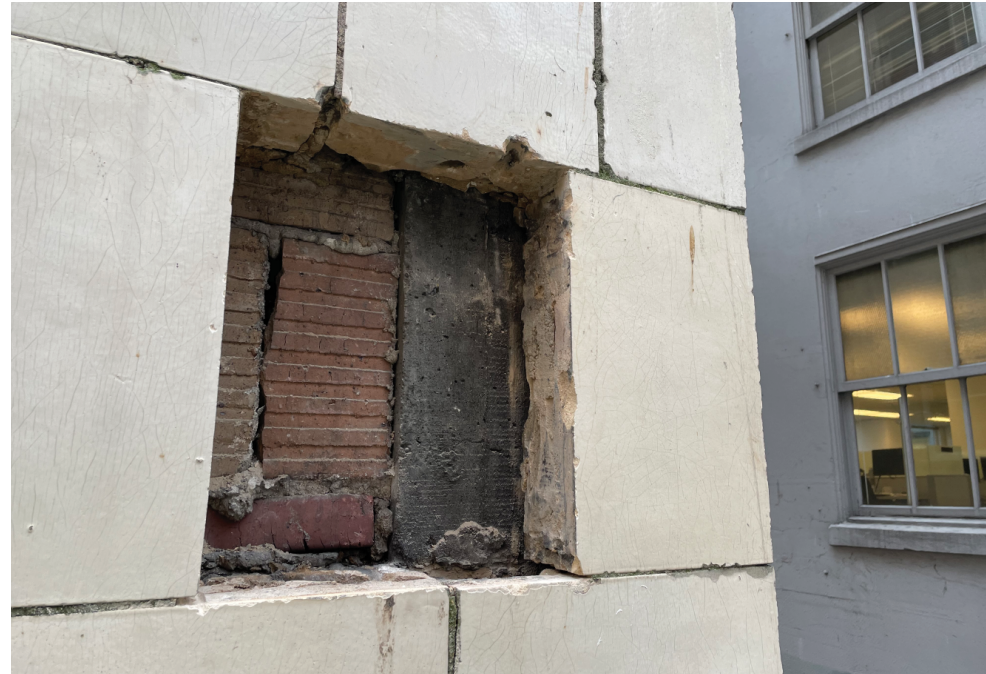
Figure 32: Terra cotta samples were removed where the existing materials were cracked or broken and planned to be replaced revealing multiple substrates and minimal anchoring of the masonry cladding. 220222 PH-Pac Sample 17 IMG\_1261.JPG. Credit: Richaven, 2022

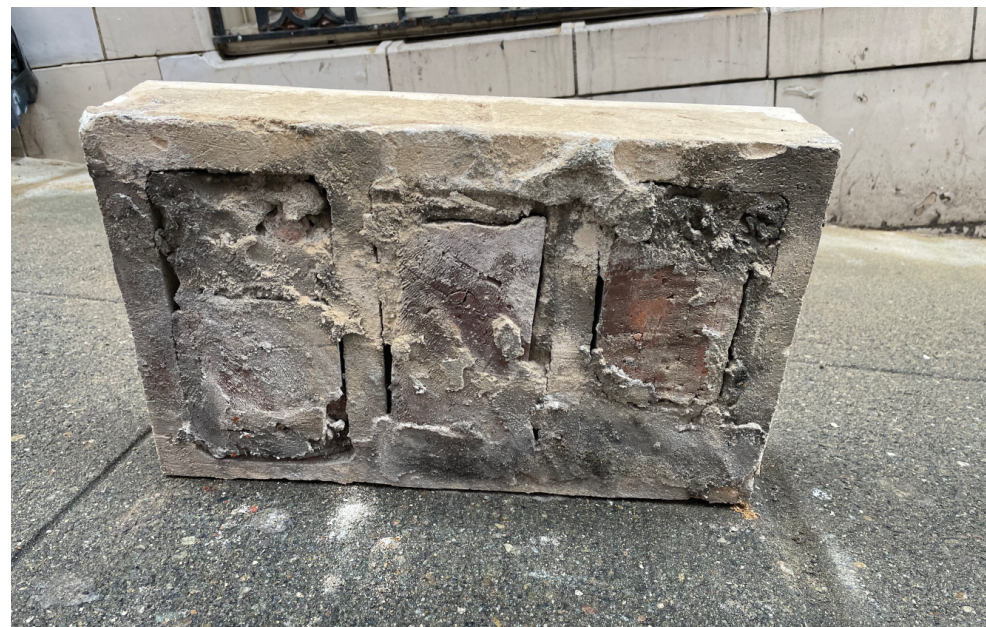
Figure 33: Terra cotta sample revealed that the blocks were filled with a variety of materials including clay tile pieces, brick, mortar, and other construction debris. 220222 PH-Pac Sample 16 IMG\_1234.JPG. Credit: Richaven, 2022
