80 Stewart St ADA Ramps

Historic District Commission Briefing

November 13, 2024

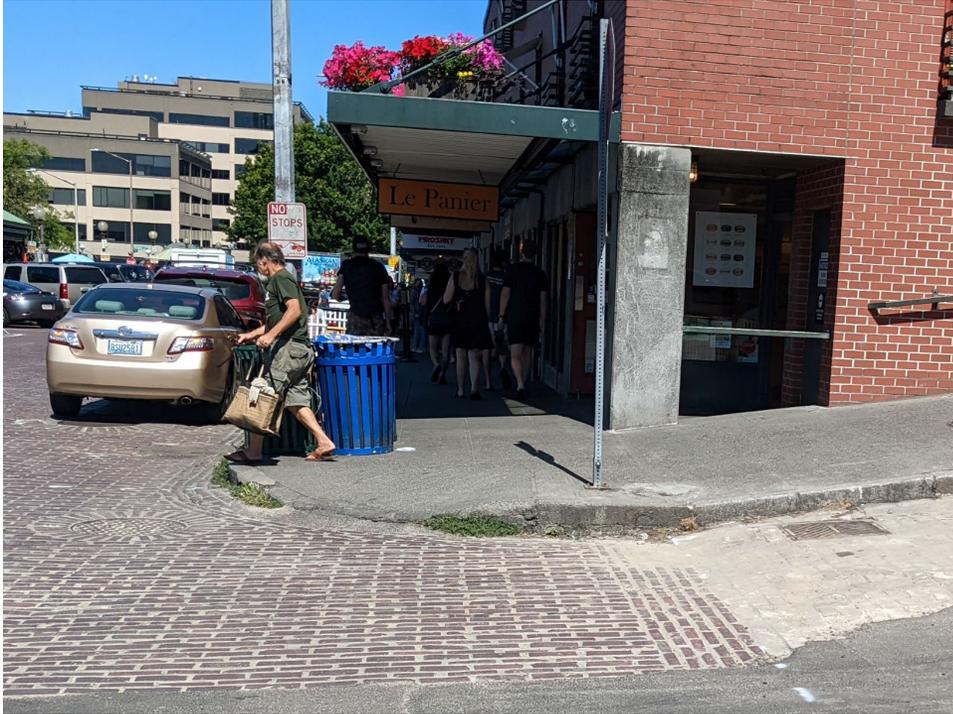
NW Corner

Stewart & Pike - Existing Ramp Conditions

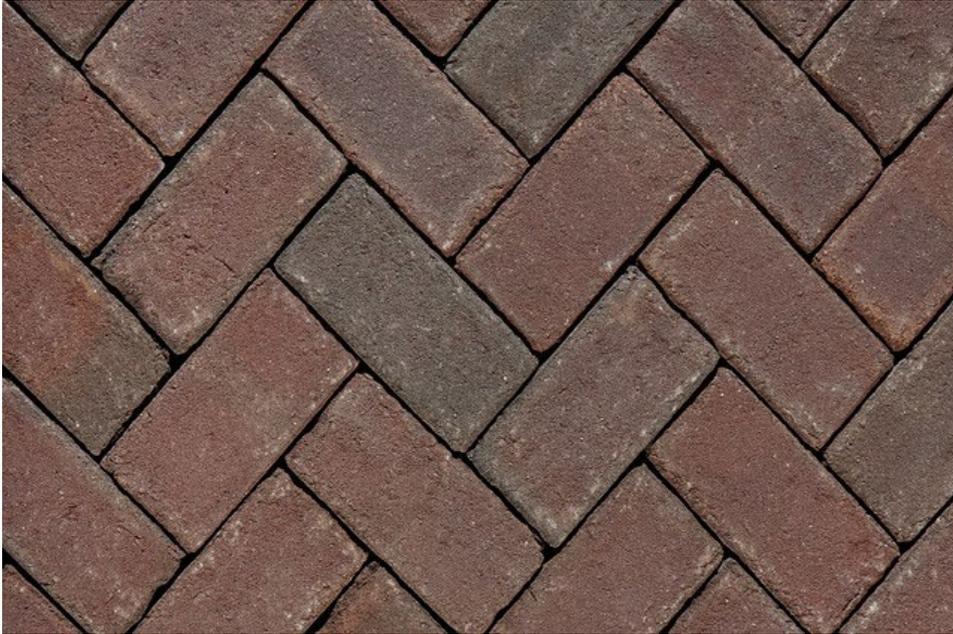
Belden Brick Company: Rembrandt Pavers

SPU has coordinated with DON for approval of a mix of 80% Rembrandt Pavers and 20% Georgian Pavers.

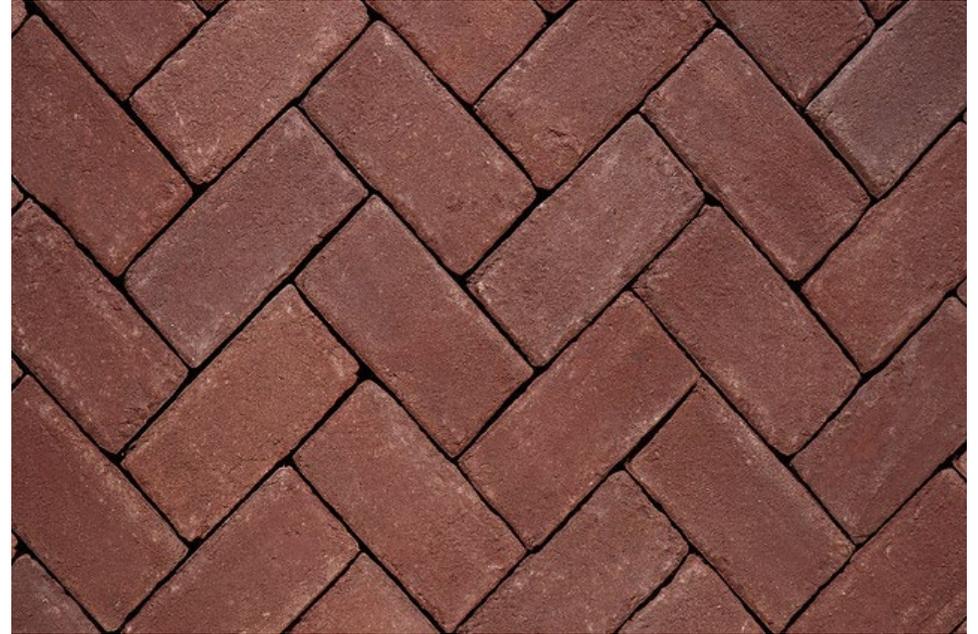
Belden Brick Company: Georgian Pavers
