Historical Report, 213 South Main Street Pioneer Square Historic District Seattle

**213 South Main Street
Pioneer Square Historic District, Seattle**

**Historical Report, September 26, 2013
Revised October 4, 2014 (No. 1) and December 3, 2014 (No. 2)**

BOLA Architecture + Planning

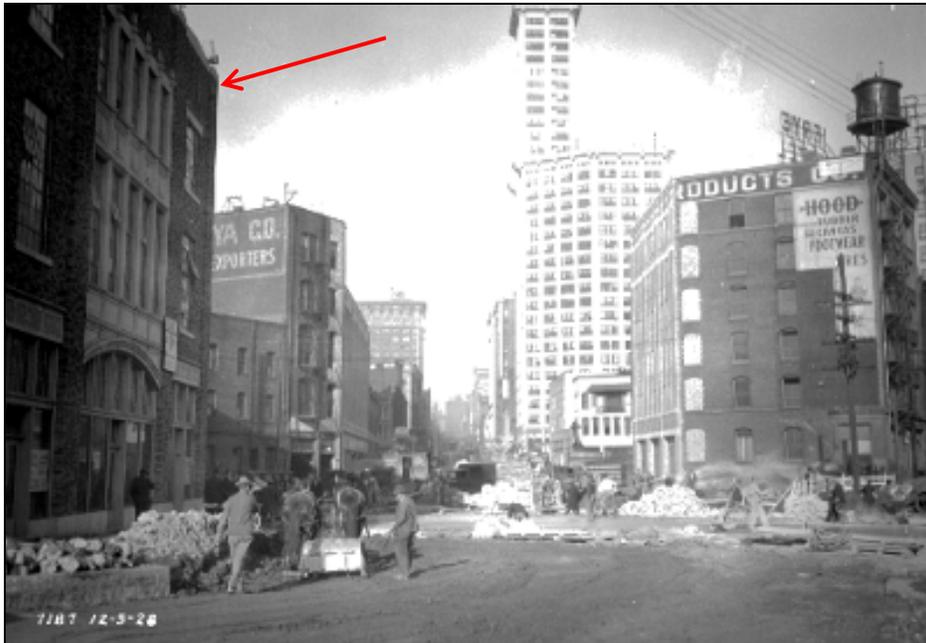
Figure 7. Above, looking north from 2nd Avenue (south of Main Street) on December 3, 1928 during construction of the 2nd Avenue Extension, with the original three-story building shown on the far left (Seattle Municipal Archives [SMA], Item No. 3140).

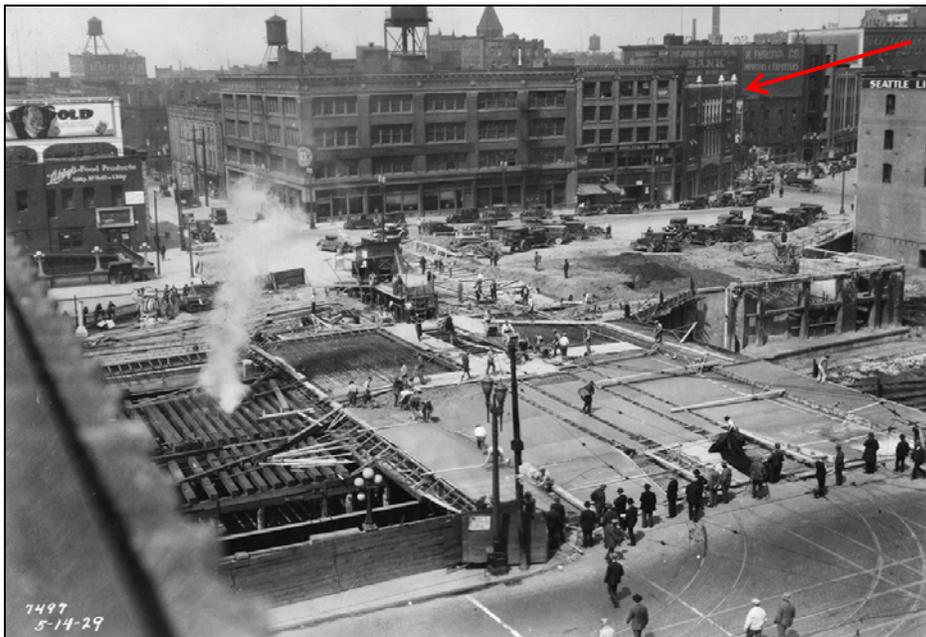
Figure 8. Below, construction of the street over the railroad tunnel on May 14, 1929. The subject building is visible in the background, identifiable by white rooftop finials (SMA, Item No. 74001).

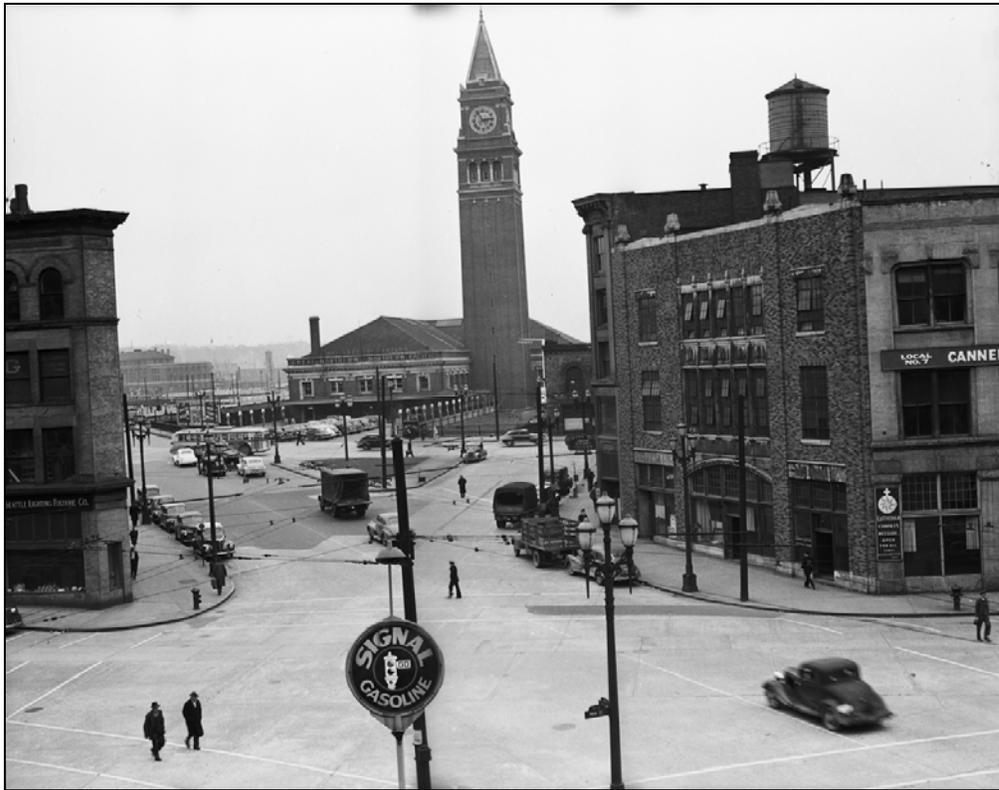
Figure 11. Above, looking southeast at the building. The photograph is dated 1961, but auto and clothing styles suggest it may date from 1931 or 1941 (SMA, Item No. 68541).

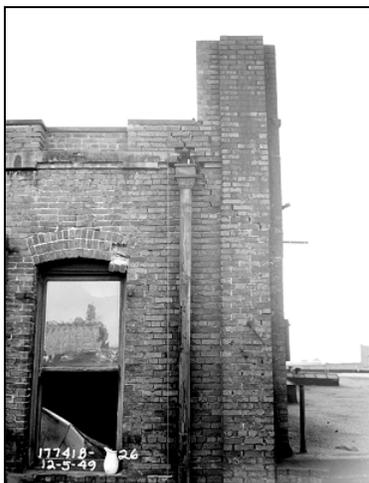
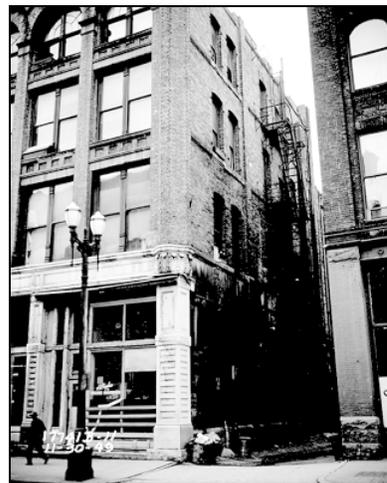
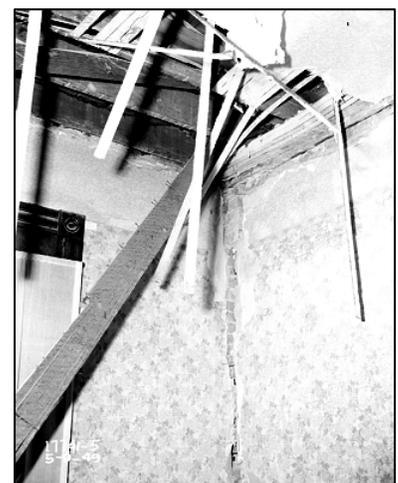
Figures 12 - 14. Below, views of buildings in Skid Row after the 6.8 Richter-scale earthquake on April 13, 1949, which show damage to other unreinforced masonry buildings. The earthquake resulted in spalled bricks, cracks, loss of parapets and cornices, detachment of floor structure from the wall, and damaged finishes. (Left to right: No. 12. Damage to a tourist hotel at 2nd Avenue and Occidental Street, photographed December 15, 1949, SMA 41837; No. 13. Exterior damage, November 30, 1949, SMA Item No. 41819; and No. 14. Interior floor and framing damage, May 9, 1949, SMA 41809.) A number of buildings were demolished as a result. None of these photos show the subject building, but damage to it was so severe that its two uppermost floors were removed in 1950-1951.

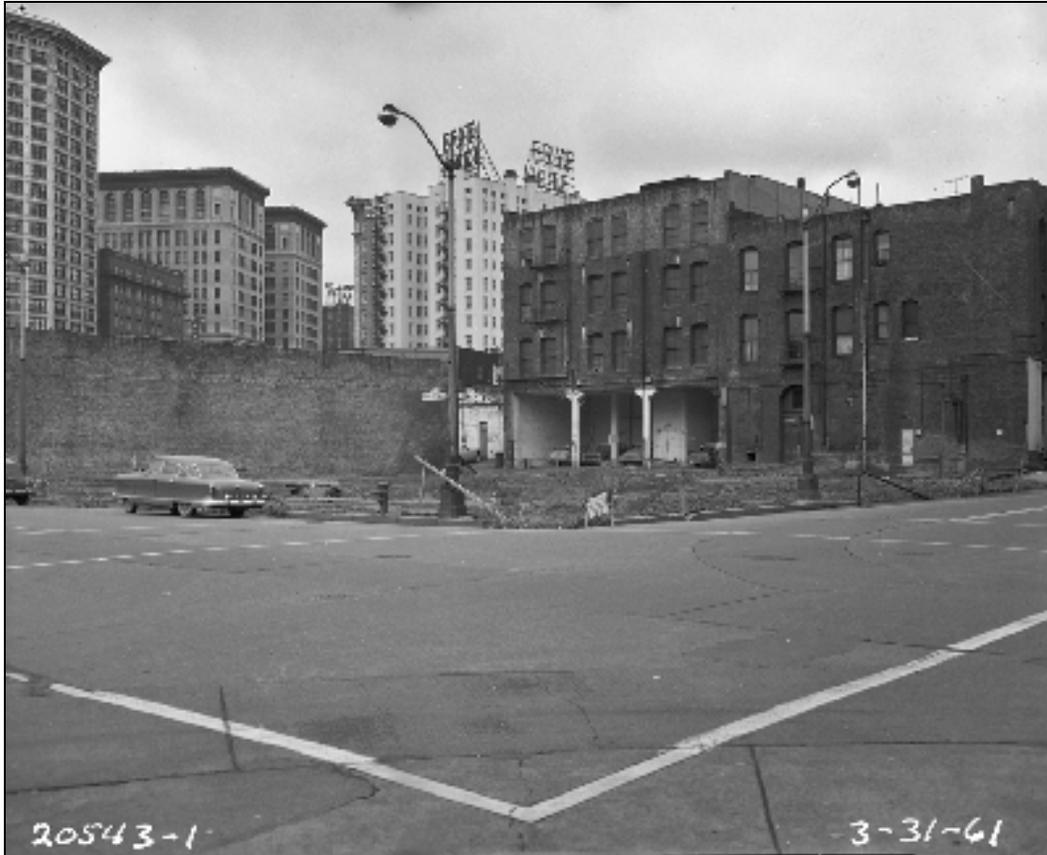
Figure 15. Below, view of the nearby vacant parking lot at the northeast corner of S Main and Occidental Streets, the site of a former building, on March 31, 1961 (SMA Item No. 66615). Kroll maps indicate that the parking lot on the parcel to the west of the subject building was created after former buildings were removed in ca. 1940-1960, presumably after the 1949 earthquake.

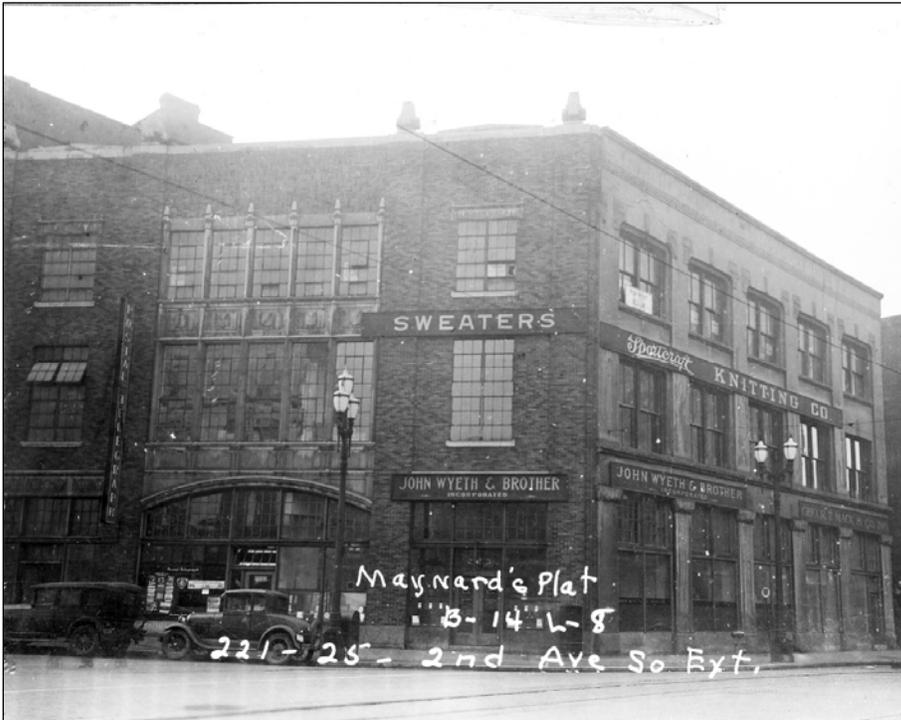
Figure 18. Below, King County Tax Assessor's Property Record Cards (1937; insert, updated 1951). The insert is a view looking southwest at the subject building on March 2, 1951 after its upper floors were removed (King County Assessor's Property Record Card, available at the Puget Sound Regional Archives, Bellevue Community College).

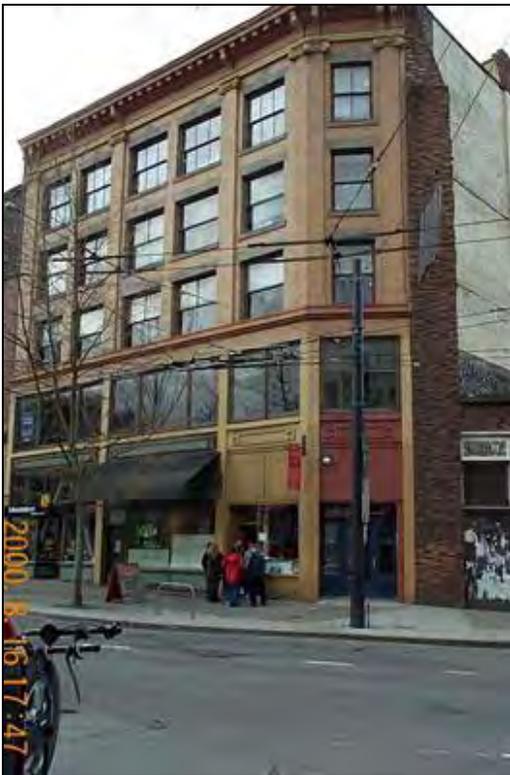
Figures 25 and 26. Below, two views looking southwest at the adjacent building at 307 3rd Avenue S, which dates from 1906. Note the angled bay at the corner, which presumably dates from the period of the street extension project. Note also the remnant of the original three-story Cascade Laundry building along the outer edge of this bay (King County i-map photograph, 2008).

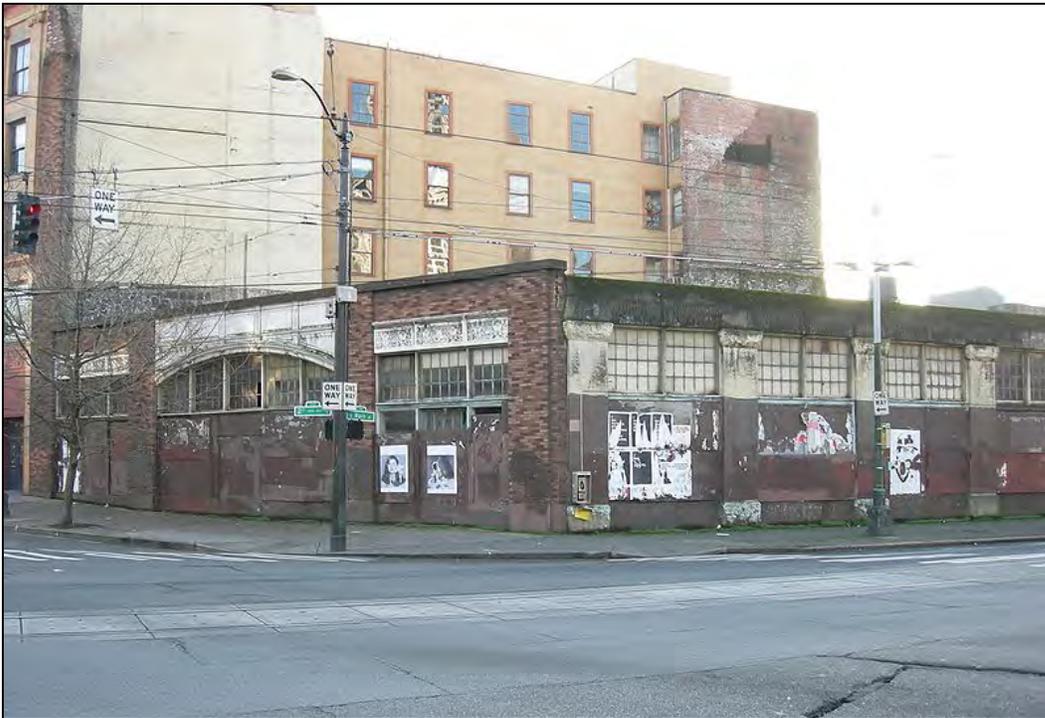
Figure 27. Above, a view of the building in 2007, showing the upper floors of the adjacent building to the south in the background. (This photograph predates the graffiti on the two street-facing east and north facades. Joe Mable, WikiCommons).

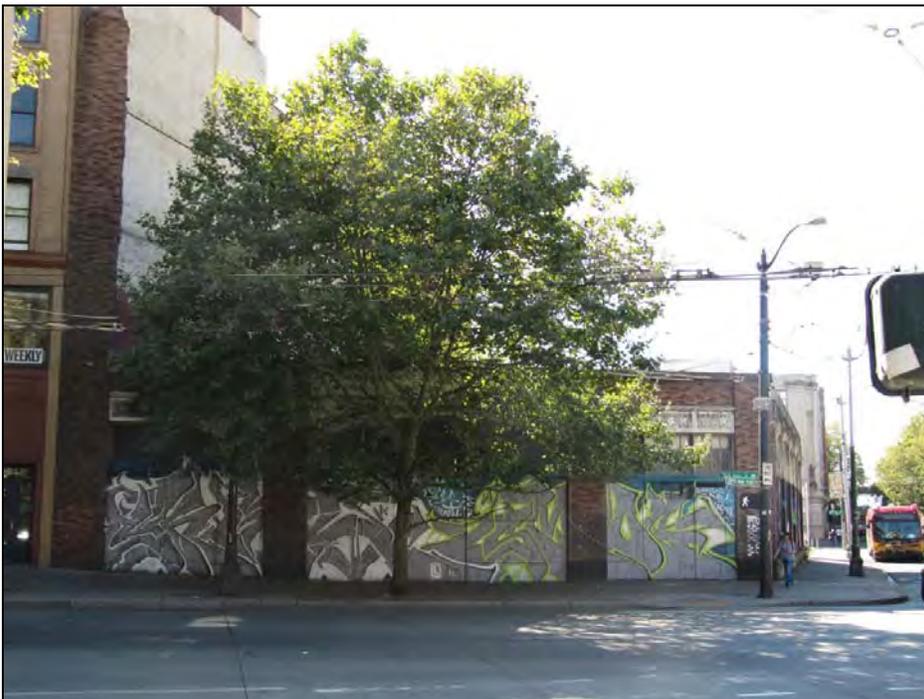
Figure 28. Below, view looking west at the primary east facade.

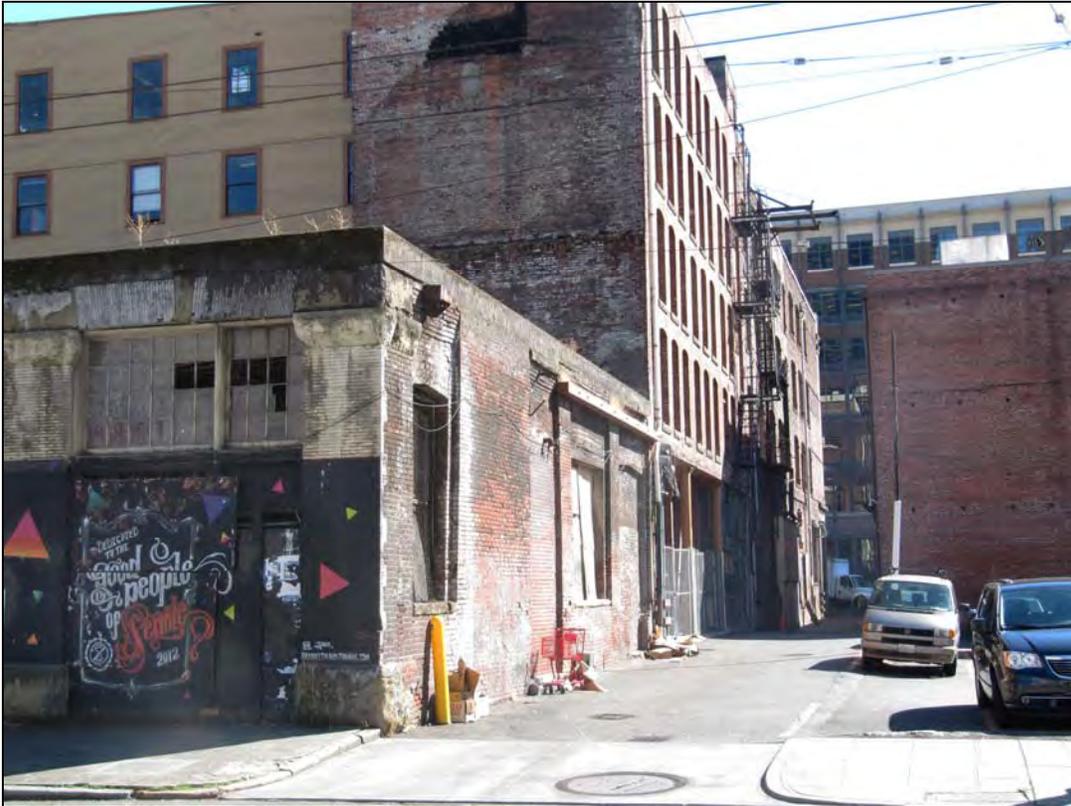
Figure 29. Above, a view looking south along the alley from S Main Street.

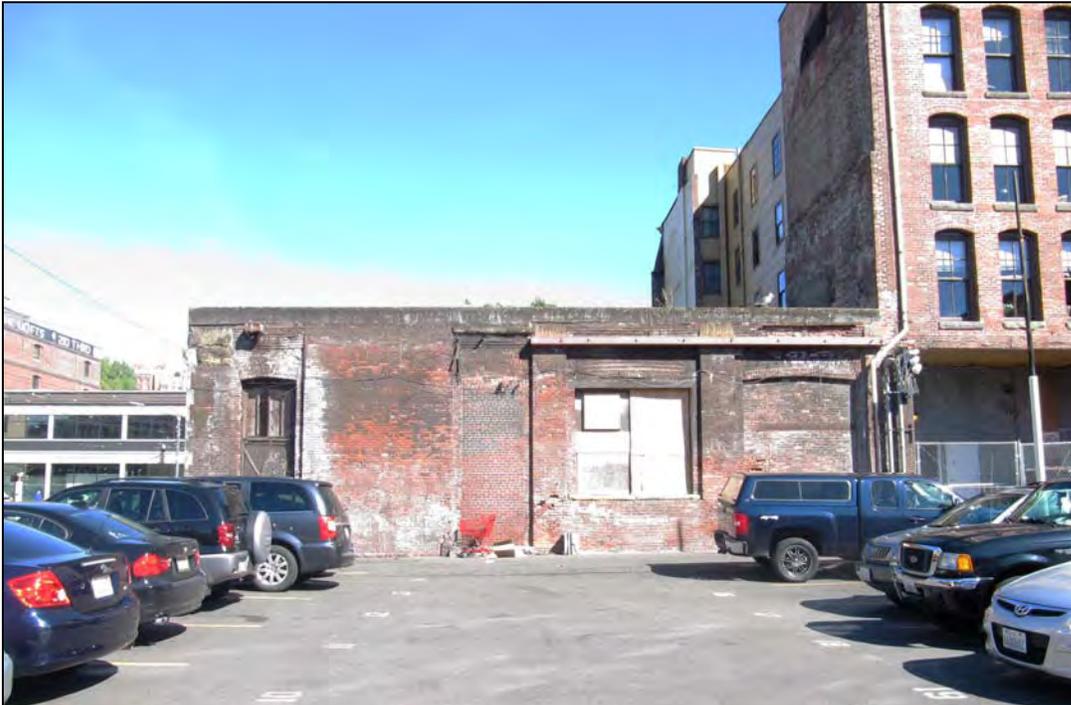
The west wall along the alley, which is a single story above grade, extends down through the basement as a two-story, bearing brick masonry wall, presumably with a stone footing below it. (Footings were not visible.) Visible on the exterior of this wall are what appears to be non-original rectangular-shaped openings as well as several arched head openings that may date from ca. 1900. Structural engineering repairs have been made to portions of this wall with the addition of an anchored, exterior steel beam. Drawings dating from 2001 from DPD microfilm files indicate a roof area of approximately 26' by 30' in the southeast corner was damaged at that time, prior to the purchase of the building by its current owner. Some later repairs were made to perimeter wall in addition to the demolition and plywood infill of several window and loading dock level openings according to a drawing by LDC Architects, Sheet A-1, of 7.14.2003.

Figure 30. Below, a view looking east at the back (west) facade from the parking lot on the west side of the block.

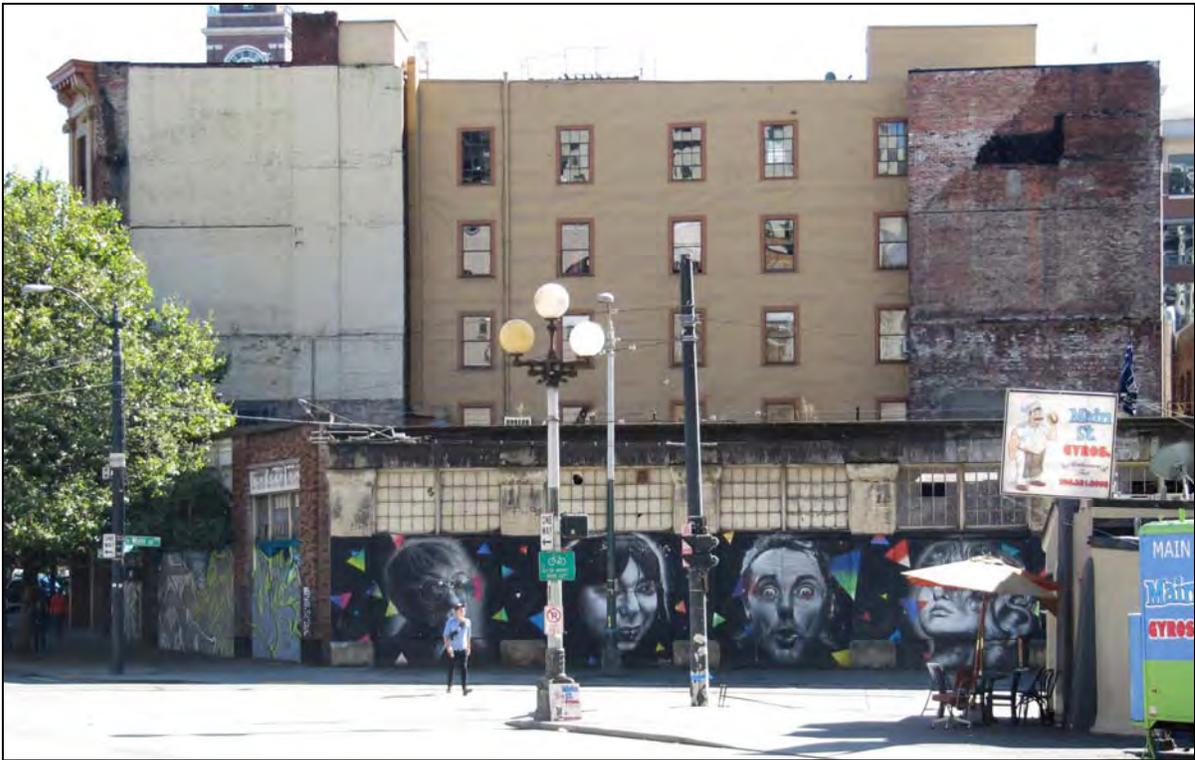
Figure 31. Above, a view looking south at a portion of the north facade. The plaster-clad and exposed brick masonry facade walls in the background are part of the adjacent Mottman Building to the south, which dates from ca.1906.

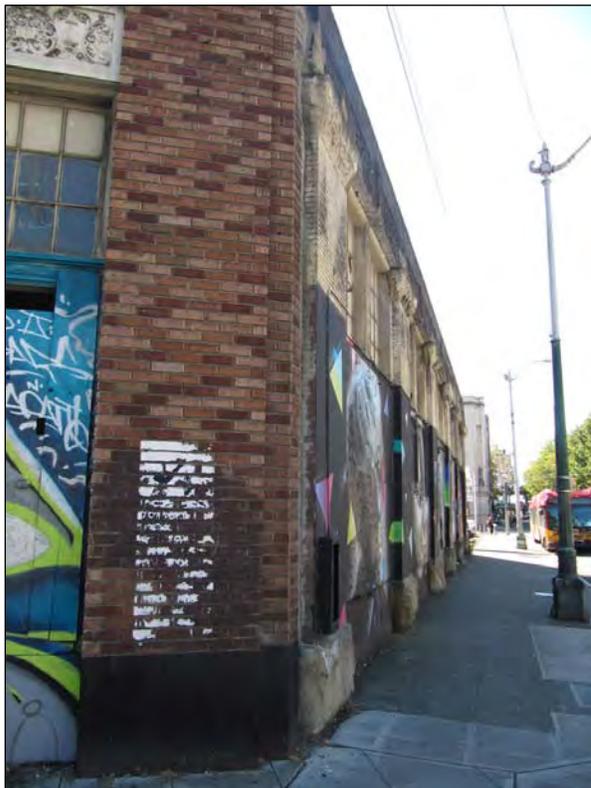
Figure 32. Left, a detail view of the northeast corner showing the brick masonry and decorative cast stone on the east facade, dating from ca. 1927 – 1928, and the original buff-colored and more deteriorated masonry on the north facade, dating from ca. 1900.

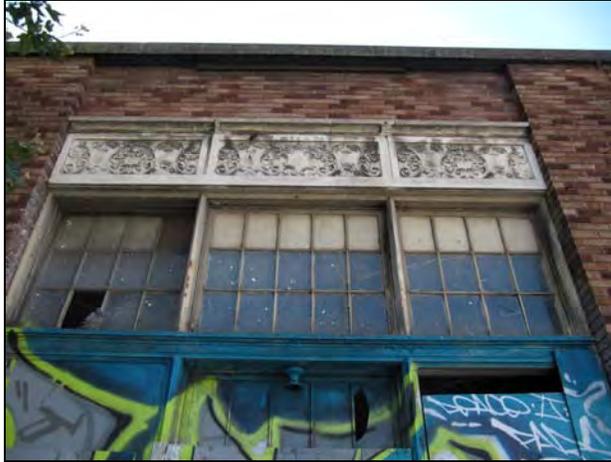
Figure 33. Directly below left, a detail views of brick masonry and terra cotta, and graffiti on the front (east) façade.

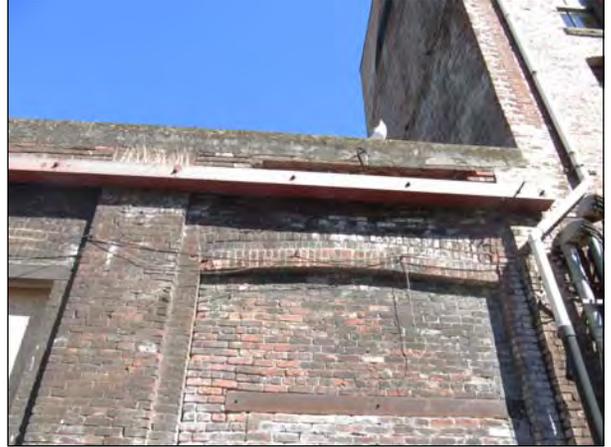
Figure 34. Directly below right, detail view of the steel beam and masonry infill in an original opening at the south end of the west bearing brick wall at the allow.

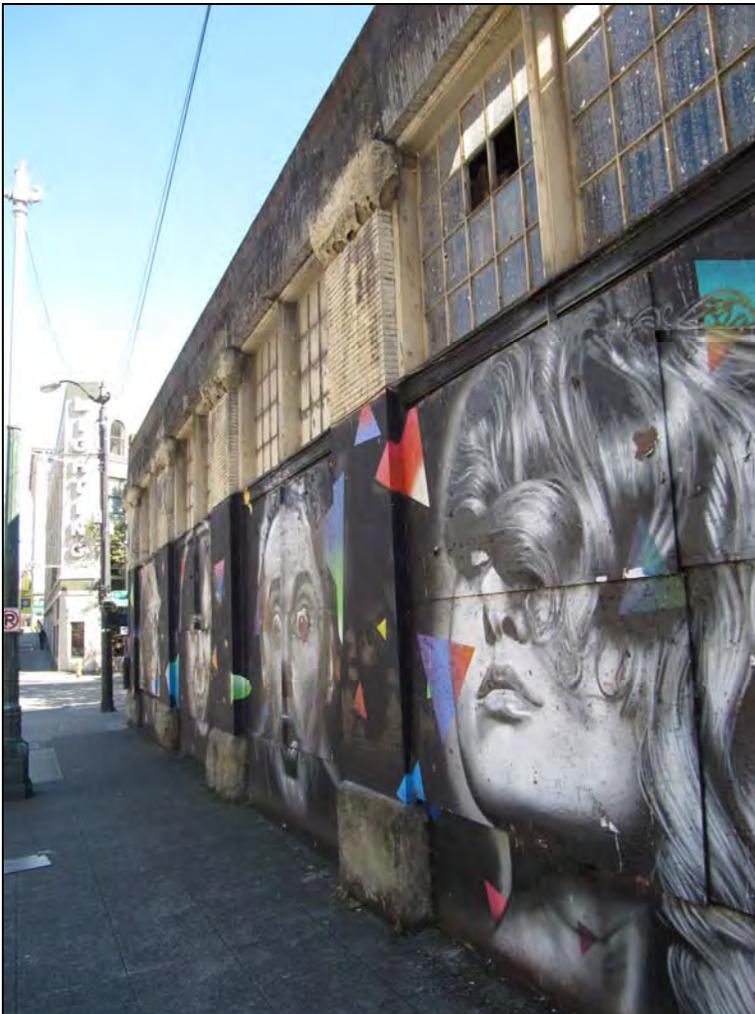
Figure 35. Below, detail view of graffiti panels, remaining transoms, and stone and brick pilasters on the north facade.

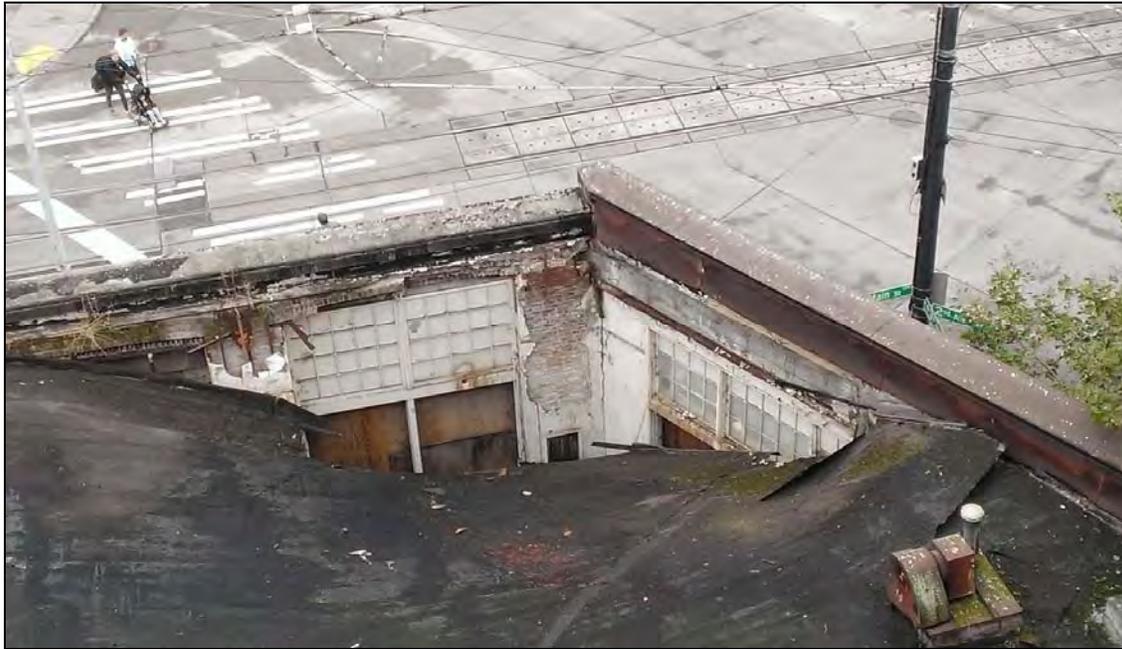
The southwest corner has seen the greatest failure at both roof and floor levels. The steel purlins are badly rusted and some have collapsed. The basement, which has a dirt floor, has been closed off from the old areaways below the north and west sidewalks, with exposed formwork and cast-in-place concrete walls visible at the perimeter. The south unreinforced brick masonry wall appears to be a party wall as it steps back with fewer wythes as it rises. The subject building's original construction, as a three-story laundry with basement, preceded that of the adjoining five-story Mottman Building on the south side, at 307 3rd Avenue S., which dates from 1906 according to the King County Assessor's Property Record Detail Report.

Figure 36. Directly below, view from the roof of the adjoining Mottman Building looking northeast at the collapsed roof area and the southeast corner interior of 213 South Main Street. (Photograph provided by the Samis Land Company, September 2014.)

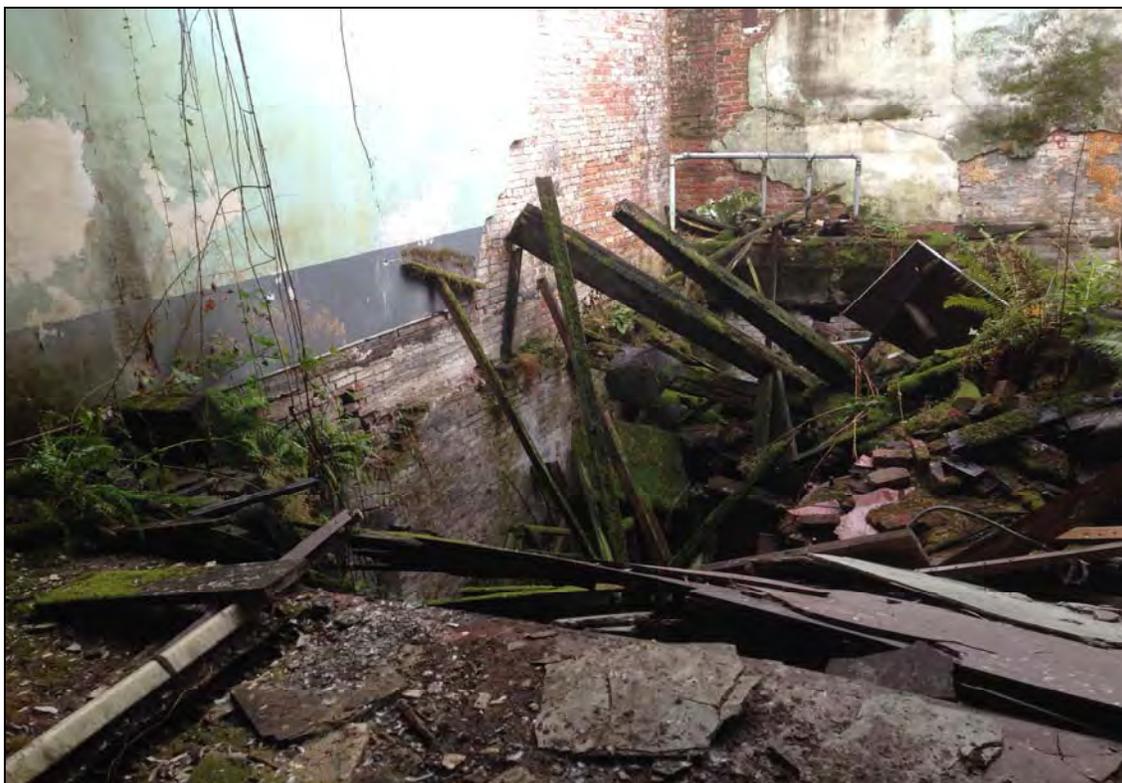
Figure 37. Below, a current view from within the first floor looking west at the southwest corner, where the roof and floor have collapsed (photograph by Don Marr, September 2014).
