Cheasty Mountain Bike Trail Monitoring – South Loop

Year 1 2023 Quarter 3 Monitoring Report

Cheasty Greenspace Mountainbike/Pedestrian Trail – South Loop

Photo monitoring Year 1, Q3 2023

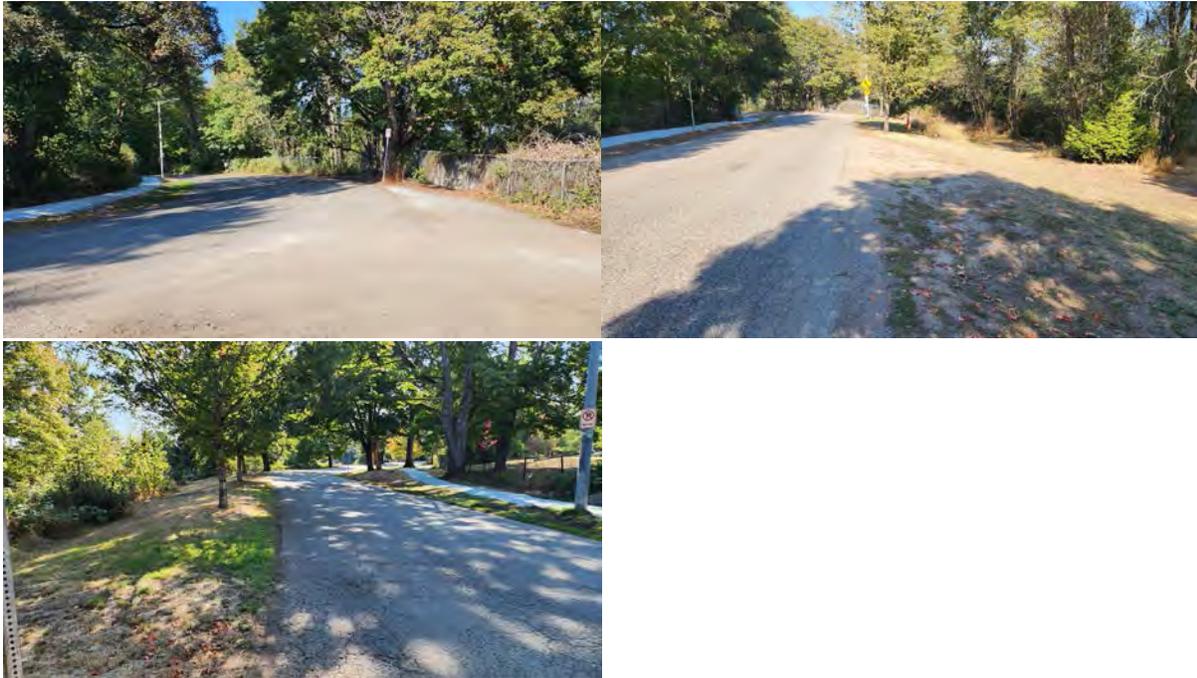
EarthCorps performed an observational survey for illegal or improperly parked cars along Cheasty Boulevard between Beacon Ave S and S Andover Street following trail monitoring. During the site visit on September 22, 2023, there were no improperly parked vehicles along the monitored road segment (see photos below). No other parking issues were observed at this time. In addition, there were no occupied homeless encampments noted near or within the Mountain Bike South Loop

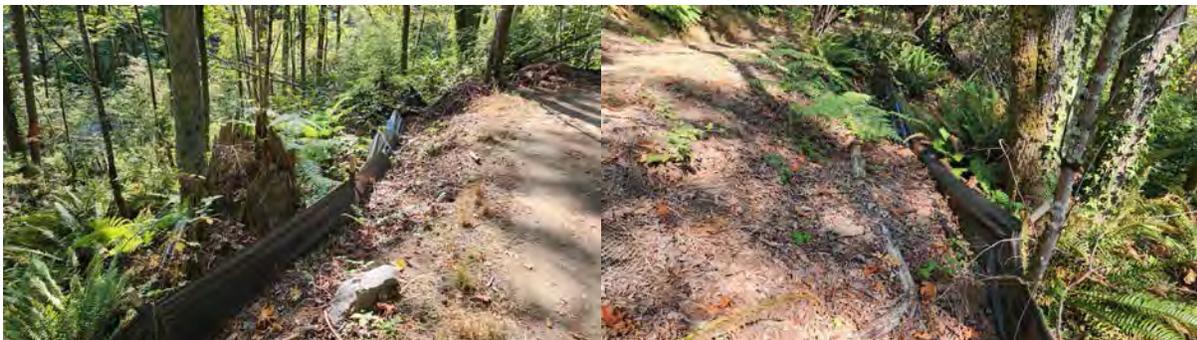
The silt fence that is in the plot and extending to the east was still generally intact although showing some signs of slumping and deterioration (see pics below), although no obvious signs of unwarranted access into the wetland was observed.

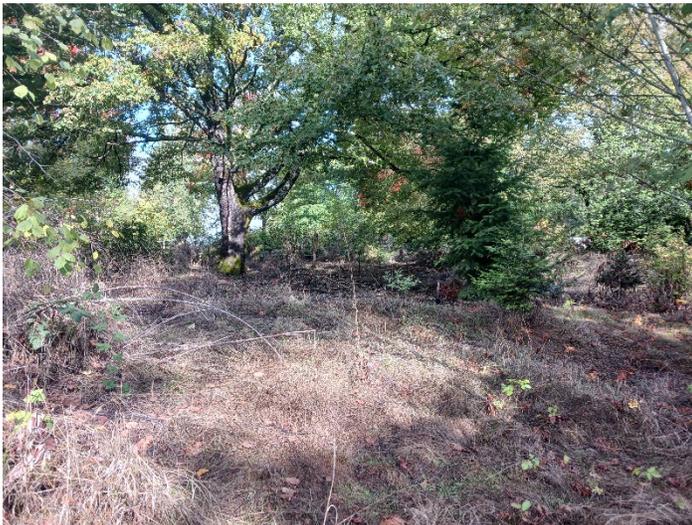
Figure 1: Previous encampment at top of Cottonwood Trail

No active encampments were seen. Two apparent previous encampments were seen near Cheasty Boulevard at the top of the Cottonwood Trail. Some trash/debris remained after cleanup at the lower previous encampment site but no new trash or debris was seen at either location.

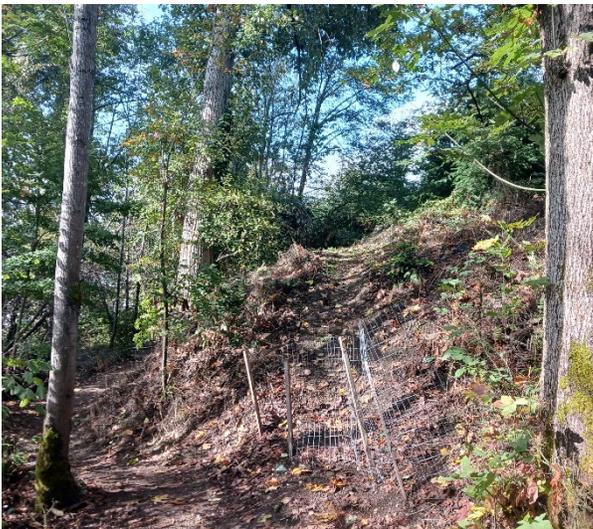
Figure 3 New social trail on Cottonwood Trail

Active social trails were observed near 24th and Cheasty, at the bottom of the multi-use trail near Columbian Way and between the multi-use trail and meadow near Cheasty Boulevard. A previous social trail off the 2nd switch back on the Cottonwood Trail has regrown and is no longer visible..

The new mountain bike hill along the Cottonwood Trail was blocked from further building by forest stewards after last quarter report and has not continued to grow. Stewards plan to close trail more permanently now that we are in the rainy season.
