Cheasty Mountain Bike Trail Monitoring – South Loop

Year 1 2023 Quarter 4 Monitoring Report

December 20, 2023

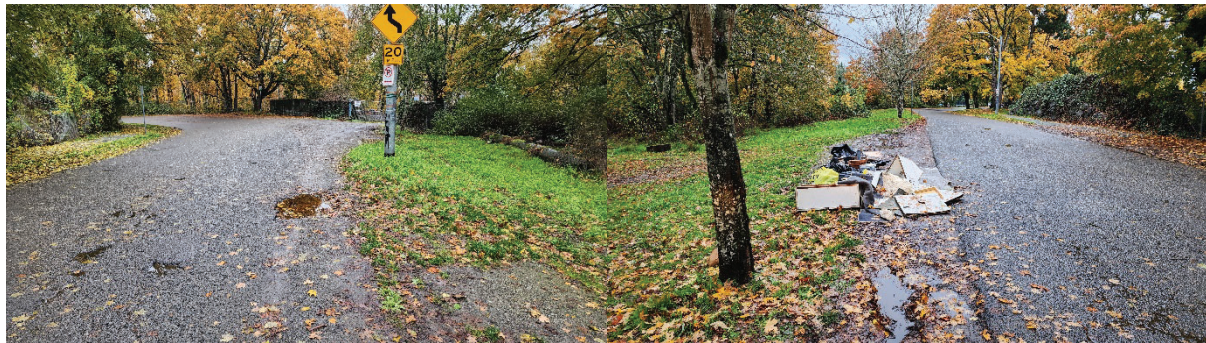
EarthCorps performed an observational survey for illegal or improperly parked cars along Cheasty Boulevard between Beacon Ave S and S Andover Street following trail monitoring. During the site visit on November 06, 2023, there were no improperly parked vehicles along the monitored road segment (see photos below). No other parking issues were observed at this time. Some illegal dumping was noted at the head of the trail and was in the process of being cleared by the City at the time of survey (see second pic). There were no homeless encampments noted near or within the Mountain Bike South Loop trail area during the time of survey.

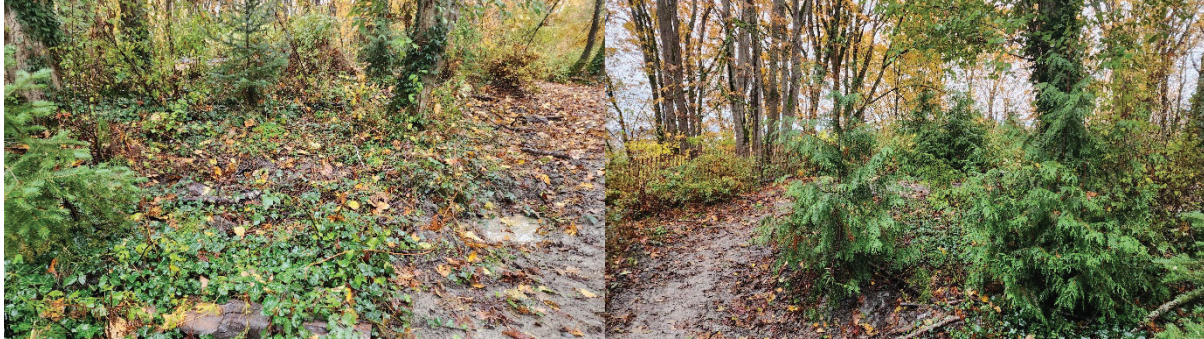
Much of the plot has common ivy (*Hedera helix*) and Common blackberry (*Rubus bifrons*) established throughout and these species can be found growing up to the new trail edges in

several places (see pics below). See photos below and in Appendix A for visual representation. General invasive plant management is recommended in the vicinity of plot #3, especially in the more disturbed eastern half of the plot and along the new trail edges.

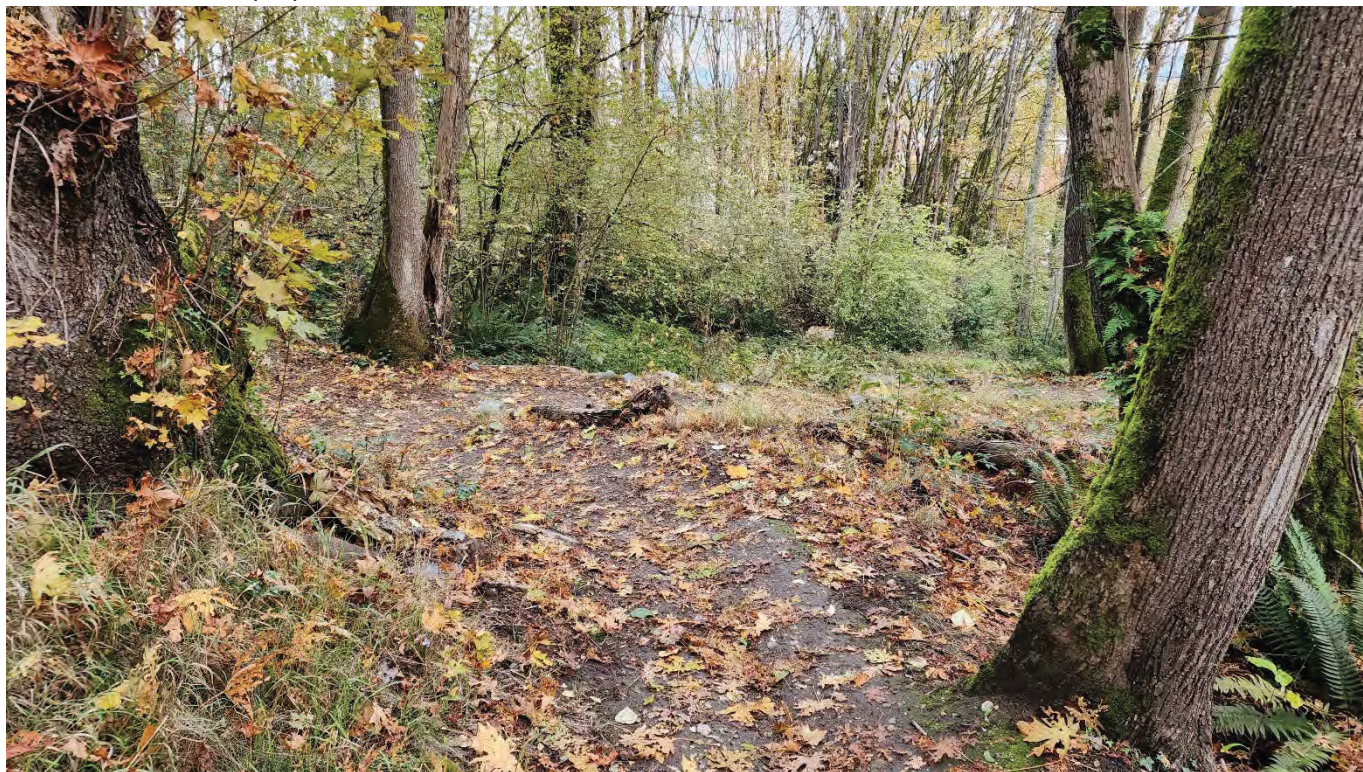
Plot 1 Photo Point 1 (NE)

Plot	# of Photos
1	4
3 photo points at: #1 top of trail looking NE (1 photo), #2 southern switchback looking NW and NE (2 photos), and #3 bottom of trail looking N (1 photo)

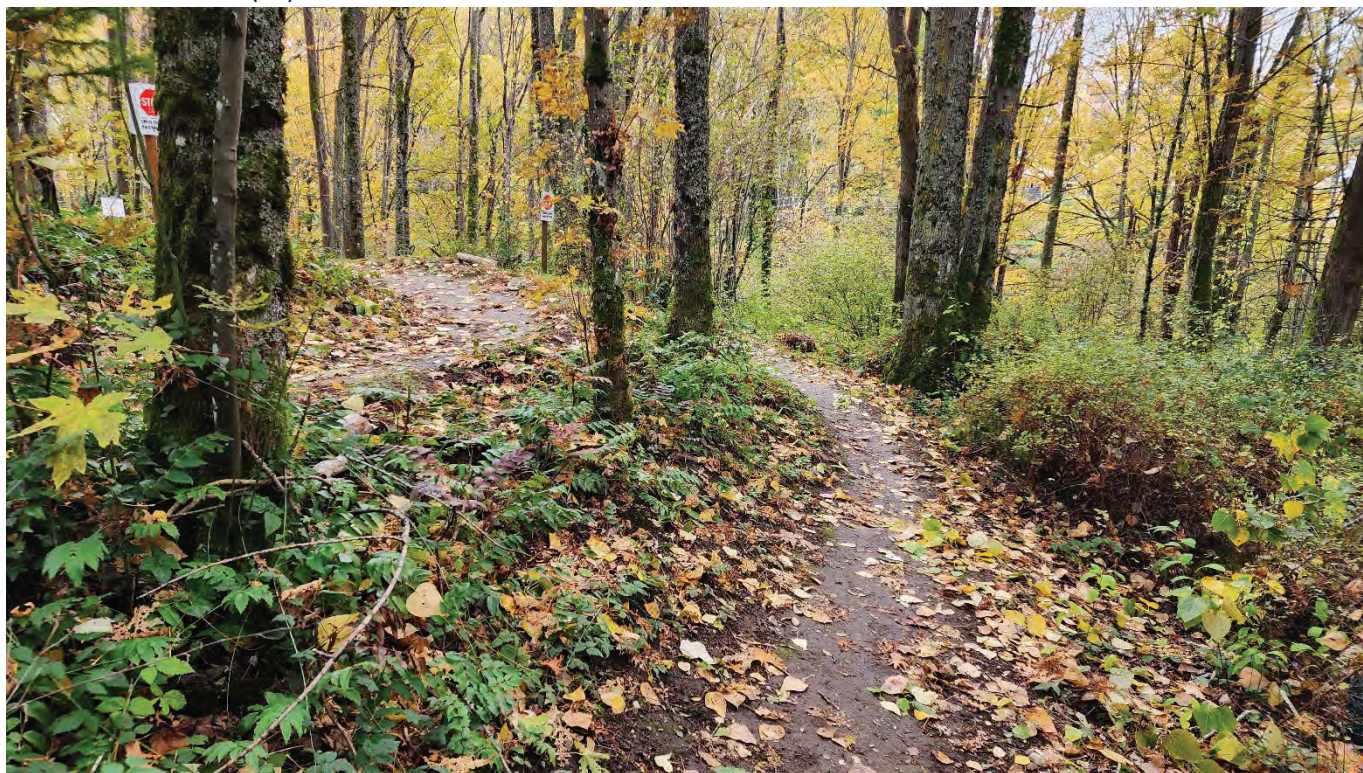
Plot 2 Photo Point 1 (SE)

Plot	# of Photos
2	4
4 photos at each of the individual trail legs that enter or exit the plot (3 looking downhill and 1 looking uphill) starting at NW trail and continuing clockwise. #1 top of south leg looking SE. #2 at top of north leg looking SW. #3 at top of 2-way looking S. #4 at bottom of 2-way looking SW

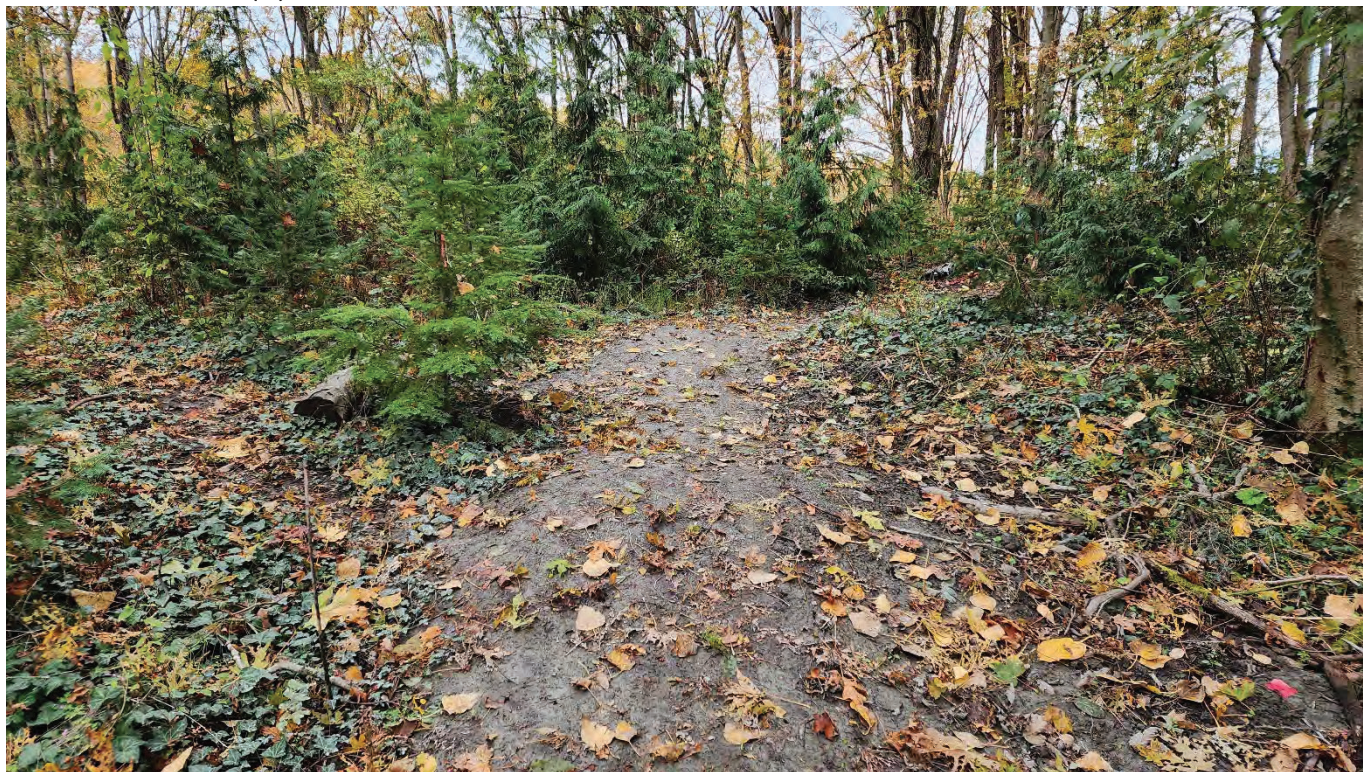
Plot 3 Photo Point 1 (N)

Plot	# of Photos
3	2
2 photo points at: #1 looking N (1 photo) along trail from entering plot from the S, #2 looking NW (1 photo) along trail entering plot from the E.

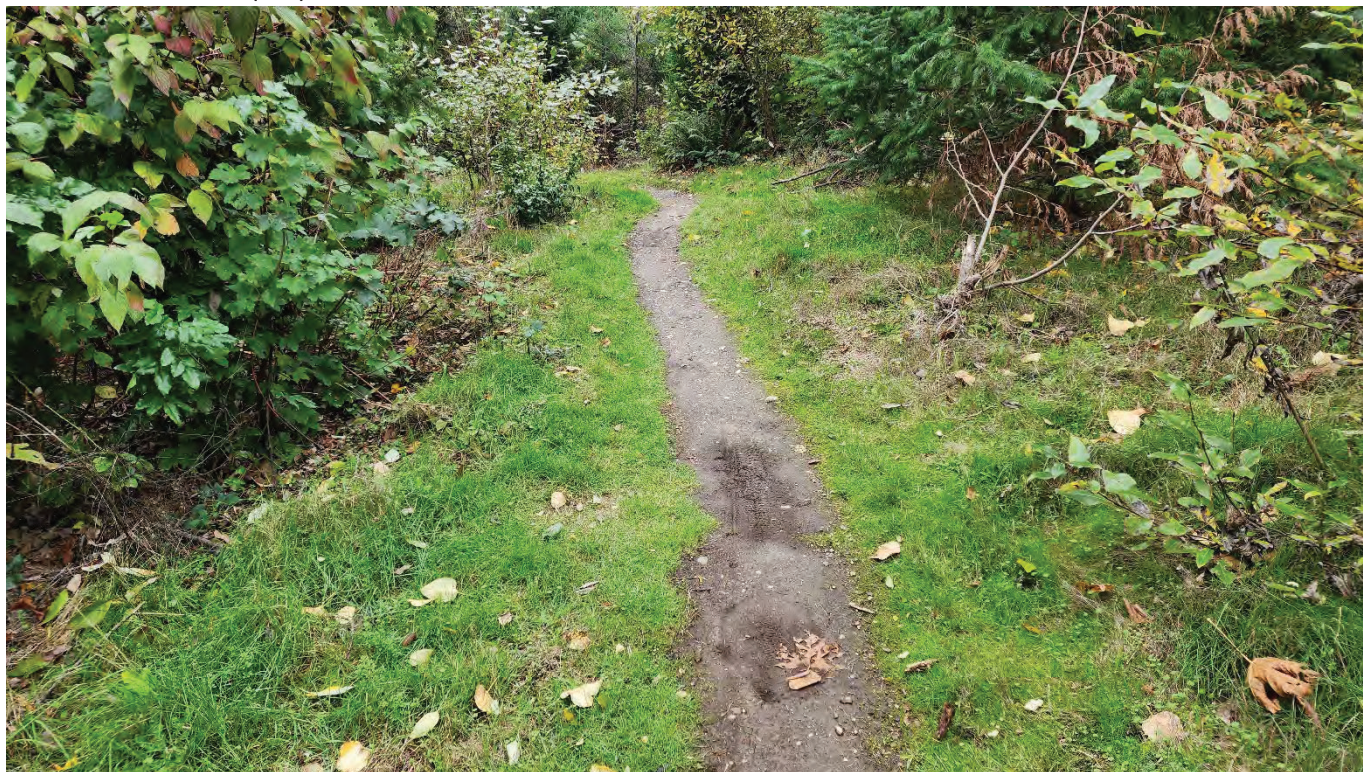
Plot 4 Photo Point 1 (SW)

Plot	# of Photos
4	4
3 photo points at: #1 top of trail looking SW (1 photo), #2 at end of line-intercept transect looking N and E (2 photos), and #3 bottom of trail looking SW (1 photo)

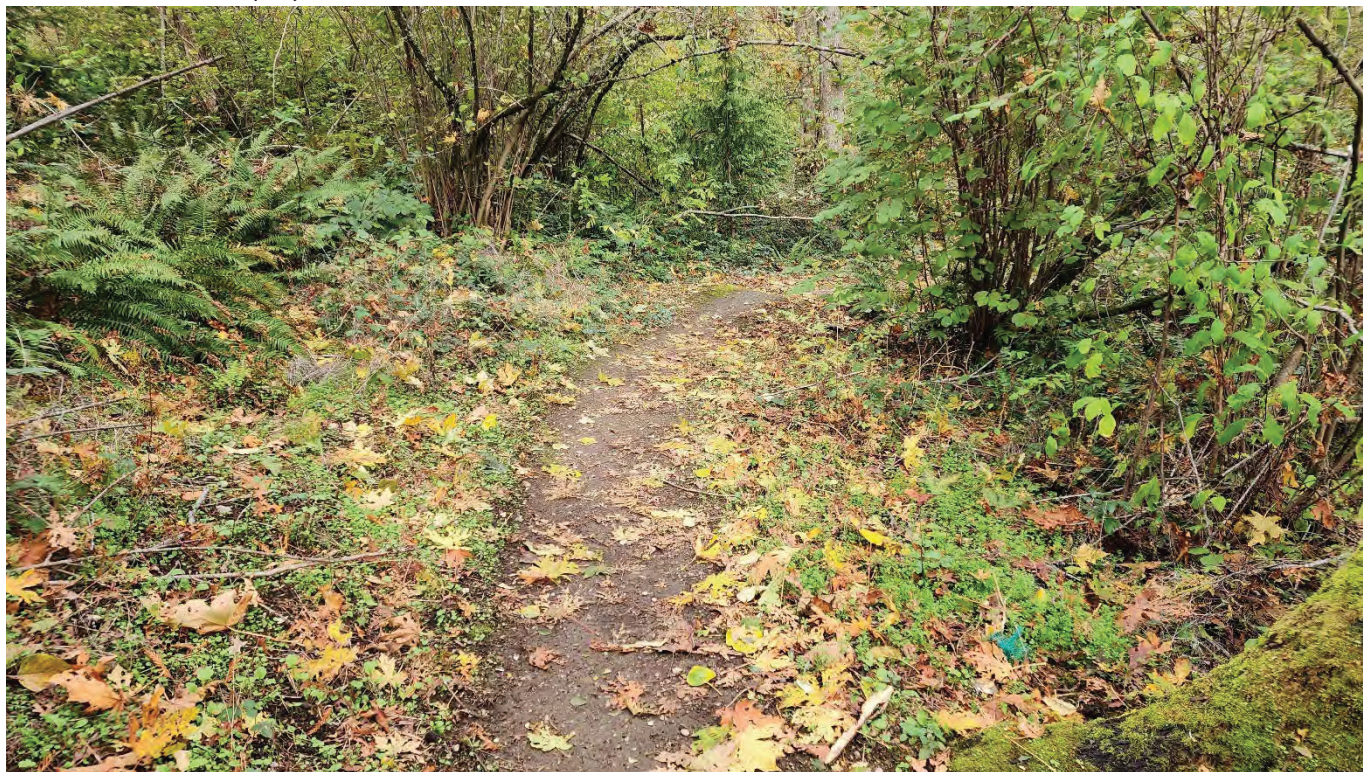
Plot 5 Photo Point 1 (NE)

Plot	# of Photos
5	2
2 photo points at: #1 top of trail looking NE (1 photo) and #2 bottom of trail looking SW (1 photo)

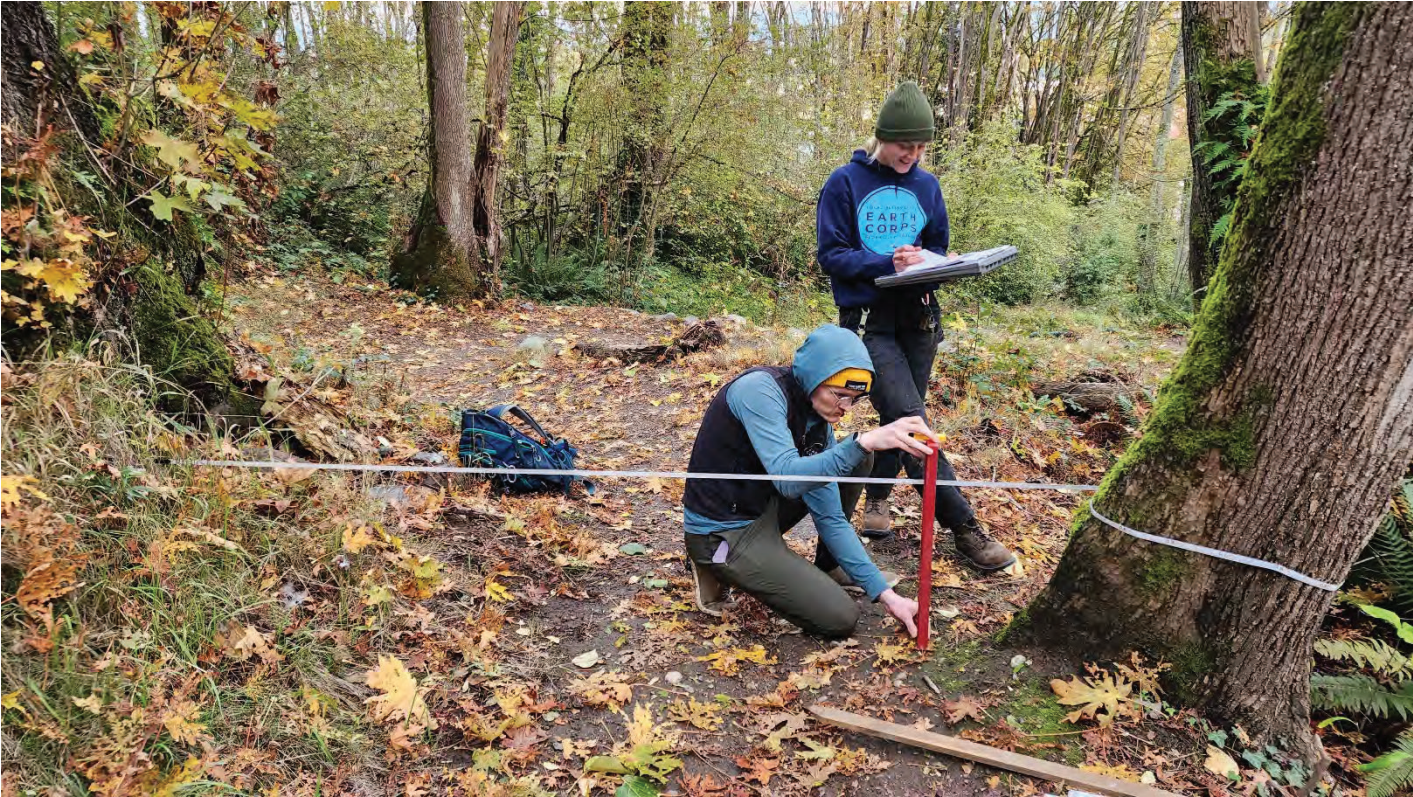
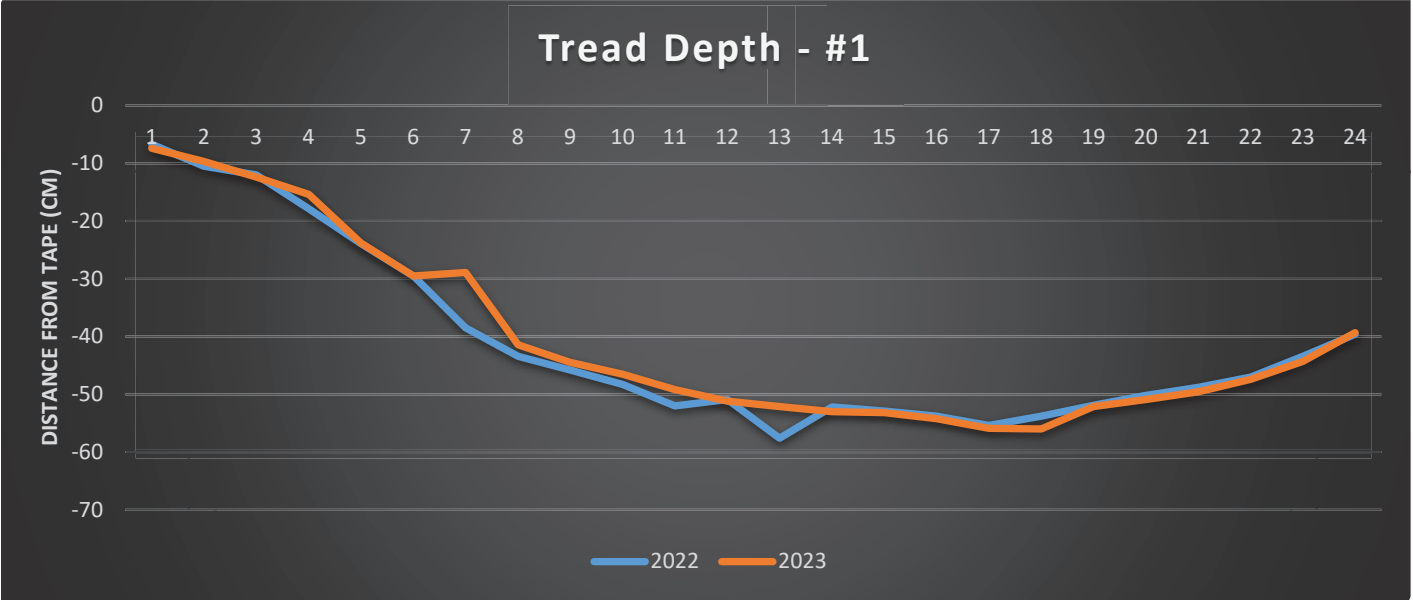
Begin on left side of trail looking downhill
Tread Plot	Veg Plot	Length	Transect inside plot near uphill side
1	1	2.8	Pins in large ACMA stump on left and small ACMA on right

In general, there were no major differences or concerns noted at any of the plots. In fact, only very minor differences in elevation were noted and no management recommendations are suggested at this time based on these data sets.

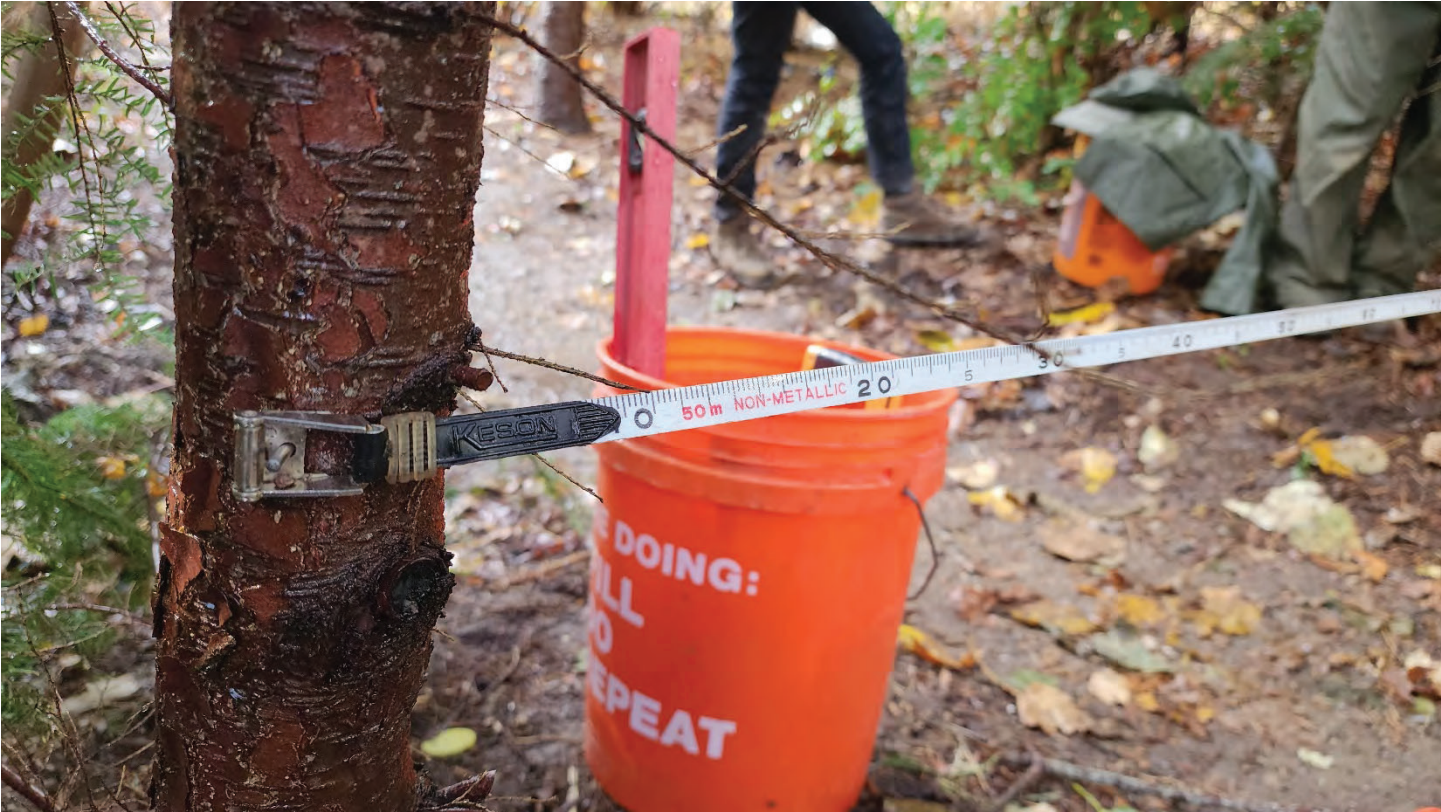
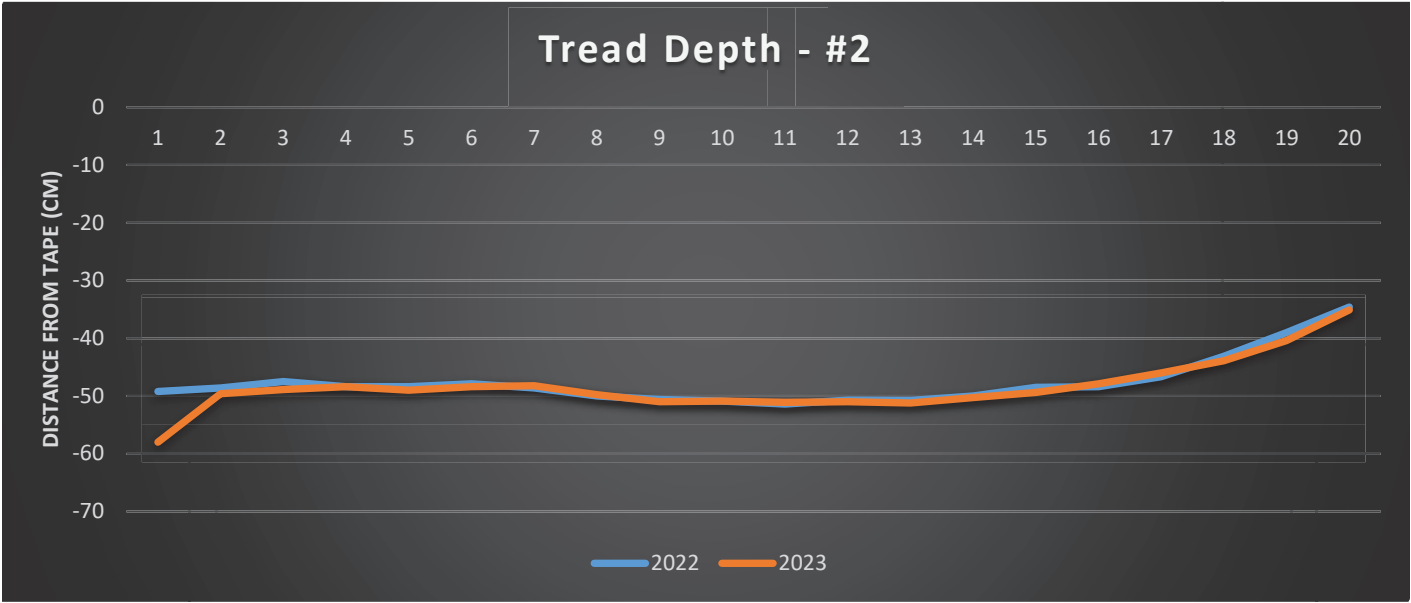
Begin on left side of trail looking downhill
Tread Plot	Veg Plot	Length	Transect inside plot near downhill side
2	4	2.16	Pins in PSME on either side of trail

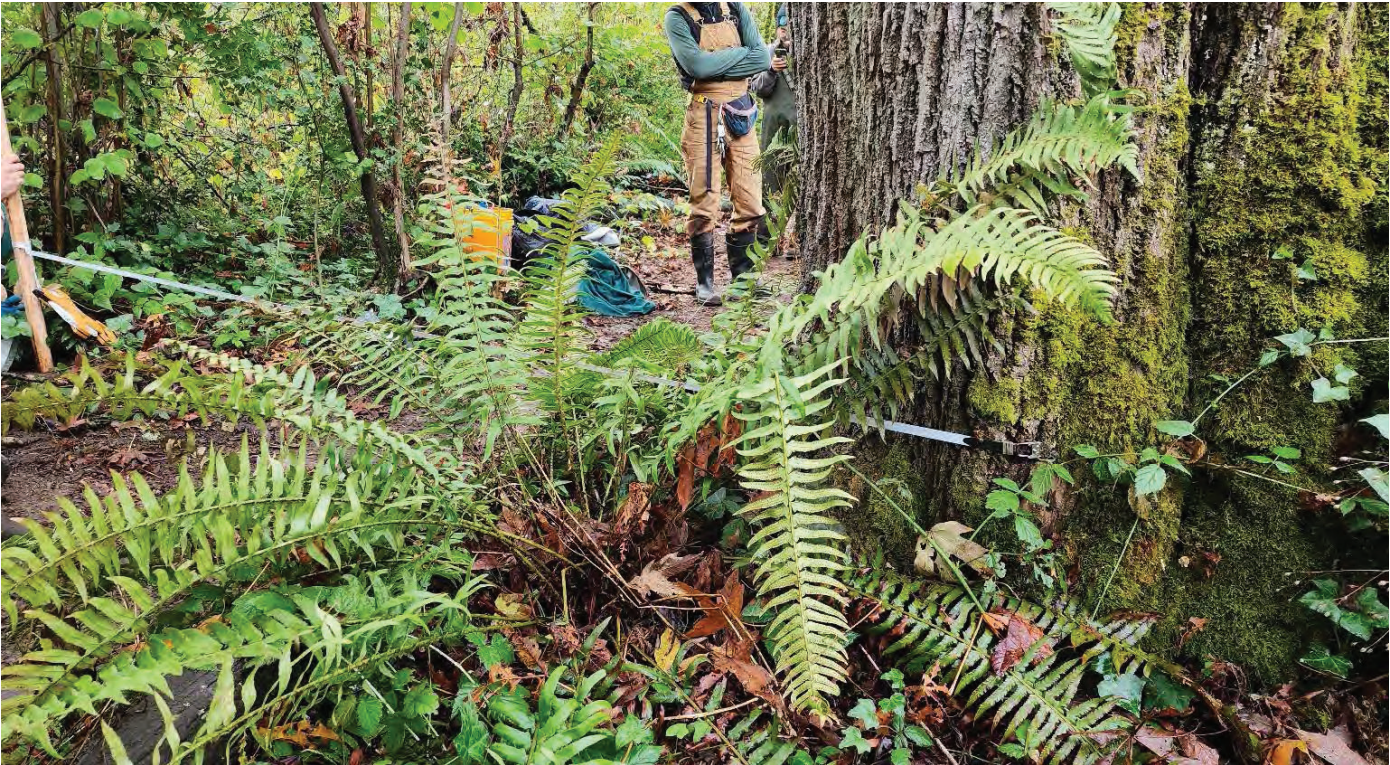
Begin on left side of trail looking downhill at 0.6m when tape clears tree
Tread Plot	Veg Plot	Length	Transect on "upper" 2-way trail (not associated w/ plots, see GPS)
4	N/A	3.1	Pin in large ACMA on left side of trail

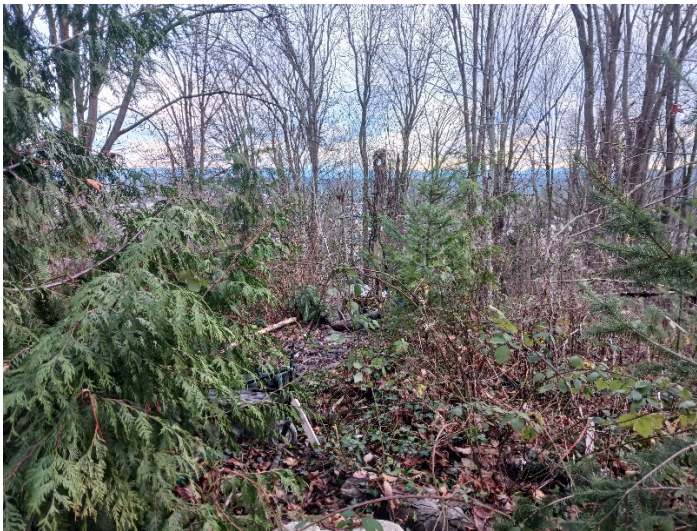
An active encampment was seen to the east of the new Snowberry Loop. Two apparent previous encampments were seen near Cheasty Boulevard at the top of the Cottonwood Trail. Some trash/debris remained after cleanup at the lower previous encampment site but no new trash or debris was seen at either location.

Figure 1: Active encampment near Snowberry Loop Trail

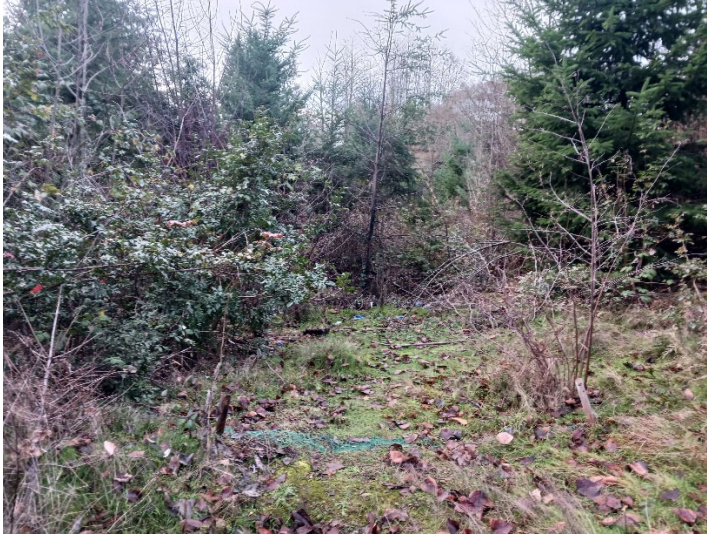
Figure 2: Debris from encampment at first switchback on Cottonwood Trail

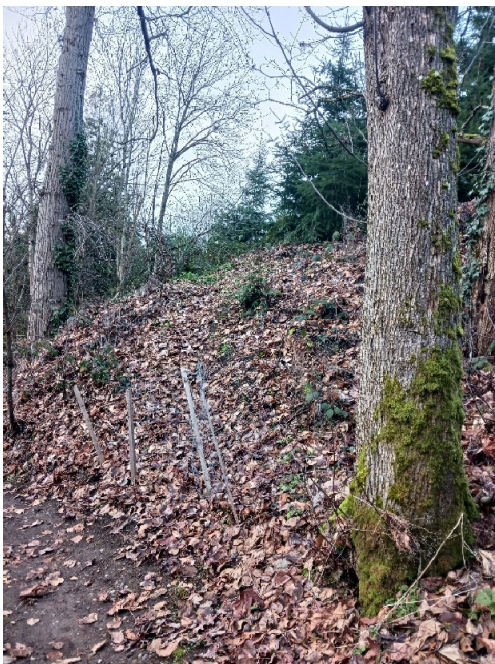
The new mountain bike hill along the Cottonwood Trail was blocked from further building by forest stewards after last summer's report and has been more permanently restored.

Figure 3 Blocked social trail on Cottonwood Trail

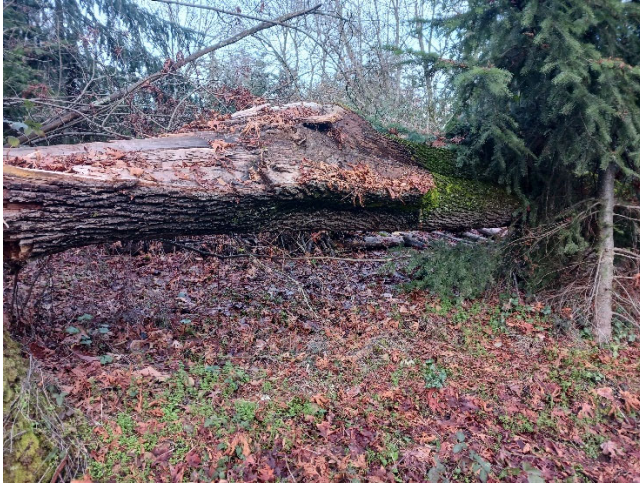
Active social trails were observed near 24th and Cheasty, and at the bottom of the multi-use trail near Columbian Way. The previous social trail between multi-use trail and meadow near Cheasty Boulevard has been blocked by a tree that has fallen. A previous social trail off the 2nd switch back on the Cottonwood Trail has regrown and is no longer visible.

Figure 4 Blocked social trail at meadow

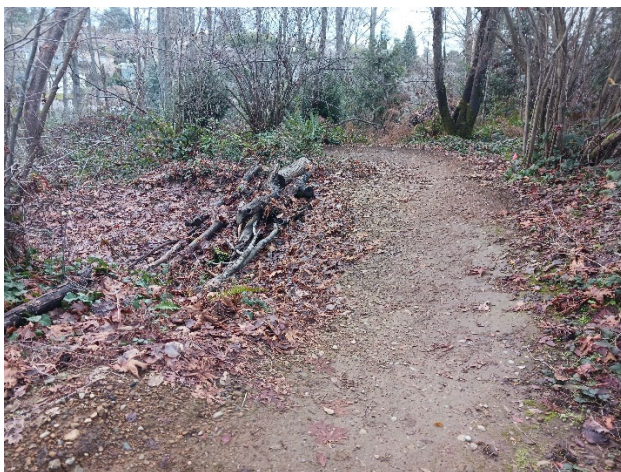
Figure 5 Red Cedar Trail reroute

Rerouting of the Red Cedar trail is complete. Most “No Bikes Peds Only” signs along the Cheasty Boulevard Trail are missing and need to be replaced.
