City of Seattle Source Control Implementation Plan

Volume 3: Appendices

May 12, 2016

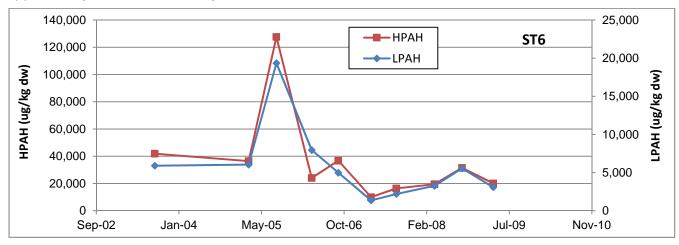
Samples collected from sediment trap ST6 at Bush Pl and Rainier Ave S also frequently exceeded the screening levels (see Map 55b). This drain line serves a mixed commercial and residential basin in Seattle's Central District. None of the three other samples collected in this sub-basin exceeded the screening levels. Sediment trap ST6 results for LPAH and HPAH are plotted in Figure 1. The highest concentrations (19,350 ug/kg dw LPAH and 127,580 ug/kg dw HPAH) occurred in the August 2005 samples. Concentrations have declined at this location and are approaching the SCO screening levels.

Figure 1: LPAH and HPAH in Diagonal Ave S sediment Trap ST6.

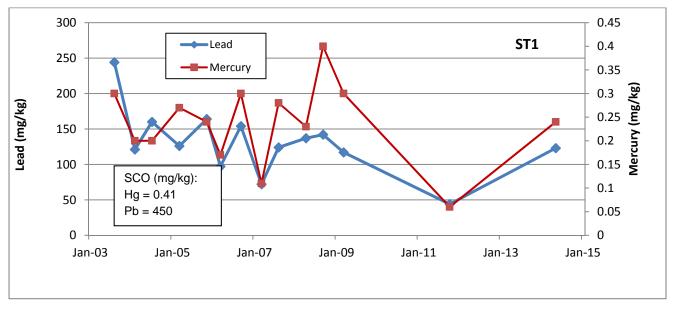
While exceedances of LAET/2LAET screening levels have occurred at various locations in the Diagonal Ave S drainage basins, concentrations at the most downstream sediment trap (ST1 at Diagonal Ave S west of E Marginal Wy S) have been relatively low (except for phthalates). As shown in Figure C-2, lead and mercury concentrations at ST1 are consistently below the SCO screening levels. PCBs and BEHP are plotted in Figure C-3. PCBs are consistently below the 2LAET screening level, while BEHP is well above the screening level. Phthalates are widespread in urban areas and will be difficult to control.

Figure C-2: Diagonal Ave S sediment trap (ST1), mercury and lead (2003-2014).

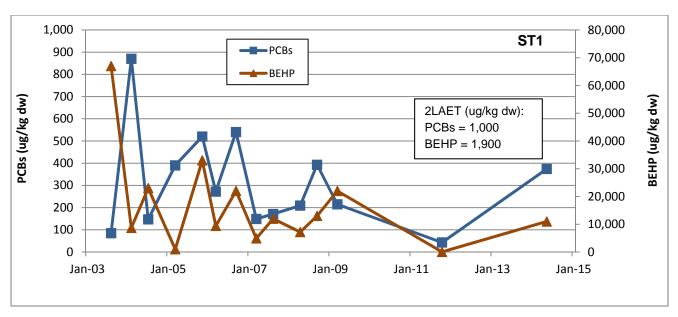
Figure C-3: Diagonal Ave S sediment trap (ST1), PCBs and BEHP.

As noted earlier, SPU removed the sediment traps in the Diagonal Ave S drainage system because concentrations for most chemicals were relatively stable. However, ST1 (downstream end west of E Marginal Wy S) and ST7 (S Dakota St and 6th Ave S) were reinstalled in 2012 to enable SPU to track changes in concentrations over time (Map 55a).

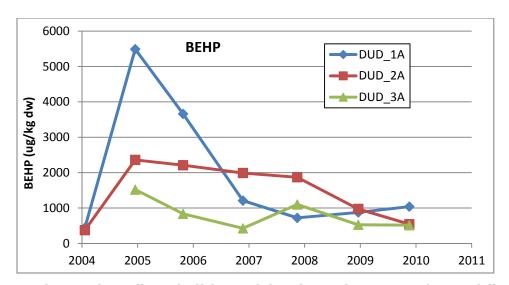
Figure C-4: BEHP in samples collected offshore of the Diagonal Ave S CSO/SD outfall post cleanup.

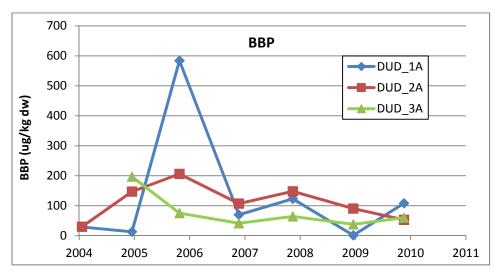
Figure C-5: BBP in samples collected offshore of the Diagonal Ave S CSO/SD post cleanup.

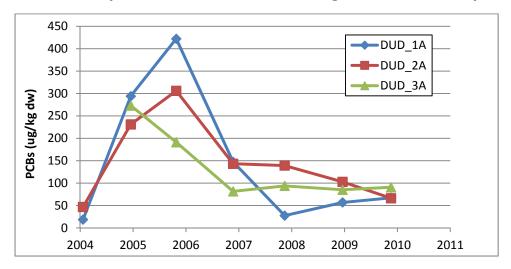
Figure C-6: PCBs in samples collected offshore of the Diagonal Ave S CSO/SD outfall post cleanup.

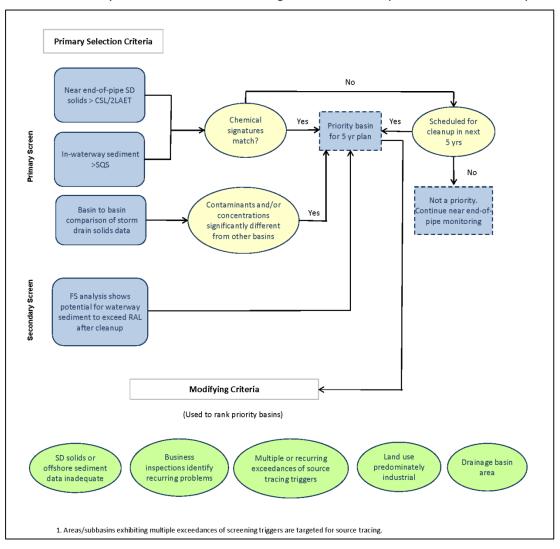
The prioritization process is summarized in Figure J-1. It utilizes two key data sets, storm drain solids samples collected by the City and waterway sediment data compiled for the LDW Feasibility Study (AECOM 2012a, available on the Lower Duwamish Waterway Group's website: http://www.ldwg.org/rifs docs9.htm#finalfs). Prioritization focuses on identifying discharges that could contribute to exceedances of the RALs for contaminants of concern identified in waterway sediment. The following three basic steps were used in the process:

Figure J-1: Basin prioritization process.

- Primary screen. Storm drains were first screened based on storm drain solids to offshore sediment and storm drain to storm drain comparisons. The solids to sediment screening was performed to identify where elevated levels of contaminants were found in both offshore sediment in the vicinity of the outfall and storm drain solids samples collected from near the end of pipe or point of discharge to the waterway. When matches were found, the basins were identified as a source control priority. Methods used in this analysis are described in more detail in Section 3. Storm drain to storm drain comparisons were conducted to assess whether one storm drain exhibited a different contaminant signature than other drains in the LDW. Differences in either the contaminants present or the levels of contaminants present can indicate the presence of a unique source(s) in that basin. Systems that exhibited higher concentrations of chemicals than other drains in the LDW were flagged as priorities regardless of whether the chemicals exceeded the CSL/2LAET trigger.
