**Arborist Report
PRELIMINARY**

Site: City Hall Park

Re: Tree inventory

Date: November 7, 2023

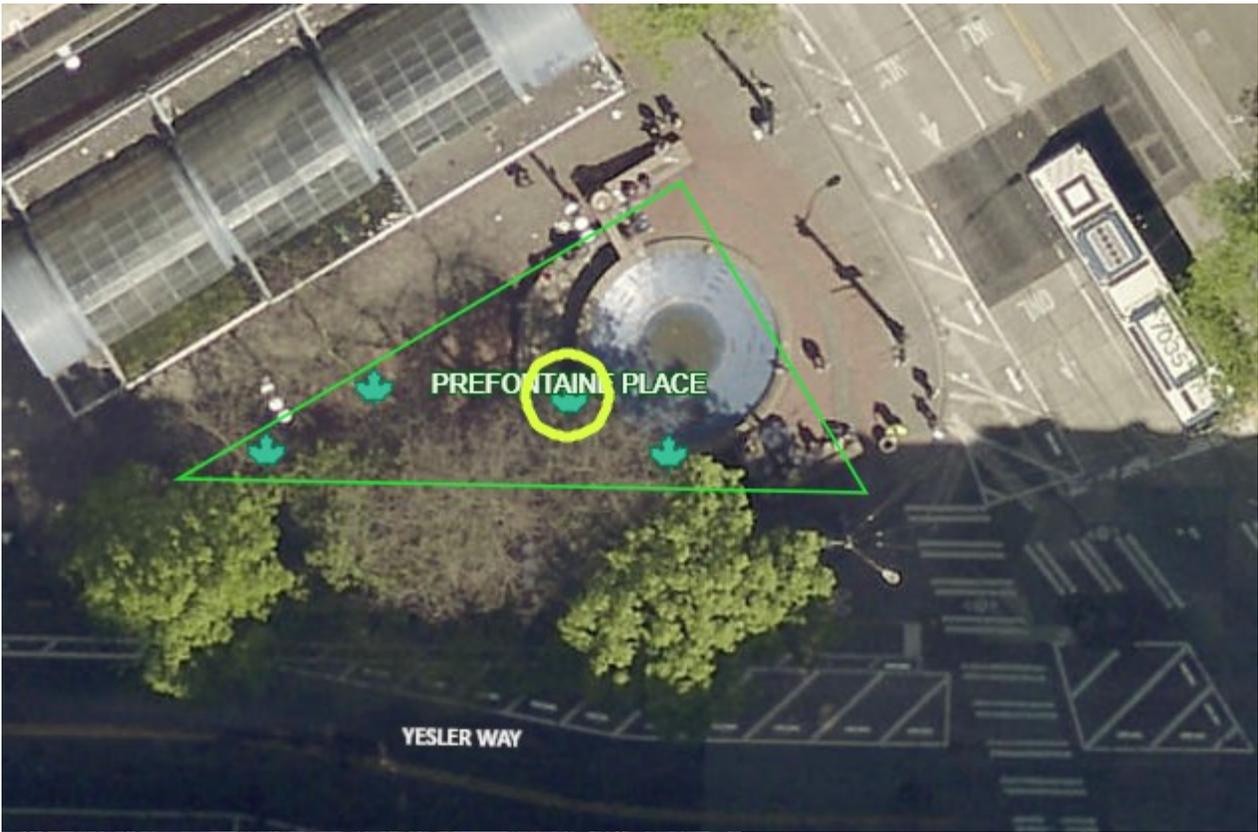
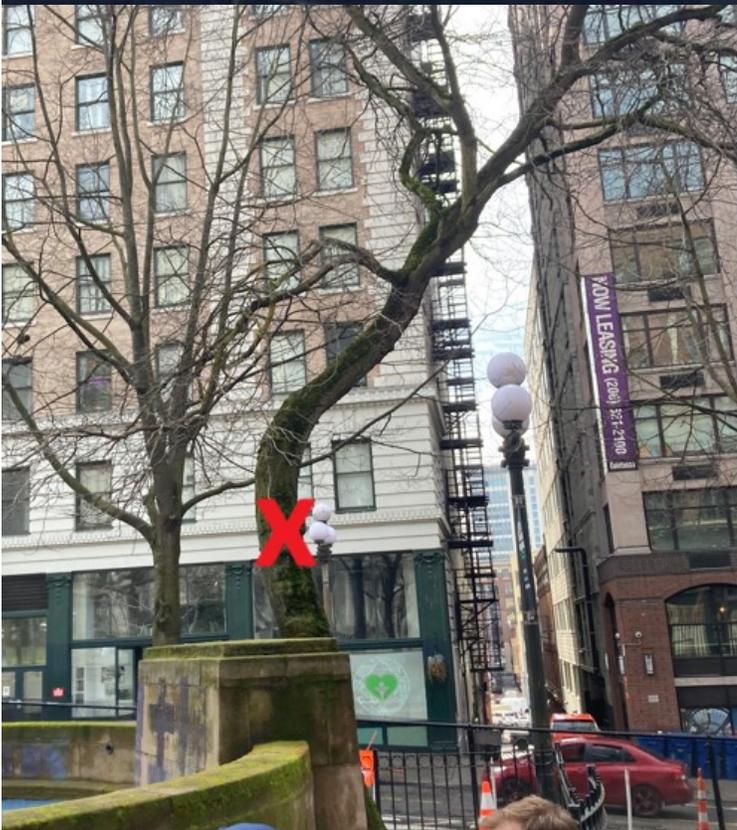
As discussed earlier, we would like to proceed with removing the tree marked with an X, which is the one most leaning. We will compensate for this tree at a 3:1 rate on a site other than Prefontaine TBD. Please confirm this understanding. Thank you!

We visited this site and with your input determined that the trees signified below with a bold red circle are in fair to poor condition and can be removed. What is the process required to expedite the removals?

Yes, confirmed. Please make sure this is reflected on the plan and the replacement tree locations are provided with the plan.

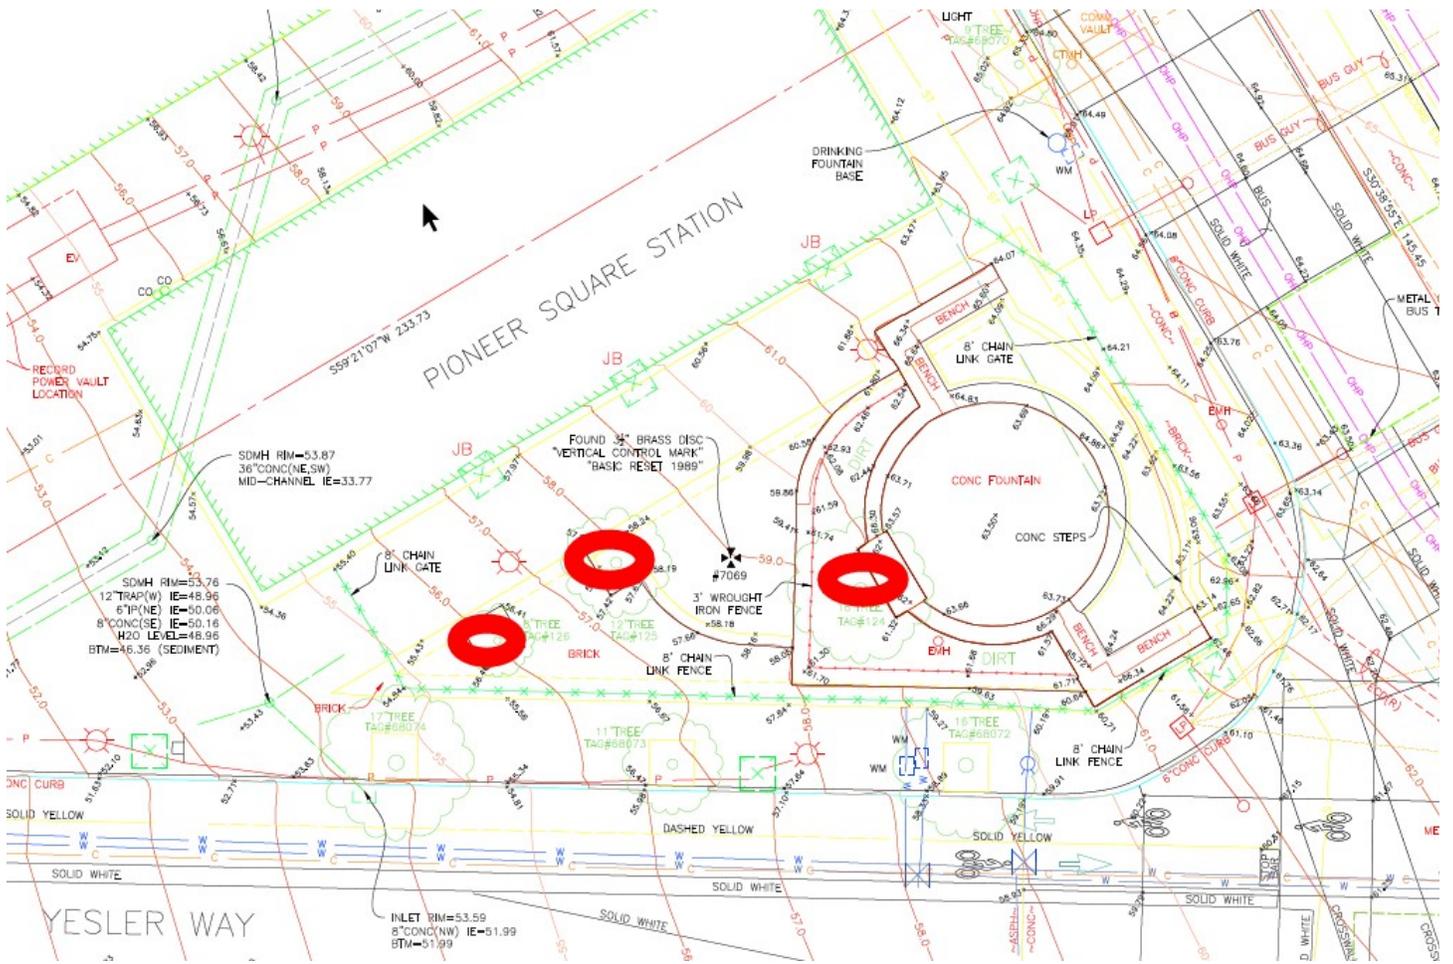
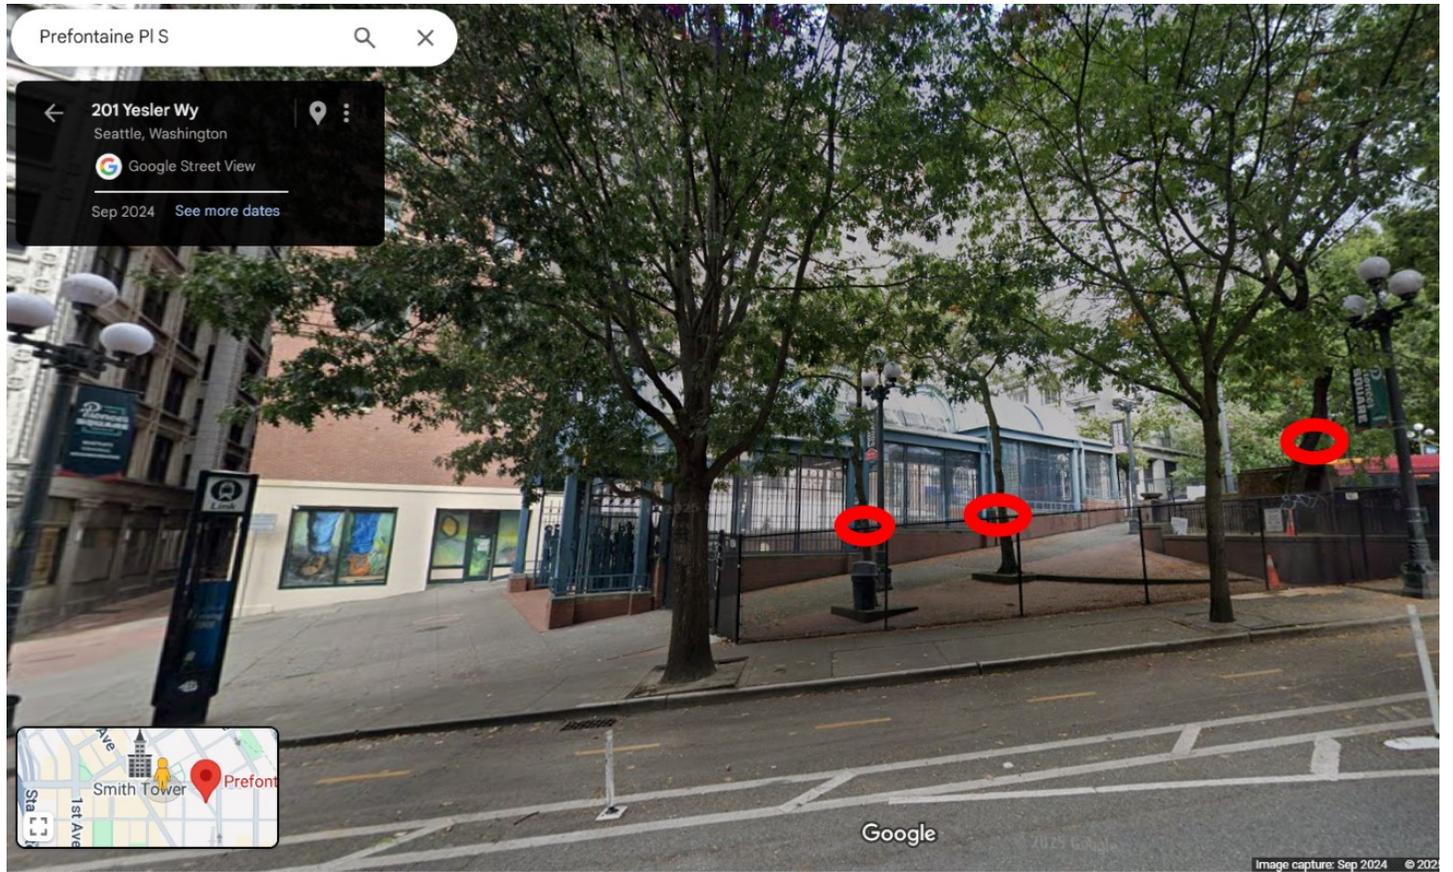
Morteza - after you left yesterday Ben and I noticed there is some damage to the main monument. Some of the blocks have shifted. After closer inspection, it appears the large tree that is leaning has been pushing on the stones in windstorms and has pushed the stones out of place by about ¼ of an inch. Ben was stressing that that tree really needs to come out in order to preserve the integrity of the structure.

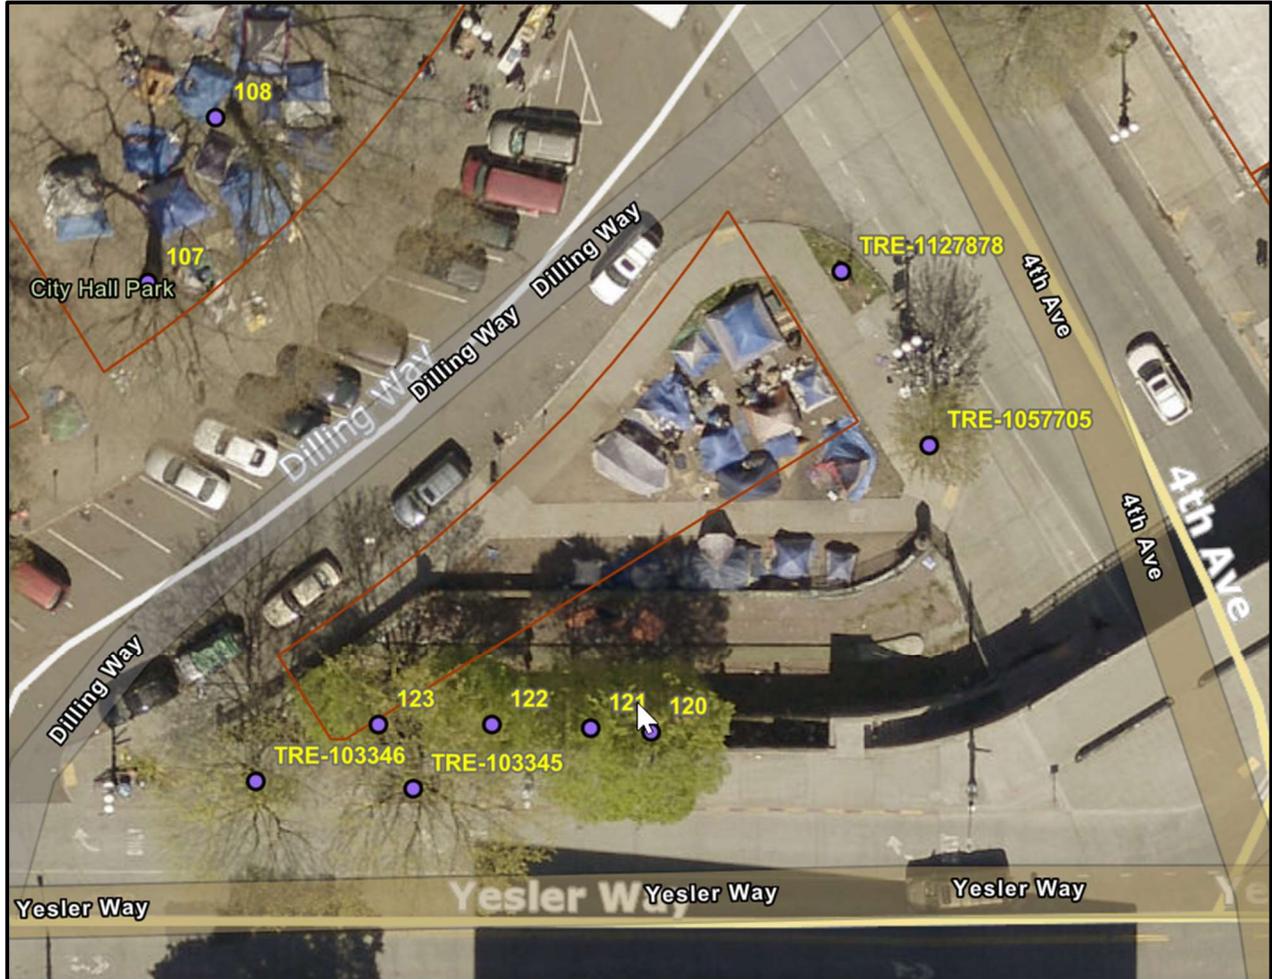
Figure 2. Tree locations and IDs for triangular area between Yesler Way, 4th Ave and Dilling way. All trees appear to be public trees managed by SDOT.

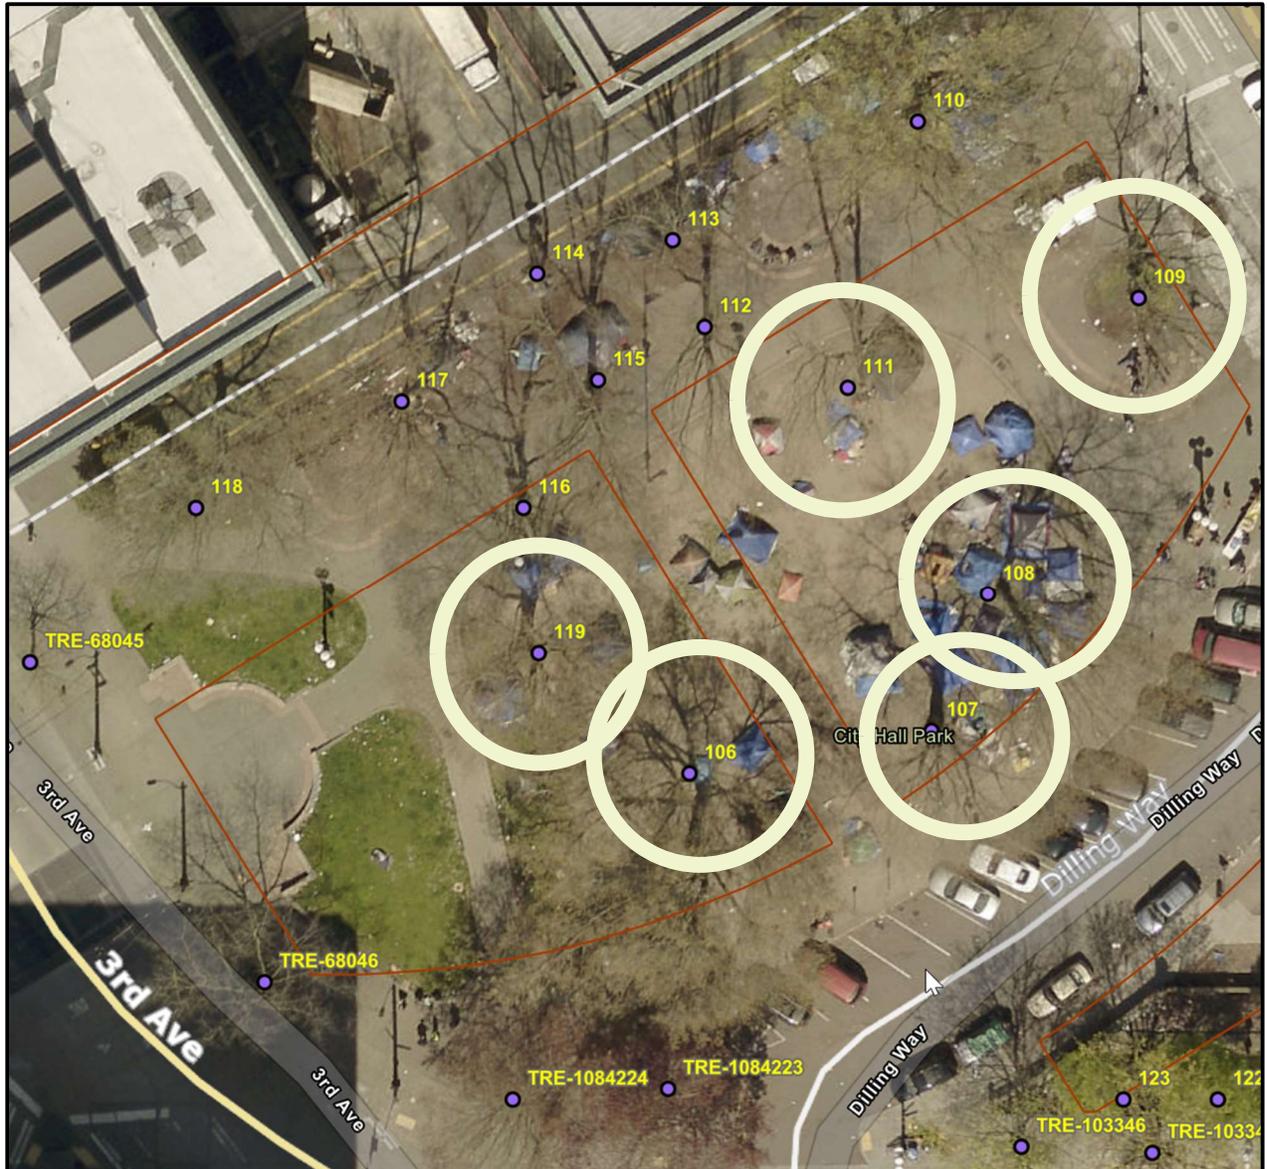
Figure 3. Tree locations and IDs for City Hall Park. Yellow circles are trees classified as 'Tier 2': Trees #106, 107, 108, 109, 111, 119.

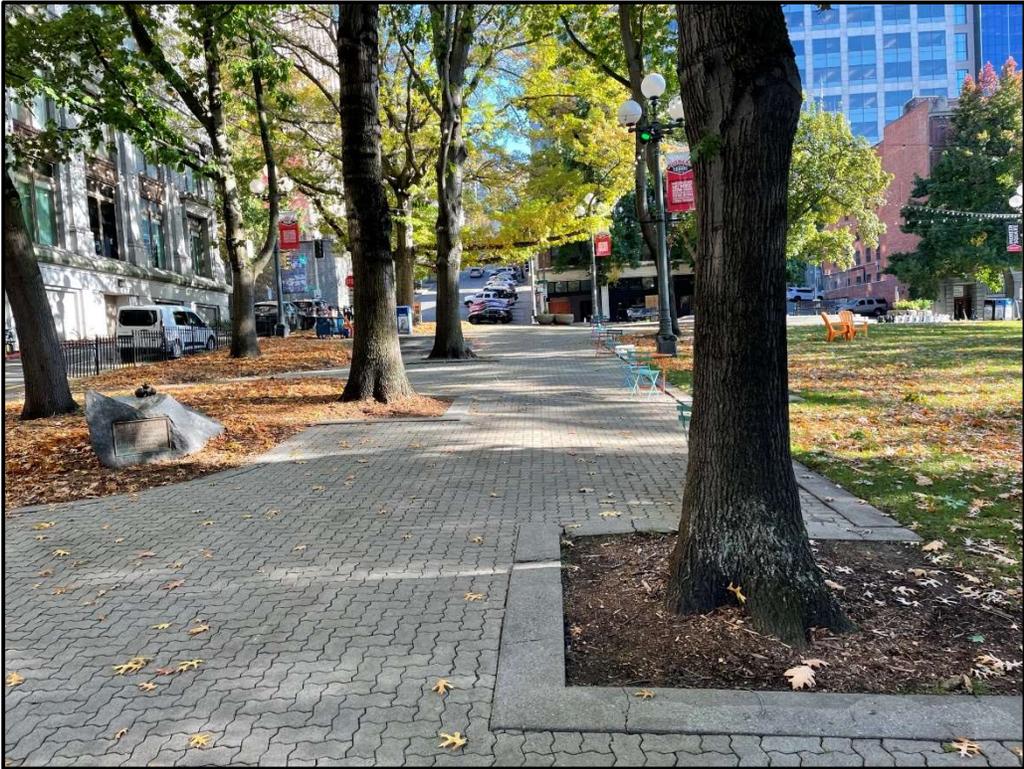
Photo 3. Trees to the left of this walkway are publicly owned trees, trees to the right are private.

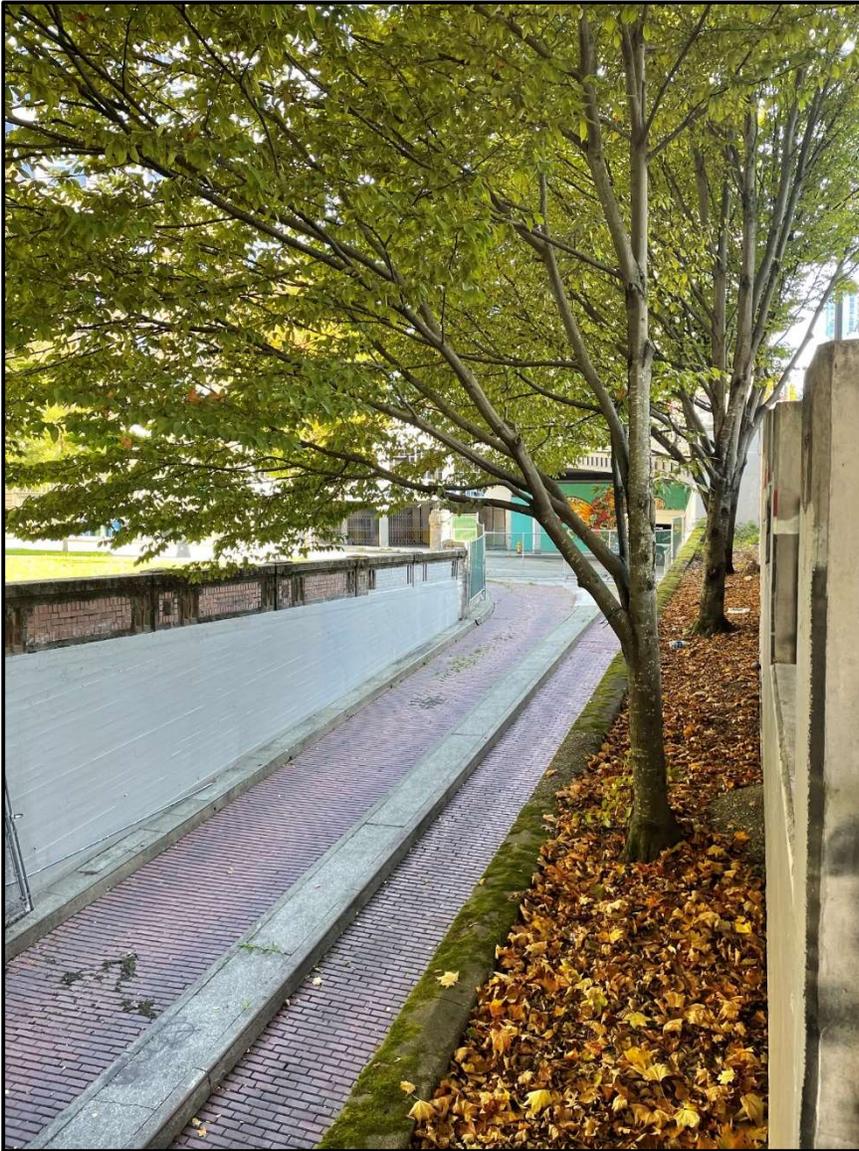
Photo 8. View east of street trees at the top of retaining wall
