# PACIFIC APARTMENTS REHABILITATION

# EXISTING CONDITIONS- CONTEMPORARY PHOTOGRAPHS

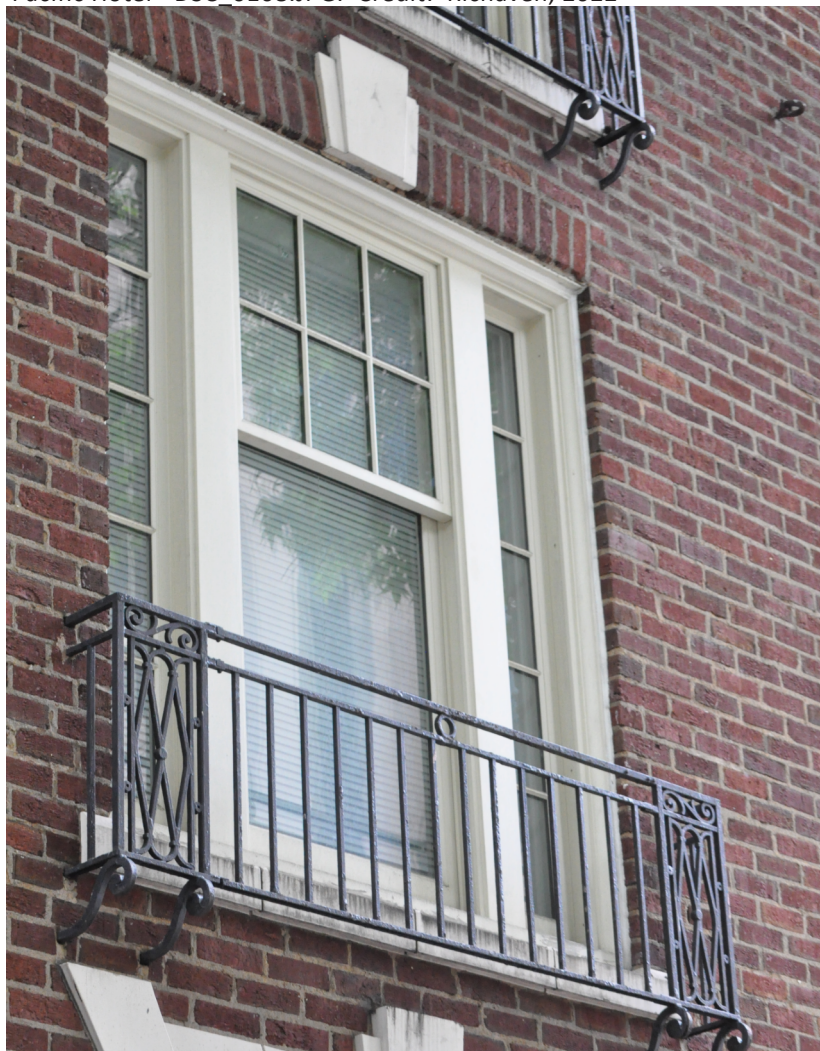
Figure 15: Typical window on the east (Fourth Avenue) elevation.  
210526 PAC EL-E DSC\_0684.JPG. Credit: Richaven, 2022

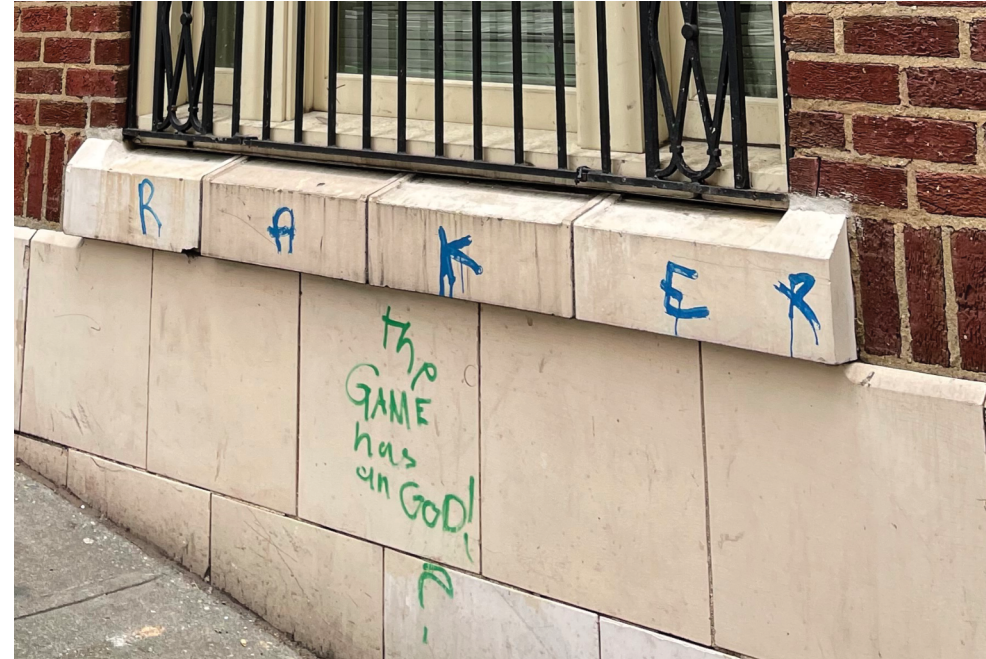
Figure 20: Typical paint graffiti on the terra cotta at the north elevation of the building.  
220222 PH-Pac Sample 7 IMG\_1068.JPG. Credit: Richaven, 2022

Group B terra cotta units have been coated with paint and/or graffiti. The initial treatment includes removal of existing paint and graffiti to determine if there are further deficiencies and the appropriate treatment required. Where Group B units are cracked or severely damaged, they will be replaced similar to the Group A terra cotta units. Where Group B units demonstrate severe crazing or deterioration of the glazing, they will be re-coated with a terra cotta patching coating. Where Group B units are in generally good condition, no re-coating of the units will be undertaken.

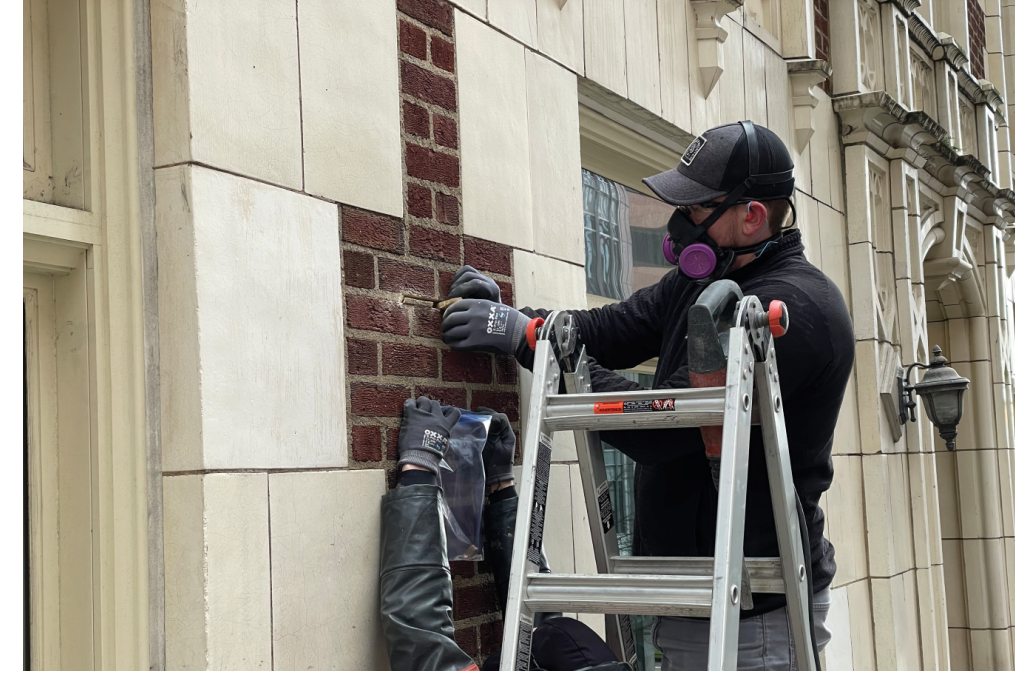
Figure 34: Mortar samples were taken at both brick and terra cotta for lab analysis to confirm the color, composition, and properties to be matched to ensure in-kind replacement materials. 220222 PH-Pac Sample 9 IMG\_1091.JPG. Credit: Richaven, 2022

Baseline repointing includes repointing 20% of the façade area with the potential to be expanded to 100% repointing if the budget permits. The emphasis of the repointing will focus on areas of worst deterioration. In-kind repointing mortar with a natural hydraulic lime formula will be used for repointing. Sky-facing mortar joints at the parapet terra cotta units will be replaced with pre-formed silicone joint fillers.

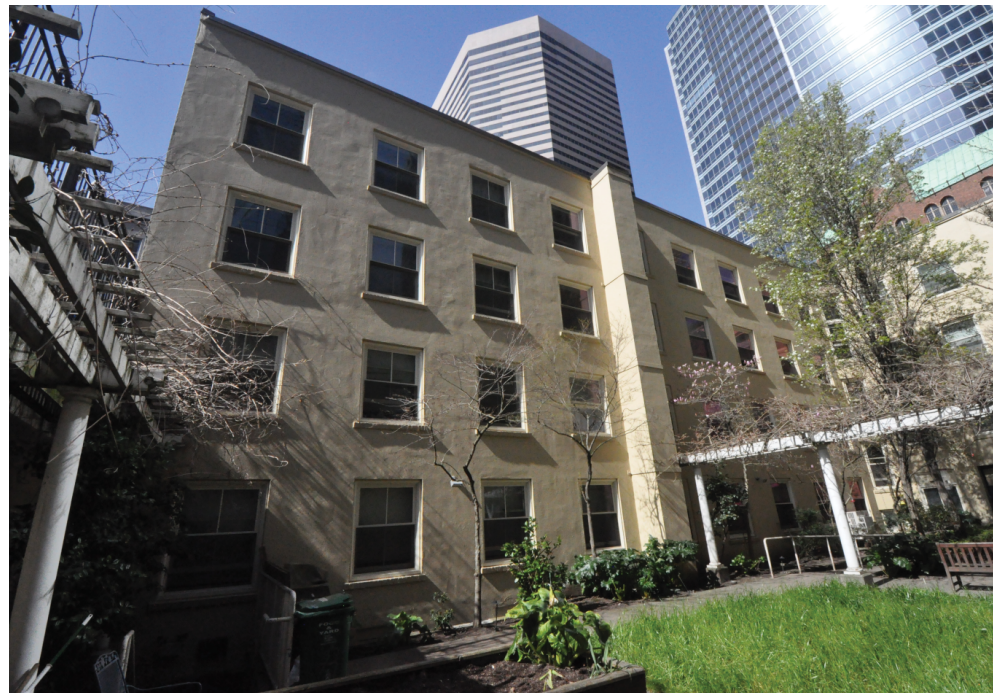
There are numerous different types of soiling and staining on the exterior of the building, including organic growth (plants, algae, moss, lichens, etc.), atmospheric soiling, graffiti, markers, crayon, spray paint, efflorescence, etc.

Multiple different cleaning processes are anticipated utilizing the gentlest means possible to remove the soiling. Optimum cleaning methods and level of cleanliness will be established through a series of mockups. Metal bristle brushes and scrapers will be avoided. Acidic cleaners will be avoided where possible due to the high potential for damage to historic building fabric and the lime content of the mortar joints. Similarly, all harsh abrasive and mechanical cleaning methods will be avoided. All cleaners will be neutralized and thoroughly rinsed off the face of the building.

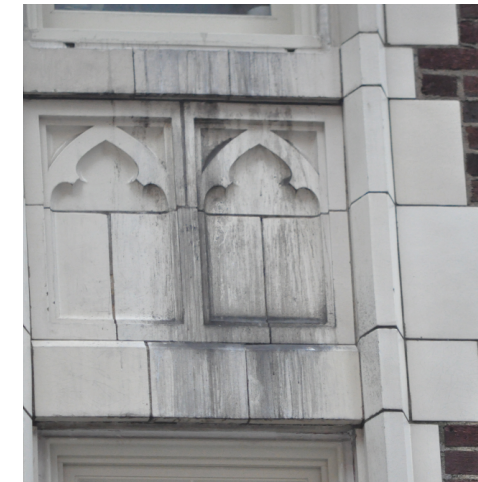
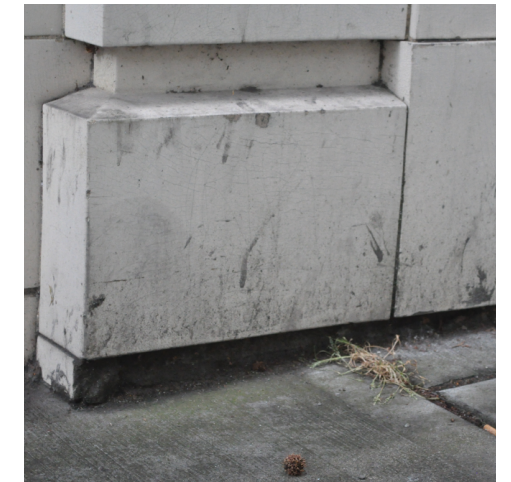
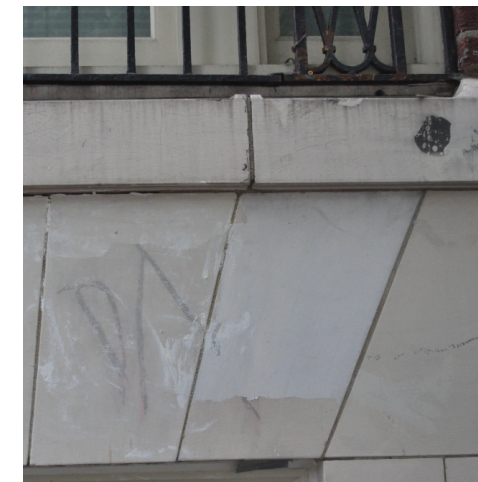
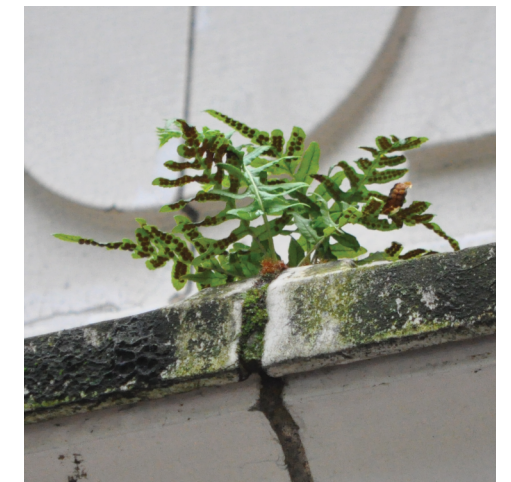
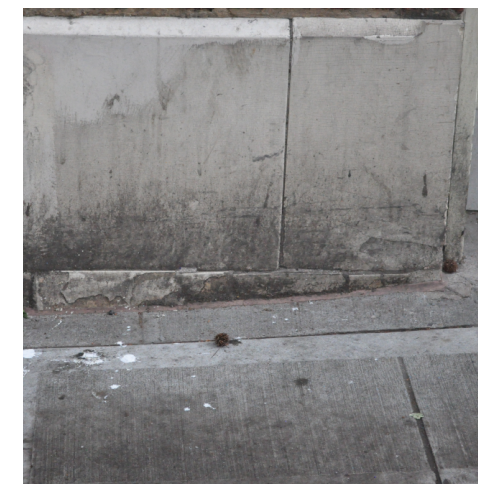
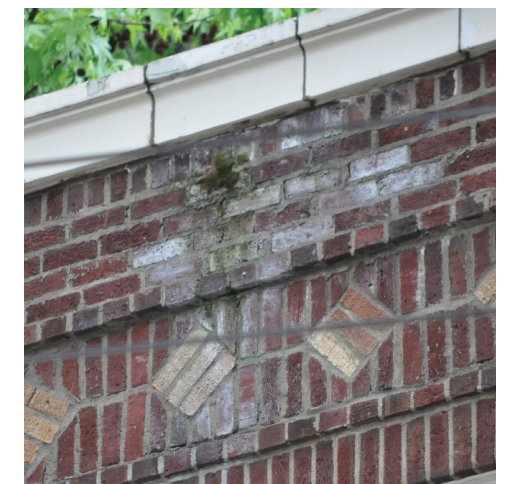
The building's structure is reinforced concrete with infill of interlocking clay tile, clad with brick, terra cotta, and stucco. The terra cotta cladding is glazed with a smooth white or cream-colored glaze and includes both flat blocks and sculptural shaped units. The terra cotta has numerous deficiencies ranging from life safety concerns to aesthetic issues, including:

- Glazing failure due to crazing
- Spalls, incipient spalls, and cracked units
- Open and poorly sealed mortar joints
- Failed mortar at terra cotta joints
- Inappropriate joint repairs (sealant, poorly matched mortar)
- Inappropriate repairs at cracked and spalled units (sealant and cementitious mortar)
- Corrosion of embedded steel components leading to rust jacking and cracking or breaking
- Out-of-plane seismic anchoring of masonry walls
- Unsealed seismic anchor penetrations

Terra cotta units have been classified as "Group A" (red) and "Group B" (green) based upon the nature of the deficiencies observed. Group A terra cotta units are cracked, spalled or otherwise damaged and will be replaced in-kind with glazed terra cotta units to match the existing deteriorated units.

Terra cotta veneer elements over and adjacent to the primary entry/exit will also be anchored via face pinning.

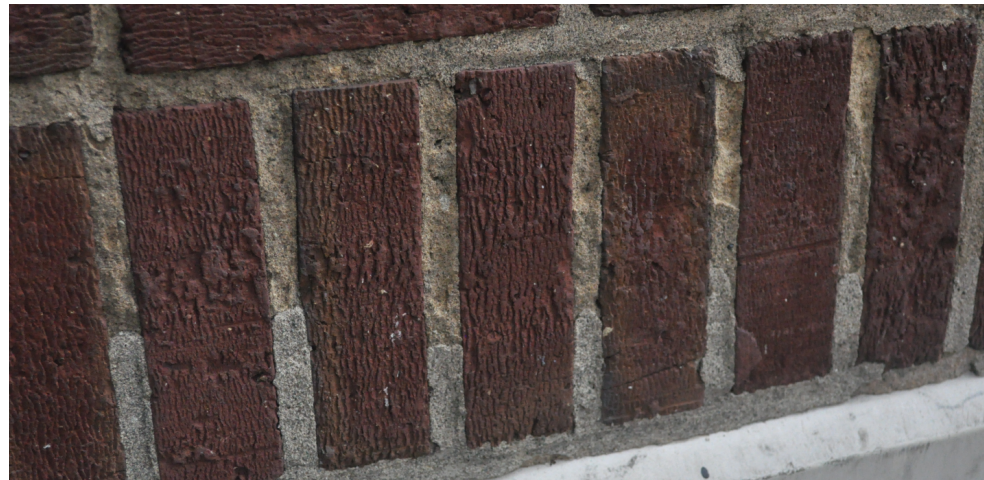
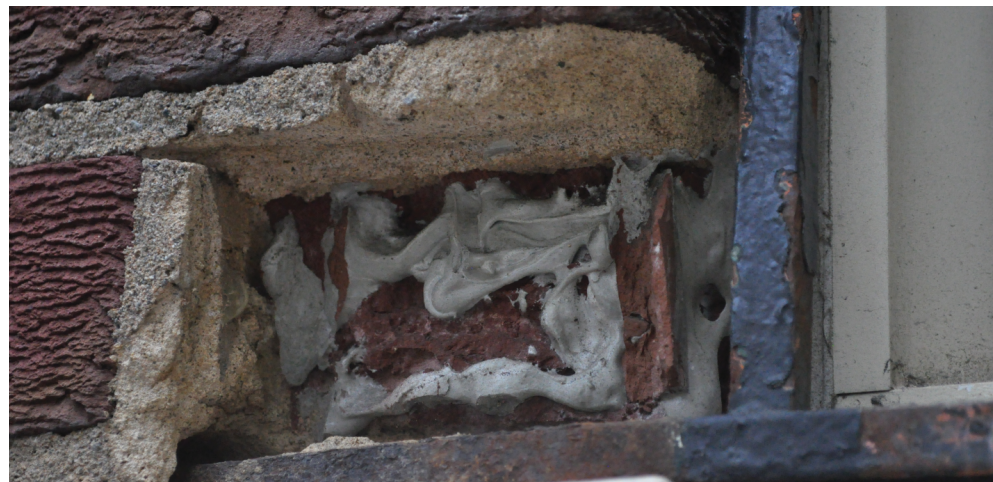
## FIRED CLAY BRICK

The building's structure is reinforced concrete with infill of interlocking clay tile, clad with brick, terra cotta, and stucco. The brick cladding is a single wythe veneer over the clay tile and concrete structure. The brick masonry units are in relatively good condition with some missing or cracked units.

Deteriorated brick masonry will be replaced in-kind with attention to size, color, texture, etc.

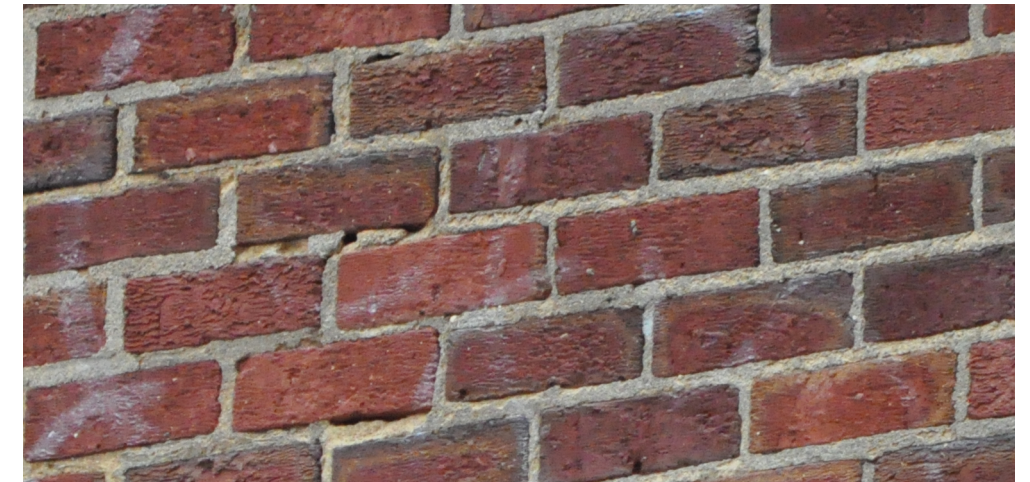
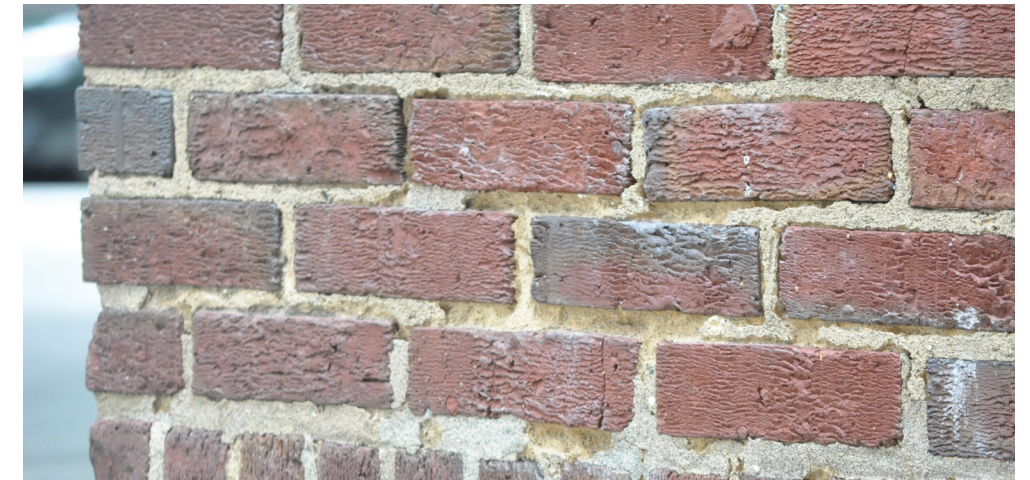
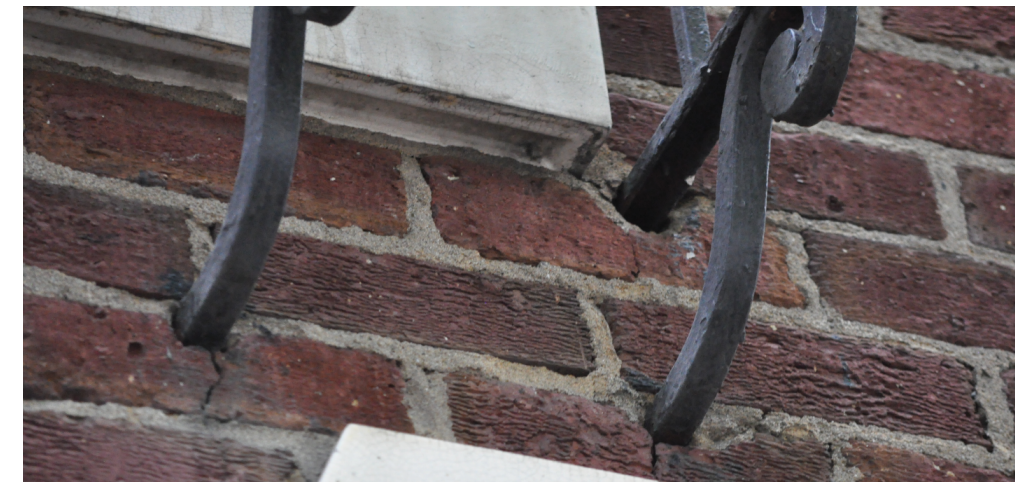
## MORTAR JOINTS

Mortar at both brick and terra cotta joints is in generally poor condition. Minor repointing and superficial repointing have been performed in the past. In some locations, mortar is deteriorating and/or disbonding from the brick masonry unit.

The brick mortar joints are typically about 3/8" wide at brick and 1/16" to 1/8" at terra cotta. The same mortar mix was used for both types of masonry units and for setting mortar as well as pointing mortar. Material analysis indicates the mortar at brick and terra cotta is a relatively uniform cement:lime : sand mix ratio of 1:2:10 Type O mortar. The mortar is generally a yellowish matrix, grey-brown aggregate, small to large pores.

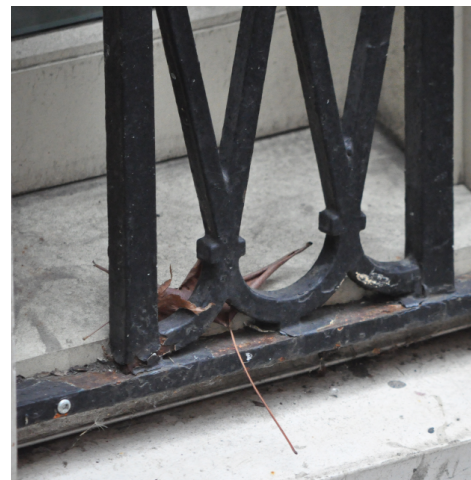
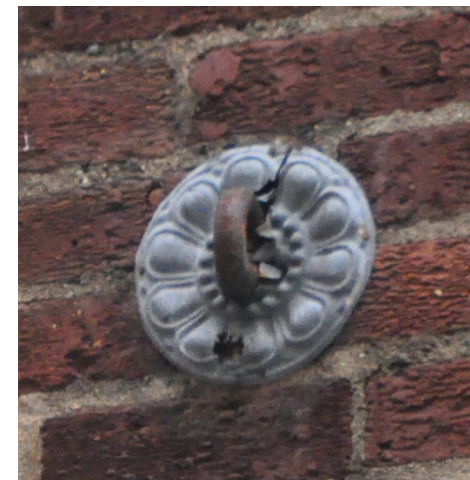
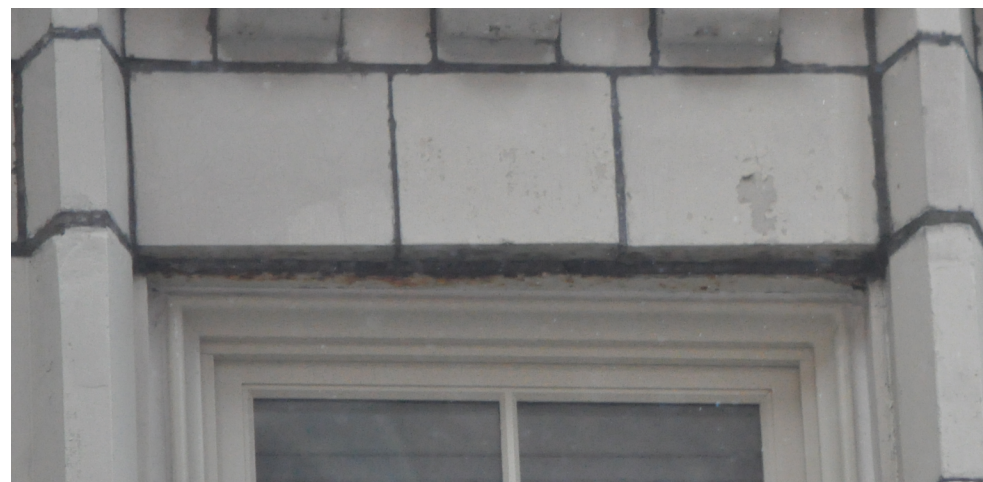
## ARCHITECTURAL METALS

The building features ornamental metal railings on the north and east elevations at the windows. These iron railings are painted black and embedded into the brick masonry cladding. They exhibit dislodged mortar, corroded metal, failed paint coatings and brick masonry due to a combination of freeze/thaw cycle damage and rust jacking from the corroding iron railing. The railings have been directly fastened into the wood window frames with long screws to provide additional stability. All embedded wrought iron railings will be cleaned, prepped, recoated, and reinstalled. In addition, railings on the Fourth Avenue and Marion Street elevations will be removed and repaired. The operable gates created in 1994 will be fixed in a closed position to repair where they were previously cut.

Inoperable hardware for the gated center sections of the railings was observed at multiple locations. This appears to be due to corrosion of the hardware (locks and hinges), sagging of the gates, and sagging of the fixed sections embedded in the walls.

Window and door openings are spanned with lintel angles. Portions of the steel angles are exposed to view and weather. Several of the steel lintels appear to exhibit a low to moderate degree of corrosion.

Steel lintels, where corrosion is observed, will be cleaned, prepped and recoated. Where deterioration warrants, lintels will be replaced in-kind.

Existing rosettes on the elevation are stamped metal shapes which will be salvaged and replicated. Replication will be completed by casting molds of the original rosettes. New cast aluminum rosettes in the same size, shape and configuration as the original rosettes will be painted and installed. Embedded eye bolts and miscellaneous anchors will be removed, and the holes patched. For sheet metal parapet copings and flashing, see the Roofing section.

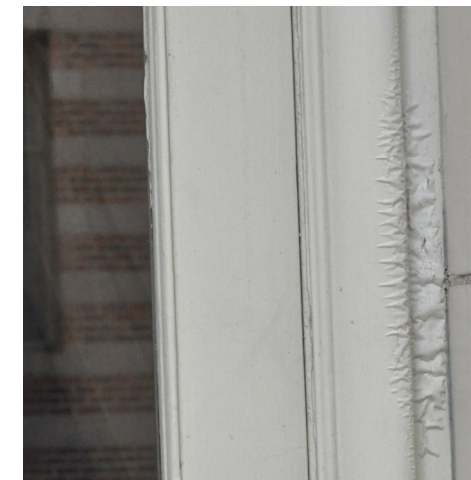
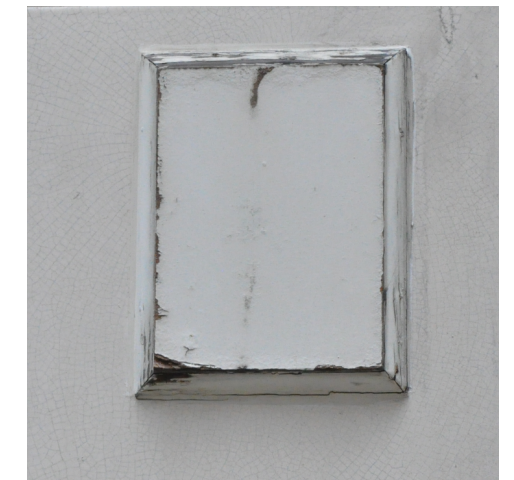
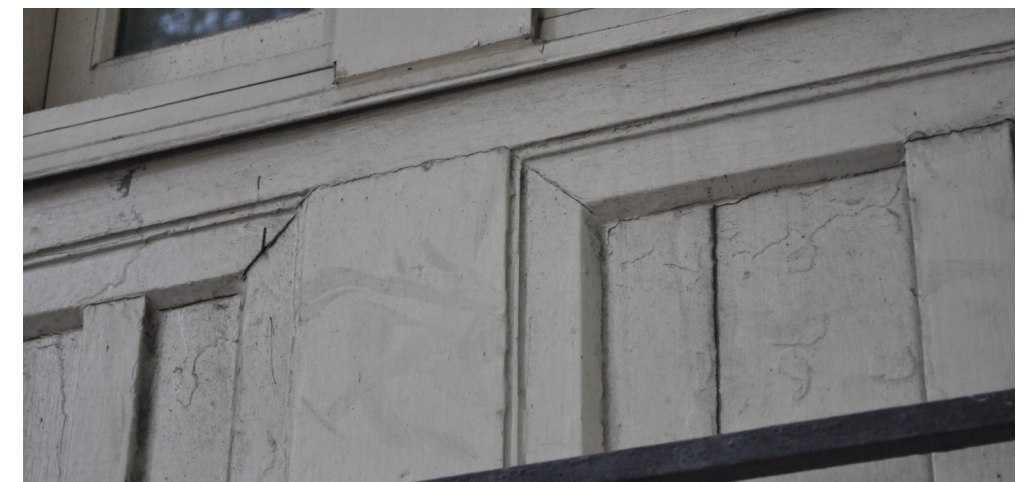
## EXTERIOR WOOD WORK

The building includes select locations of wood features, typically at the window and door trim, including wood panels below windows. Wood materials are typically painted white, though the main entry doors are varnished. The wood finishes are dirty (atmospheric soiling) and deteriorating in many locations. Exterior historic woodwork will be cleaned, prepped, and repainted. Minor repairs to the woodwork will be completed to repair cracks and similar minor deterioration. Existing glazing, hardware, frames, sashes, and other components will remain in place during the work.

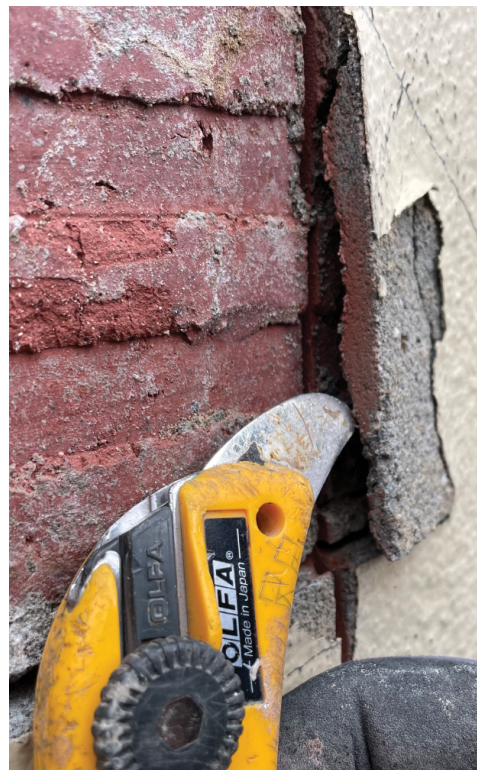
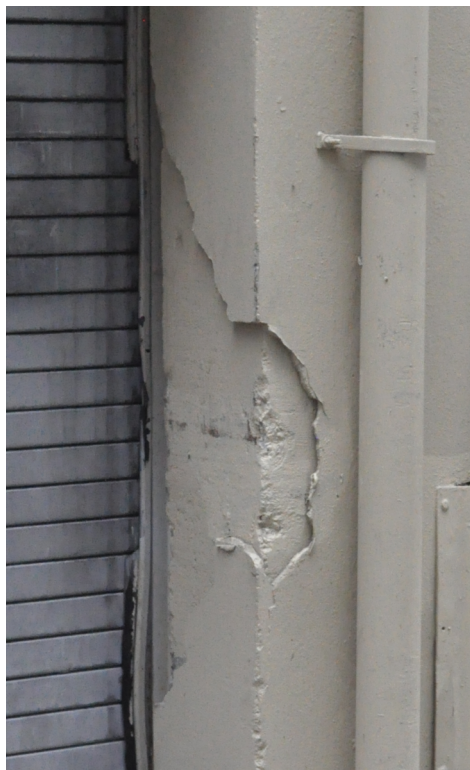
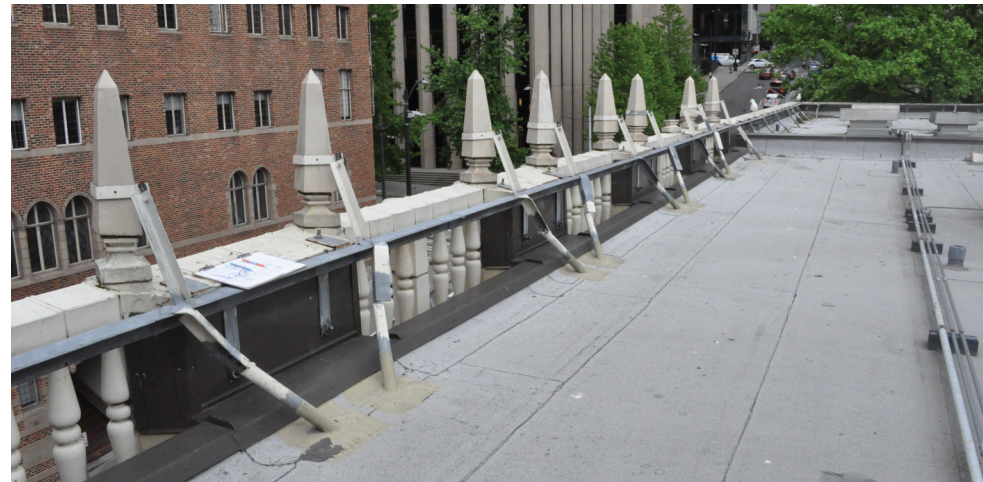
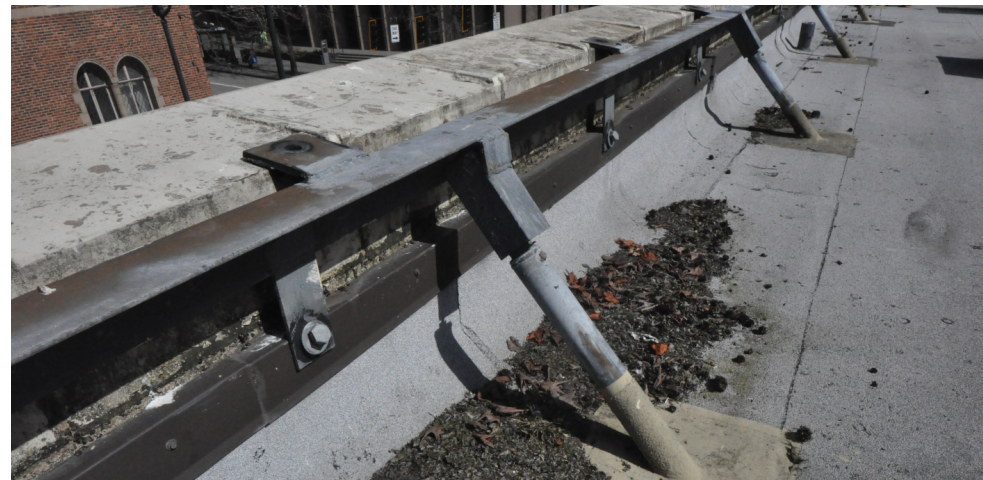
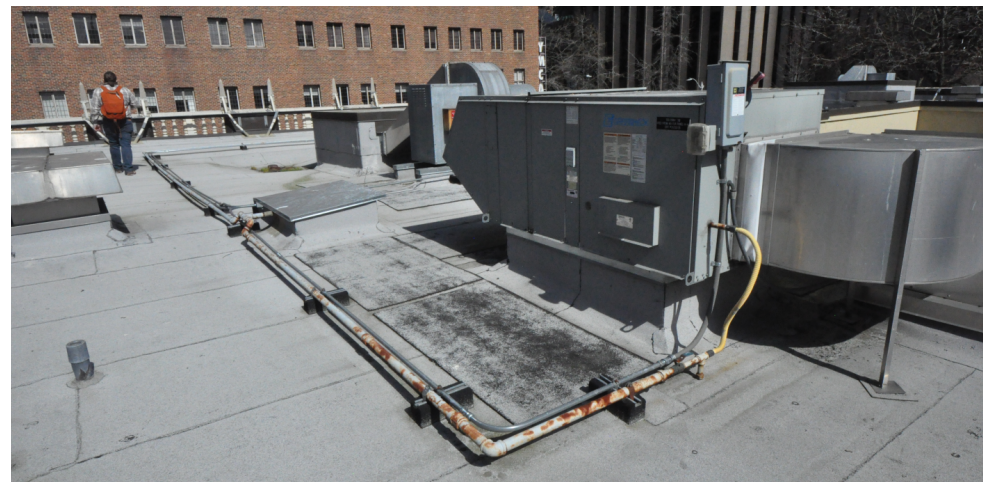
## STUCCO

The structure of the building is reinforced concrete frame with infill of interlocking clay tile at the exterior walls. The majority of the exterior walls are clad with stucco over the concrete structure and clay tile. The 1/2" thick grey stucco has a yellow colored acrylic paint finish but no lath or movement relief joints. The stucco shows limited cracking, coating failure, and delamination totaling about 15% of the stucco wall area.

All stucco clad walls will be fully sounded to confirm areas of delamination. Delaminated stucco will be removed, and replaced with in-kind stucco with anchors and lath to prevent delamination in the future. The stucco mix ratio is 3/4 parts lime : 1 1/2 parts cement : 3 parts sand. All stucco surfaces will be re-coated with vapor permeable coatings or mineral paints.
